' COMMISSARIAT '
MARITIME MUSEUM

CLIFF STREET , FREMANTLE
WESTERN AUSTRALIA

by Gordon Palmoja

PUBLIC WORKS DEPARTMENT
ARCHITECTURAL DIVISION
W.E. BATEMAN F.R.A.I.A.
A/PRINCIPAL ARCHITECT

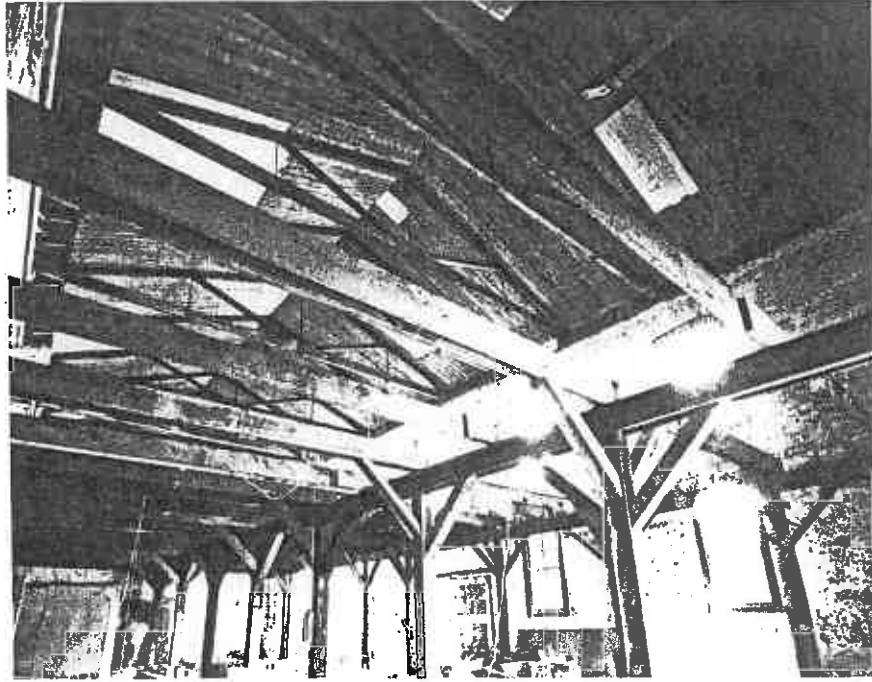
Removal of first floor section for
Batavia Gallery.

Access onto the deck of the fully rigged stern section (complete with cannon) is to be from a mezzanine floor. To form the void for the Batavia, most of the original first floor of a store room of the Commissariat Building was removed. This floor formerly supported an external limestone wall which, although now unsupported and over eight metres high, was determined to be structurally adequate after repair and restoration. Further strengthening of the wall will be provided by the supports for the Batavia stern.

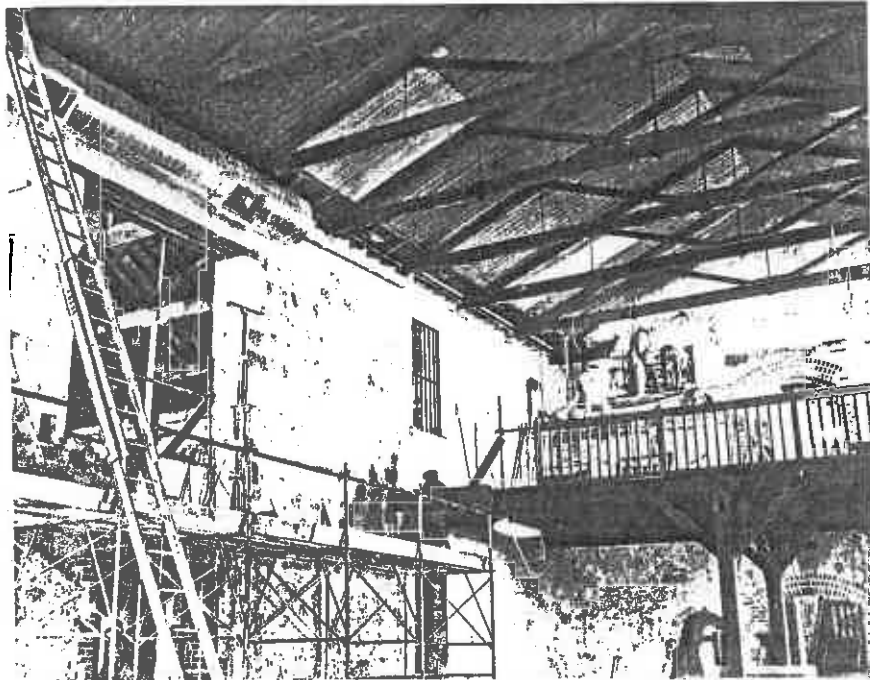
Removal of floor section complete.

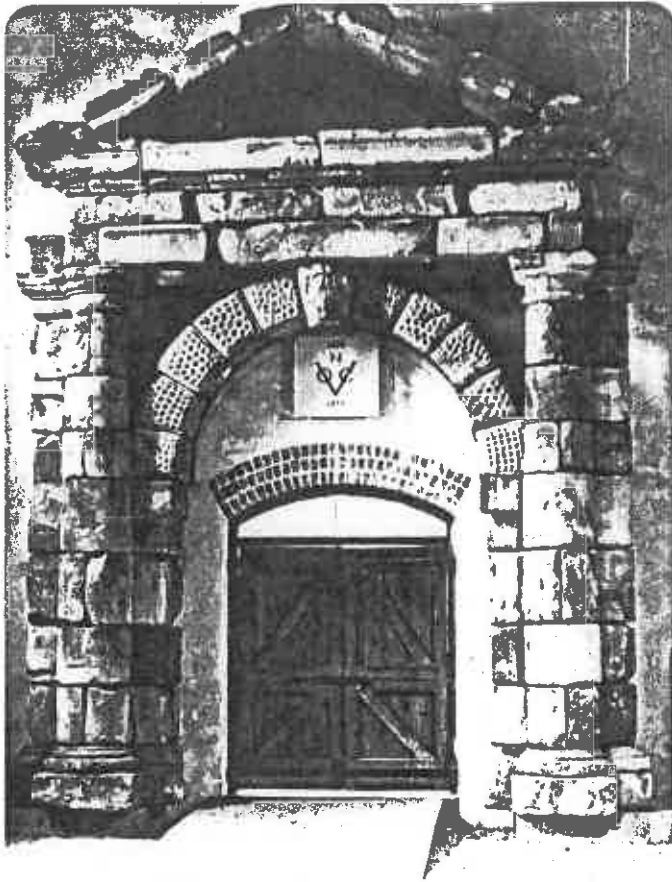
Stone portico in the
Batavia Gallery.

The stone portico was prefabricated in Holland and carried as Ballast to be erected as the entrance portico to Batavia Castle. The ballast portico has been reconstructed on a steel frame with each stone being held in position with chemical anchors.

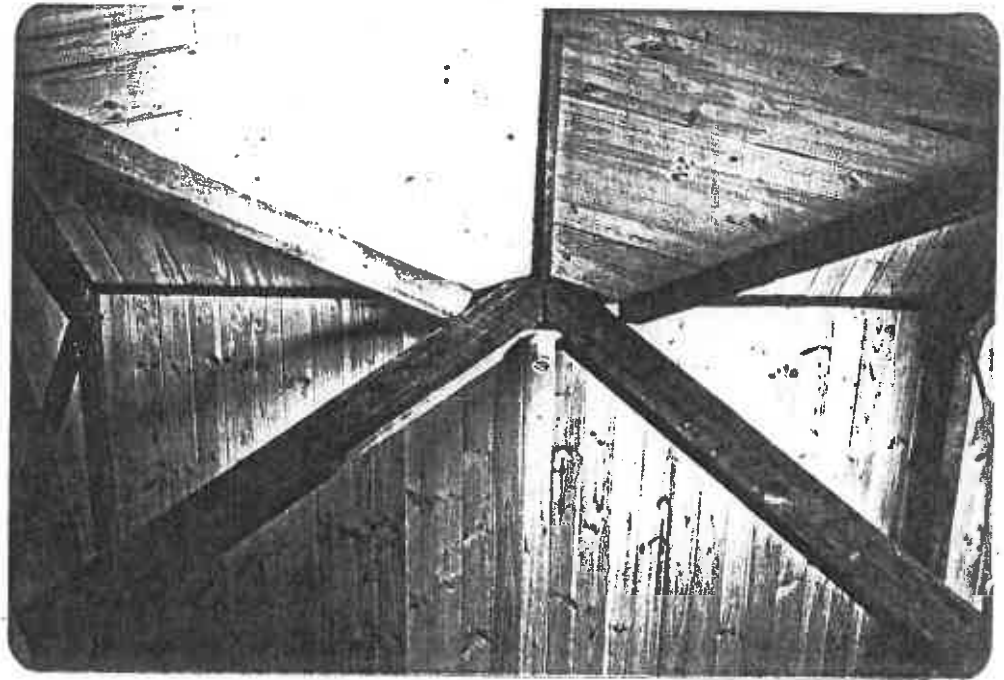
New T & G pine ceiling in Conservation area.

Ceiling Renovation; The underside of purlins were lined where required to match existing with T & G pine boards, and mineral fibre insulation was installed above the ceiling.

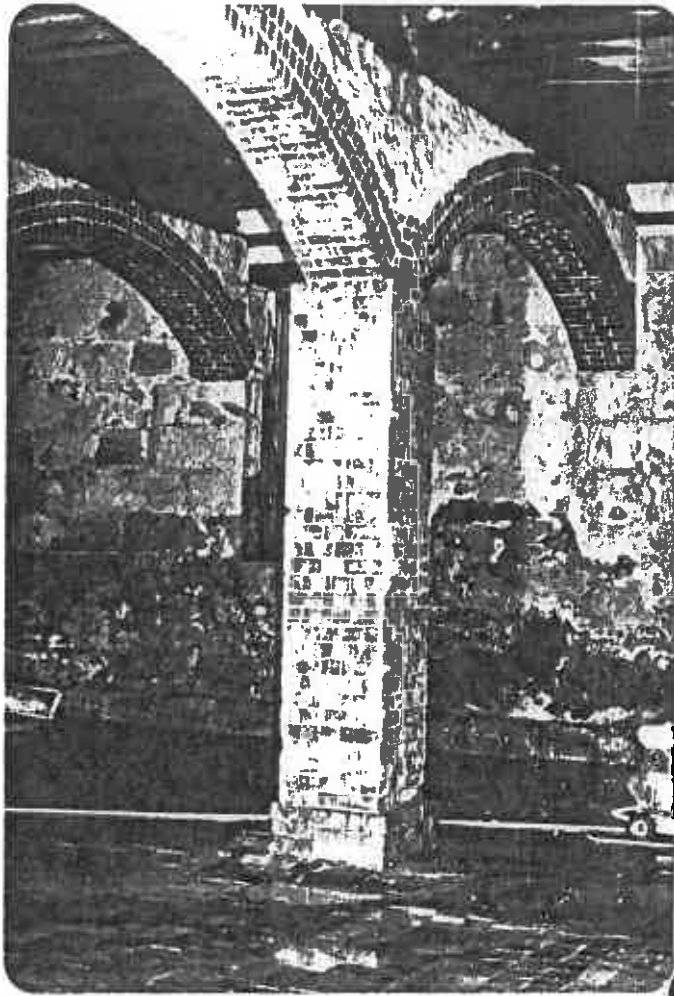
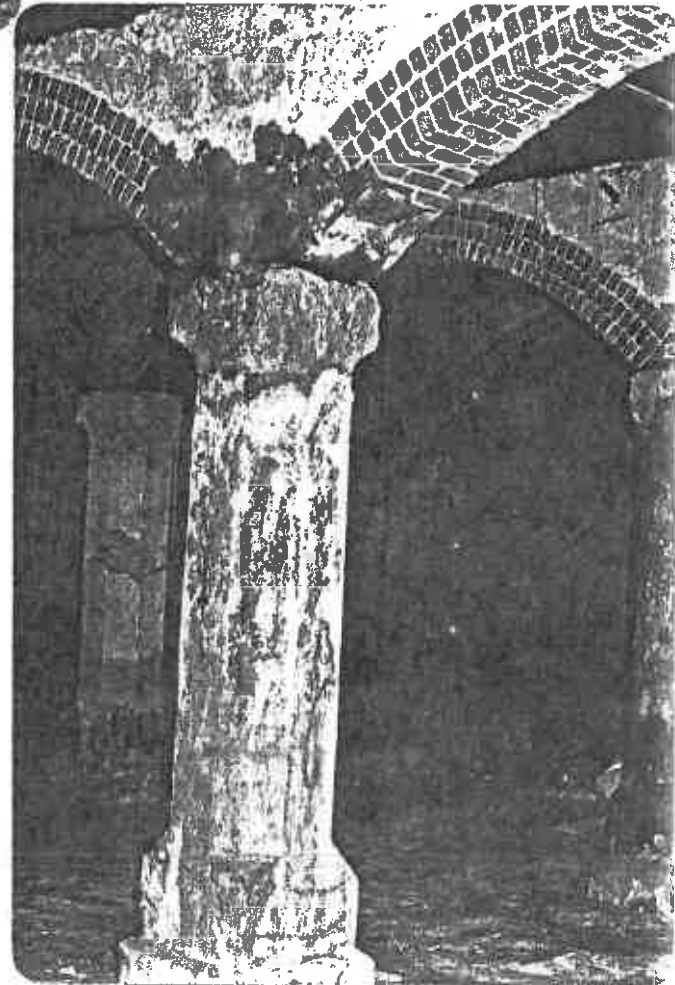
Conditions of brick and
limestone columns before
renovation.

Pressure injection of a mortar coloured epoxy grout was the method used to strengthen the original brickwork arches of the Lower Display Area. Scavenged bricks of the same vintage and appearance complemented that work. Construction of a new arch to mask a previous steelwork extension was so well executed in scavenged bricks and concrete that the layman could not differentiate between the old and new arches. Matching new bricks have also been successfully used in the restoration work.

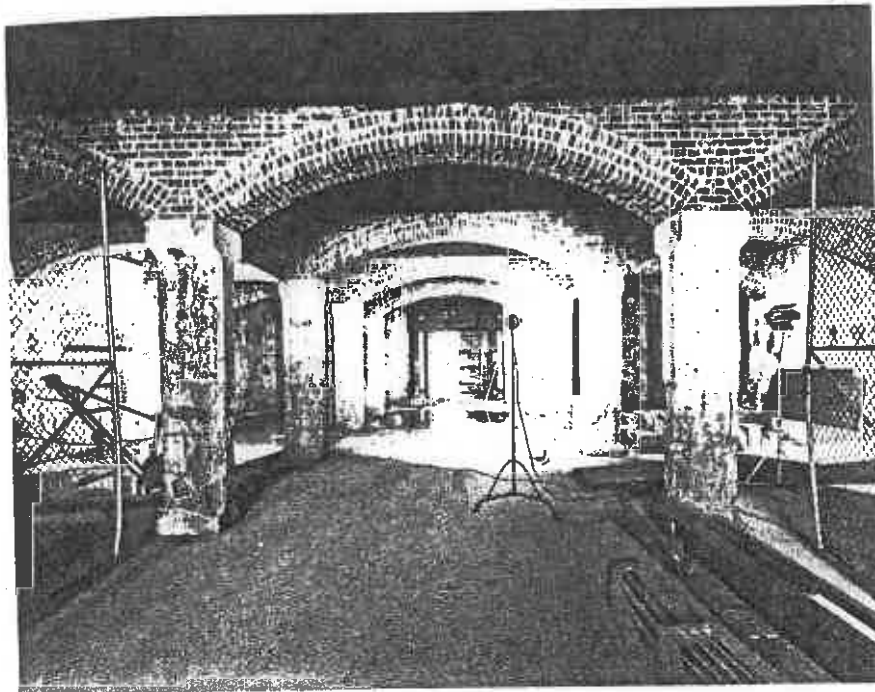
Limestone Columns and brick arches in the Display Gallery before renovation.

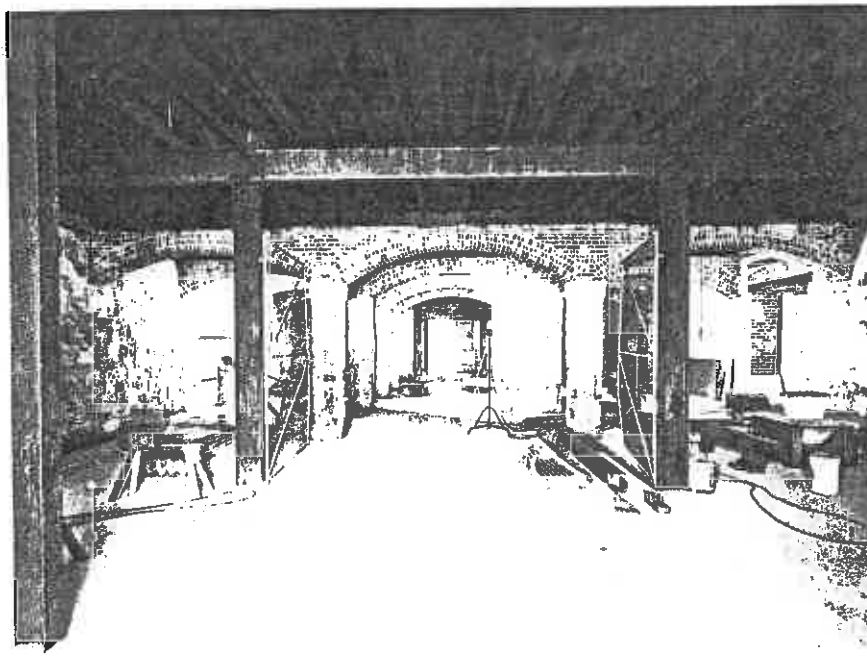
Steel column and beam replacing existing limestone columns and brick arch.

To facilitate the removal and reconstruction of the existing columns at ground floor level it was decided to prop the roof trusses, first floor and brick arches to remove the load from the columns.

A freyssinet jack between new steel columns and their new footings will be used to jack the columns against the arches to take up the load before the props are removed. Formwork used for the new concrete columns in Stage 1 will be re-used to clad the steel columns with cobcrete which, when painted, closely resembles the original rendered limestone.

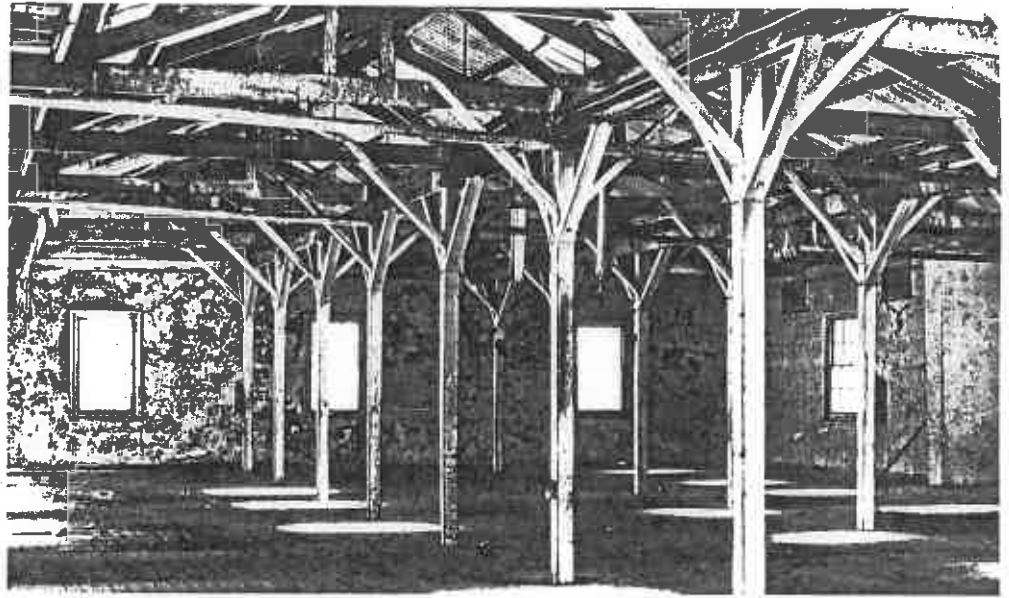
North wing first floor before renovation.

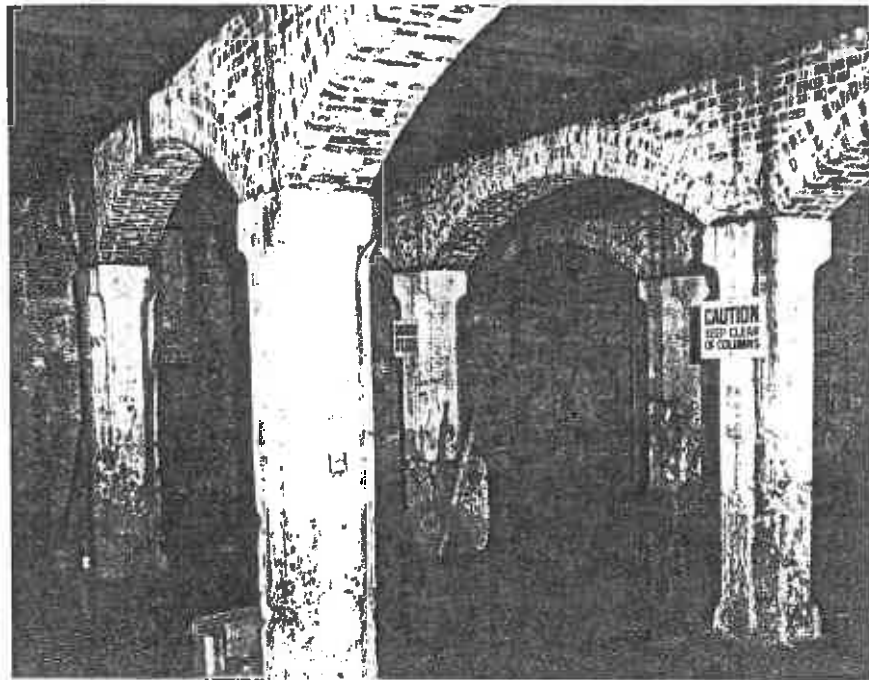
Interior of the 1st Stage of the Commissariat before restoration.

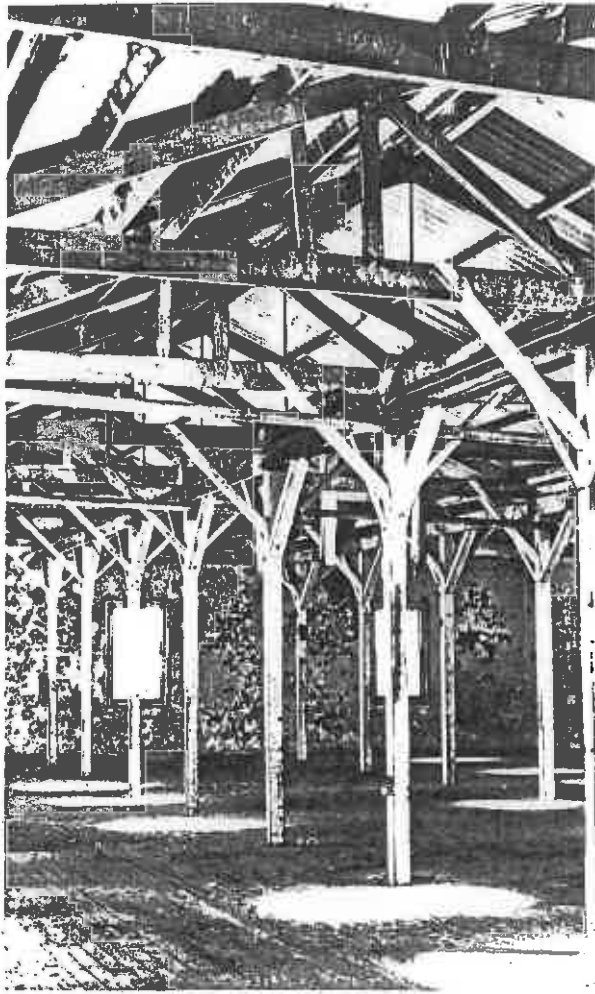
1st floor north and "B"
store before restoration.

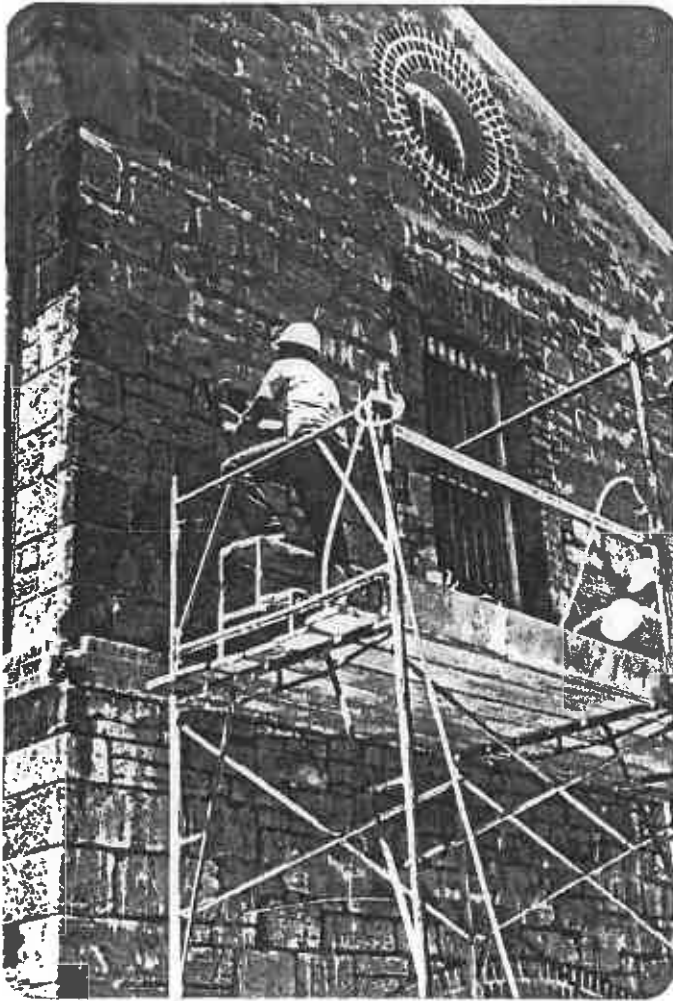
Restoration of external limestone walls by chipping and brushing - later abandoned in favour of hydrocleaning.

Limestone Renovation; this was perhaps the most time consuming, painstaking activity of the renovation programme. Some of the stonework was in extremely poor condition, to the extent that daylight was visible through the walls. The deterioration was caused by the building's exposed situation and the high water table. In winter the water would rise and in summer fall, leaving salt deposits in the wall which break down the limestone structure. The walls were first cleaned, either by hydroblasting or chipping and scrubbing. Stone blocks were replaced as necessary. The footings were treated with Raffles "Goliath" masonry water repellent with 7.2% silicone resin in white spirit gravity fed into 45° holes, 150mm above ground level at 300 centres. The walls were also sprayed externally with a silicone resin solution.

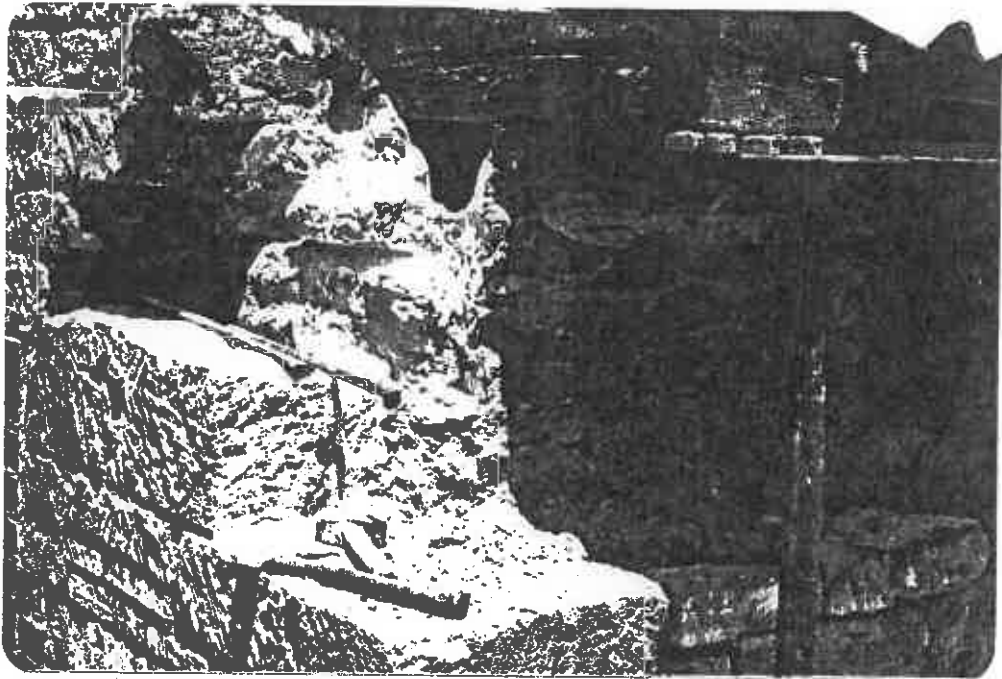
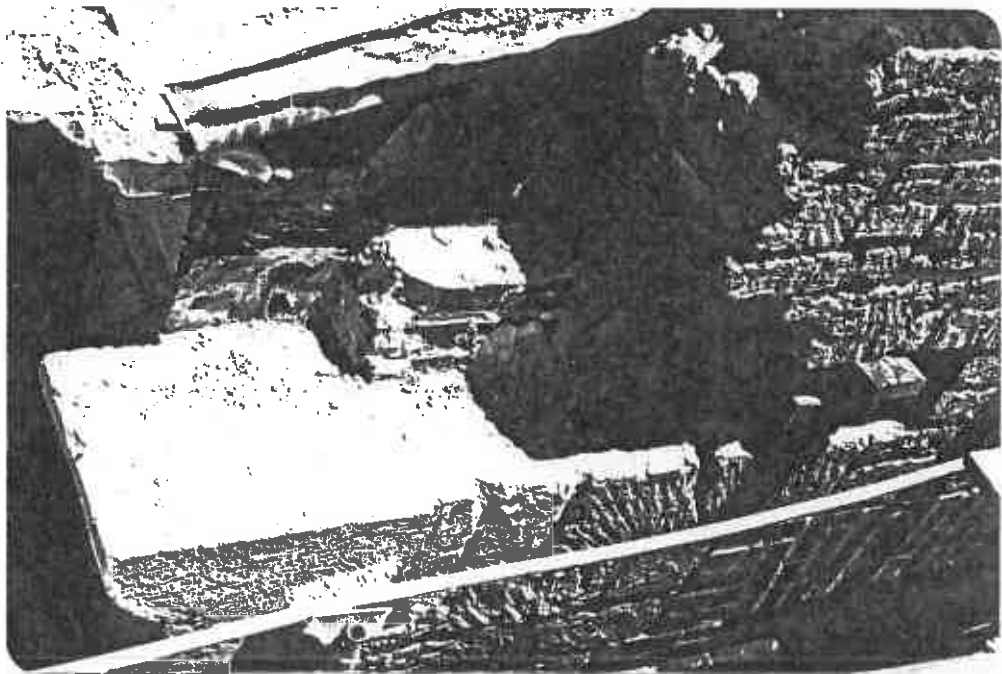
Corbel re-construction.

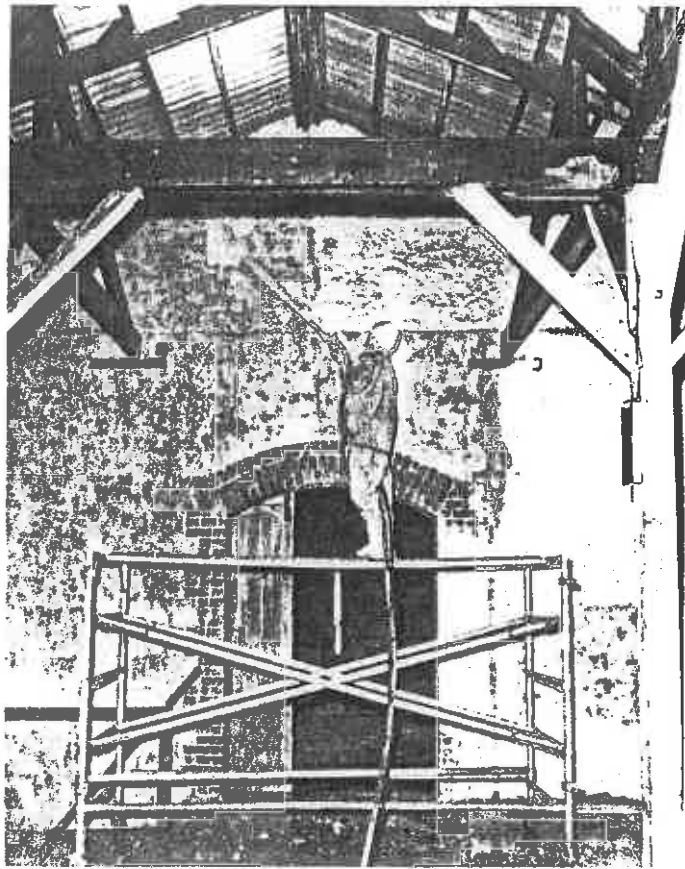
Hydrocleaning of
internal limestone
walls.

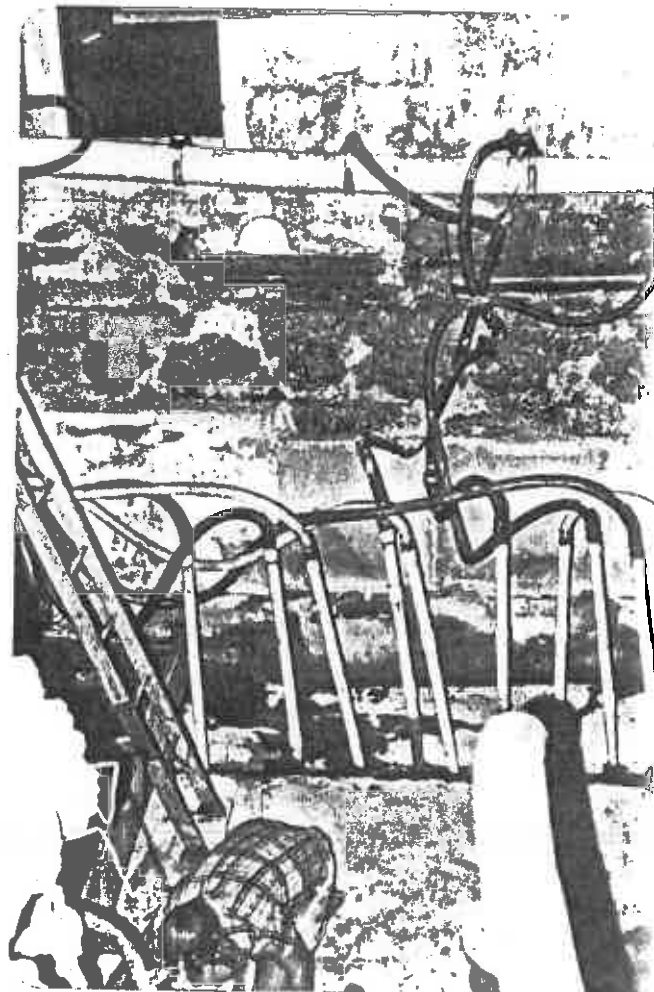
Dewatering and under
pinning in lift shaft.

The lift shaft and lift mentioned earlier have now been installed. Dewatering of the lift shaft overrun excavation and underpinning of an adjacent limestone wall were the main structural problems. Cramped conditions made placement of dewatering and excavation equipment an interesting exercise, especially when dewatering problems necessitated a second ring of spears, manifold and pump. Dewatering was difficult because a layer of compressed seaweed below the footing level but above the bottom level of the lift shaft allowed water from the nearby Indian Ocean to flood in at a rate the original system could not handle. The second ring of spears was placed at a higher level and both sets successfully depressed the water table to allow excavation by hand and conveyor belt. The wall was underpinned by using a variation on a conventional method - holes were dug in a hit and miss pattern and infilled with super plasticised concrete.
