Report on the corrosion of iron shipwrecks in South Australia: with particular reference to the River Murray

Ian Donald MacLeod

Department of Materials Conservation

Western Australia Museum

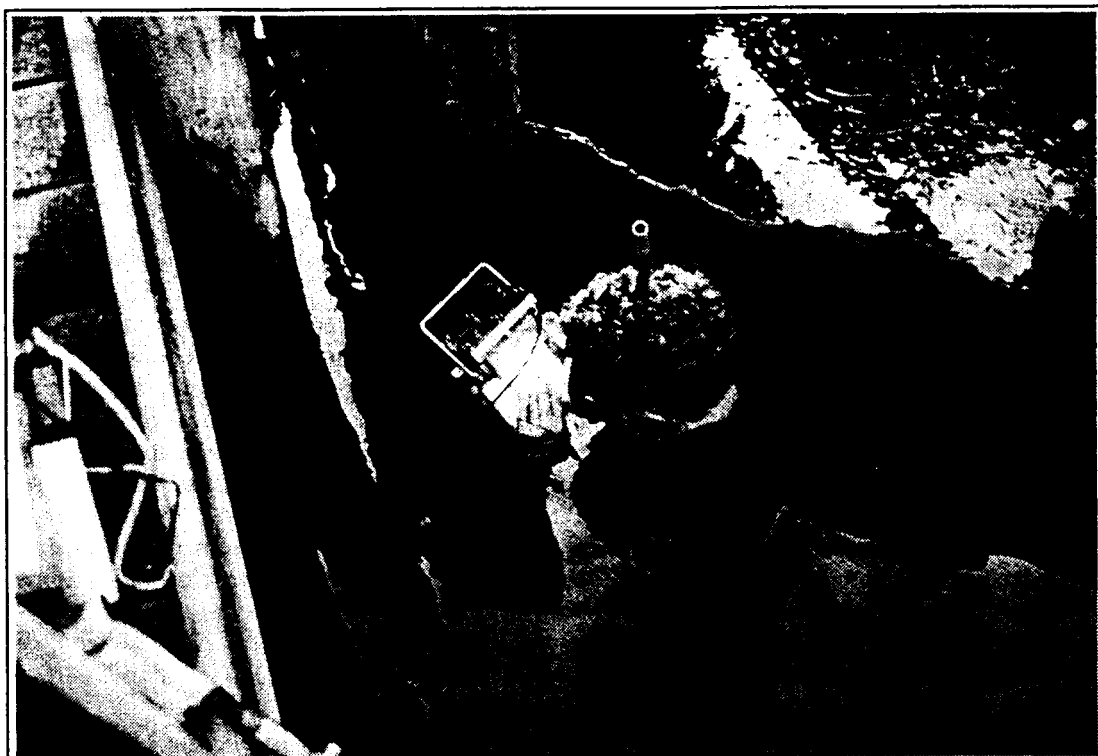
The build-up of a mixture of corrosion products and the slime around and below the waterline, near the stern, had allowed a 1 cm layer of concretion-corrosion matrix to develop. This obviously facilitated the pH gradient from the water value of 7.92 to 6.46 at the corrosion product-water interface approximately 20 cm below the water line. The wood on the *Uranus* appeared to be more degraded than on the *Albion* although this is not reflected in different pH values—it should be noted that the original colour of the *Uranus* timber had not yet been exposed at a depth of 3 mm into the surface.

Figure 1 Measurement of surface pH of wooden stem post in the *Uranus*.

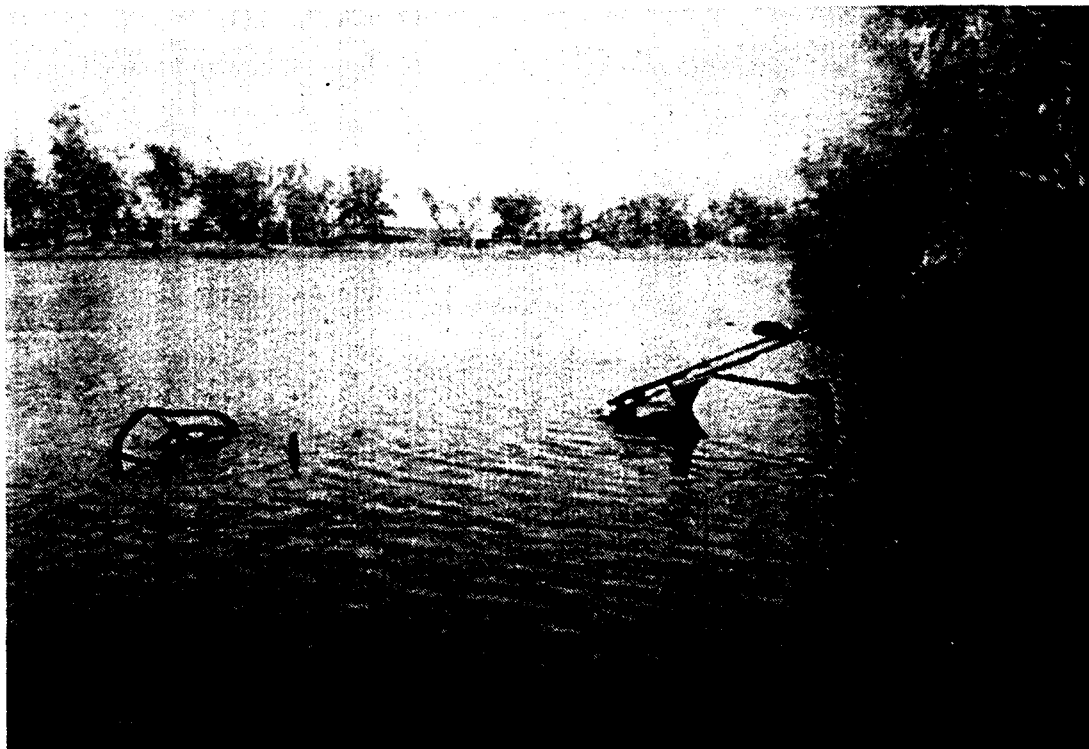
The mean corrosion potential of the solid iron fittings, frames and plating on the *Cobar* was -0.111 ± 0.006 volts vs. NHE. This average value is higher (more corrosive) than the *Corowa* and the *Crowie* and this is due in part to the fact that more of the iron in the vessel is protruding from the surface which gives increased access to oxygen and to the setting up of a series of differential aeration cells.

Figure 3 View of the exposed frames of the Cobar and the stem wheel of the William R. Randell.

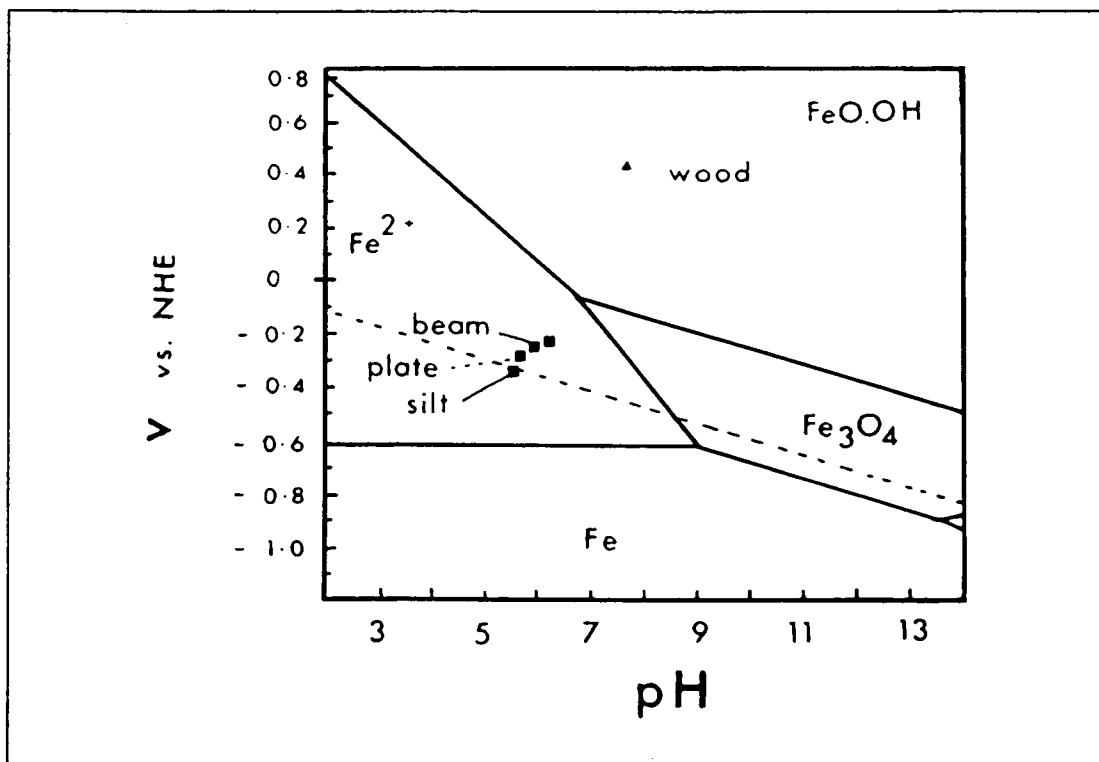
The average corrosion potential for all of the iron fittings on the vessel is -0.282 ± 0.014 volts vs. NHE. The average water depth of the site was between 4 and 8 metres with the remains of the vessel resting on the edge of the river bank which falls away quite quickly once one moves away from the shore line. The low values of the corrosion potentials is indicative of a good state of preservation of this material.

Figure 4 Pourbaix diagram showing corrosion potentials for materials on the Jolly Miller.

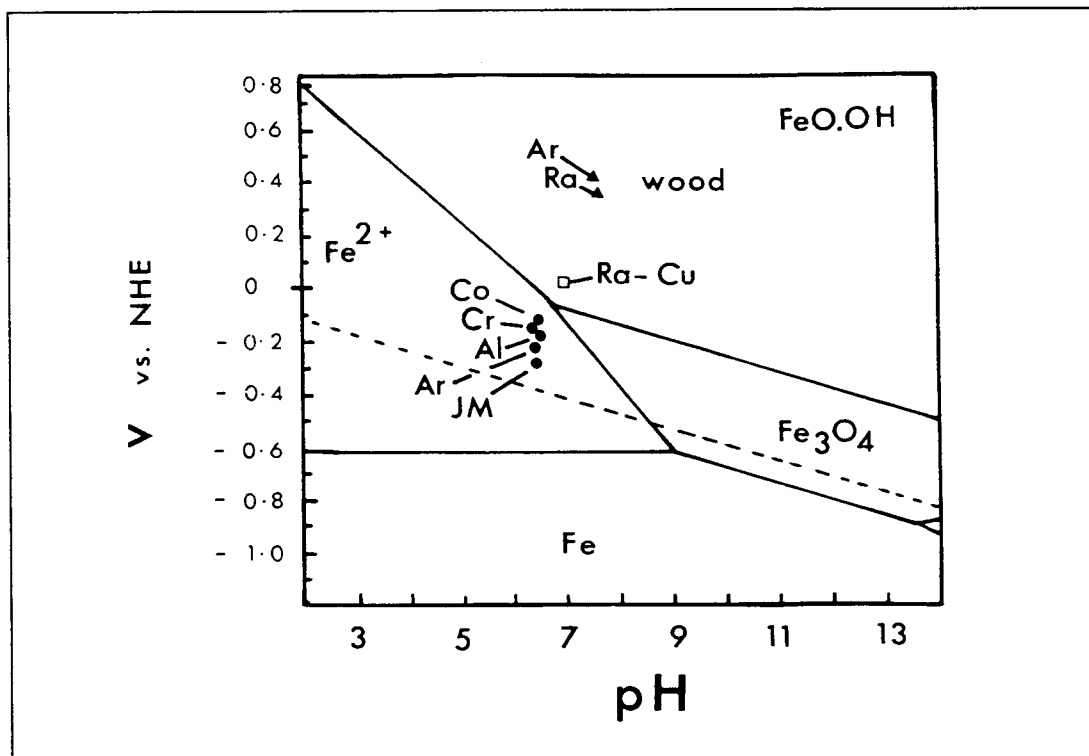
Figure 5 Pourbaix diagram showing corrosion parameters for wrecked barges and paddle steamers in the River Murray. The symbols used are : Ar(Arnold), Ra(Randell), Ra-Cu(galvanically coupled), Co(Cobar), Cr(Crowie), Al(Albion) and JM(Jolly Miller).

By plotting the average corrosion potentials for the iron fittings and structural materials, from the different sites, on a Pourbaix diagram, it is very easy to appreciate the different nature of the sites at a glance. Some of the data is shown in figure 5 where sites with essentially the same average Ecorr. were omitted for the sake of clarity.

When the site parameters are summarised in this form we see that all the average E_{corr} values for sound iron are in the region of active corrosion. The equilibrium reactions appear to be related to the corrosion of iron to produce Fe^{2+} ions which are in equilibrium with magnetite, Fe_3O_4 , according to the following reactions,

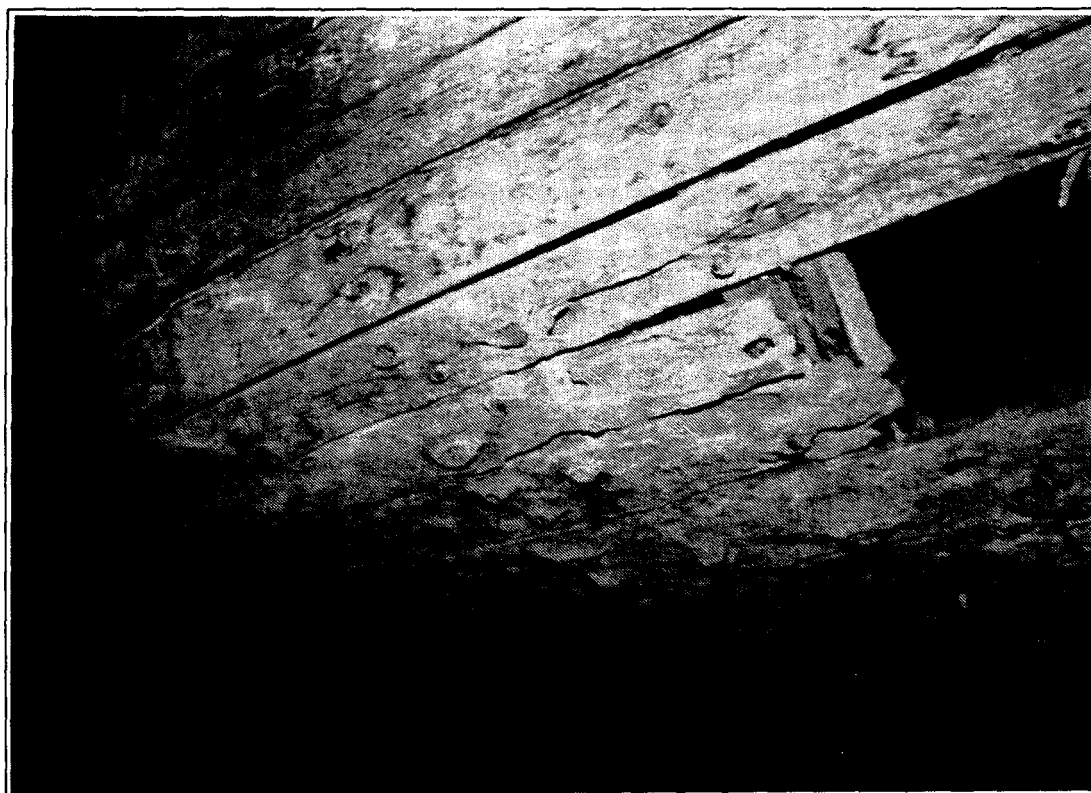
An example of the effects of water movement on the preservation of timber is seen in the degradation patterns on the bottom of the P.S. *Colonel*. The timber has apparently been degraded to a much greater extent in the area adjacent to the wash from the paddles than in the sections where the water flow is less turbulent. The iron corrosion products have apparently preserved the wood in the vicinity of the bolts, see figure 6, whereas iron is normally associated with the increased rate of chemical and biological deterioration. Further work need to be done to clarify the mechanism of this apparent reaction—the surface profile may also be due to specific biological degradation mechanisms that pertain to the riverine and riparian environments.

Figure 6 Hull planking on the P.S. Colonel.
