Abstract

In situ corrosion monitoring of the iron shipwreck *City of Launceston* (1865)

Ian D. MacLeod

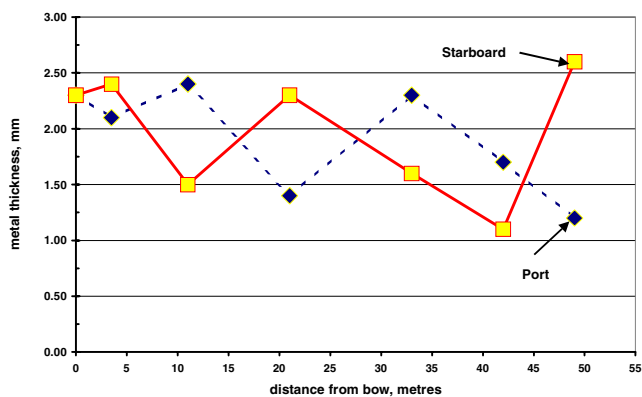
Figure 1, Metal thickness of hull plates on port and starboard sides vs. distance from the bow

Reproducible measurements of metal thickness involved clearing areas typically 8 cm in diameter, owing to the roughness of the corroded plates. Eighteen surveyed locations from the bow to the stern on port and starboard sides were measured (Figure 1). There were several areas where the cleaning showed up perforated plates. The mean metal thickness was 1.98 ± 0.47 mm after more than 130 years of corrosion but there is no systematic trend of metal thickness with distance from the bow, nor is there any direct relationship between the thickness and the present E_{corr} data. Although there is no real difference between the mean 1.9 ± 0.5 mm thickness on the port side and 2.0 ± 0.6 mm on the starboard side, there was a difference between the mean pH data. The higher silt mound on the portside gave lower corrosion rates, i.e. it was less acidic than the starboard side, with the mean values being $pH_{\text{port}}^{97} = 6.83 \pm 0.56$ and $pH_{\text{stbd}}^{97} = 6.48 \pm 0.70$. Two years later the same trend continued, but the lower pH values of $pH_{\text{port}}^{99} = 7.22 \pm 0.23$ and $pH_{\text{stbd}}^{99} = 7.14 \pm 0.43$ are due to the incomplete re-colonization. The surface pH of the corroding metal is normally a good indicator of localized corrosion since the hydrolysis of the primary corrosion product of iron (II) chlorides produces increased acidity, viz.,

During the 1997 survey five of the 58 hull plates were totally corroded but this number had increased to ten out of the 56 one year later. Using the mean 1997 corrosion rates, the calculated metal loss over 132 years was 15 ± 2 mm, which matches the mean depth of graphitization of 15.4 ± 1.9 mm. The original plate thickness was estimated by adding the residual and lost metal values, which gave a value of 16.5 ± 1 mm. Since the construction specifications are unknown these data indicate an original 5/8" plate (15.9 mm) was used to build the vessel.

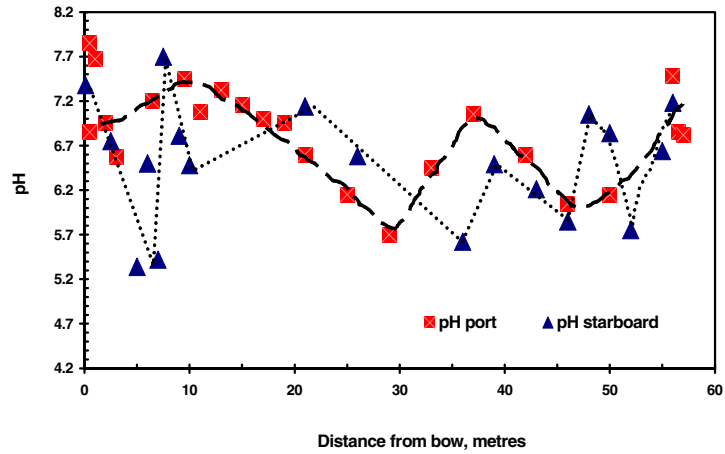
Figure 2. 1997 in-situ pH for port and starboard hull plates

Plots of the 1997 pH values from the bow to the stern (Figure 2) shows a number of points along the length of the vessel that have lower pH and these generally correlate with higher E_{corr} values, both of which indicate a higher corrosion rate. The starboard side of the *City of Launceston* has pH minima at 7 m from the bow and then at 36 m, 46 m and 52 m from the bow while the port side has pH minima at 3 m, 29 m, 46 m and 50 m from the bow.

When the pH data are plotted on the site plan there is a trend toward the port side minimum occurring several metres before a corresponding minimum on the starboard side. The mean angle of the lines joining the adjacent minima is $32^\circ \pm 9^\circ$ from north, which is close to the angle at which the vessel lies with regard to

the flow of the current across the site. Clearly there is a strong correlation between the localized corrosion rates and the current that brings the dissolved oxygen. Analysis of the comprehensive 1997 data indicates that the pH is dependent on the log of the thickness of the residual metal x , where x is in mm of metal. The starboard plates followed equation 3, and had a five-point correlation factor of 0.85.

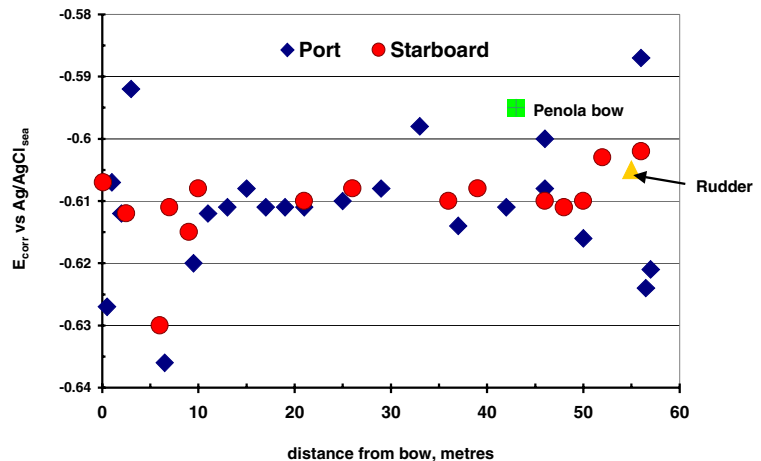
Figure 3. 1997 season of E_{corr} measurements for port and starboard hull plates

Localized increases in corrosion rate (less negative E_{corr}) were coincident with two of the pH minima on the starboard side at approximately 6 m and 35 m from the bow. The fact that low pH values at 46 m and 52 m were not mirrored by elevated E_{corr} values is probably due to the hull plates being in contact with more protected parts of the wreck. A diagrammatic representation of the corrosion environment in 1997 is shown in Figure 3, which highlights the lack of uniformity

of the microenvironment. Comparison of the E_{corr}^{98} and E_{corr}^{97} values for solid metal plates showed that the mean E_{corr}^{98} value is 15 mV more anodic than in 1997, i.e. it has a 12% higher corrosion rate. Hull plates that are extensively corroded and have very little solid metal are characterized by potentials that are between 100 mV and 350 mV more anodic than the E_{corr} values of sound plates (MacLeod 1981, Pourbaix 1974). The *Penola* bow was 22 mV more anodic than the nearby hull plates (Figure 3), which is due to a mixture of the effects of increased localized turbulence and differences in alloy composition and residual stress associated with the ramming. The 32 mV elevation in the E_{corr} of the rudder is probably due to localized turbulence and the effects of non-annealed cold working.

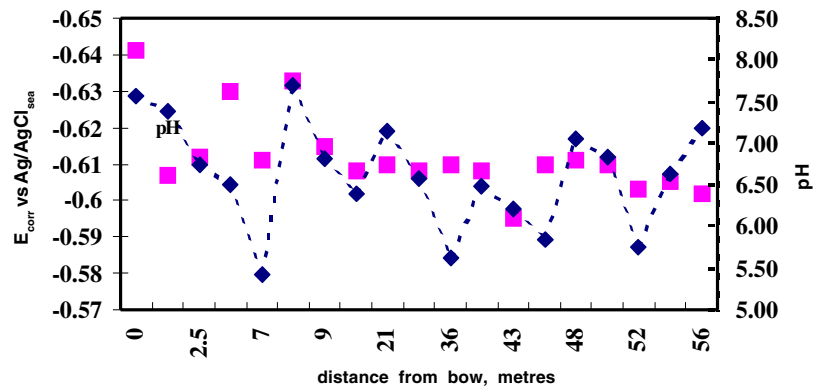
Figure 4. Starboard in-situ values of pH and E_{corr} for 1998 as a function of distance from the bow

In moving from the bow to the stern, the starboard 1998 pH data indicate that there are zones of increased localized corrosion activity at 3m to 8 m, at 25 m, at 43 m and at 55 m from the bow. Apart from these hot spots the overall trend is towards a more uniform value of the pH, which is probably due to the lack of colonization only one year after stripping. The E_{corr} data, as the solid line in Figure 4, generally follow the trend of the pH data except between the 36-m and 52-m marks. Here the elevated voltages are reflecting the impending demise of the steel hull plates in that area.

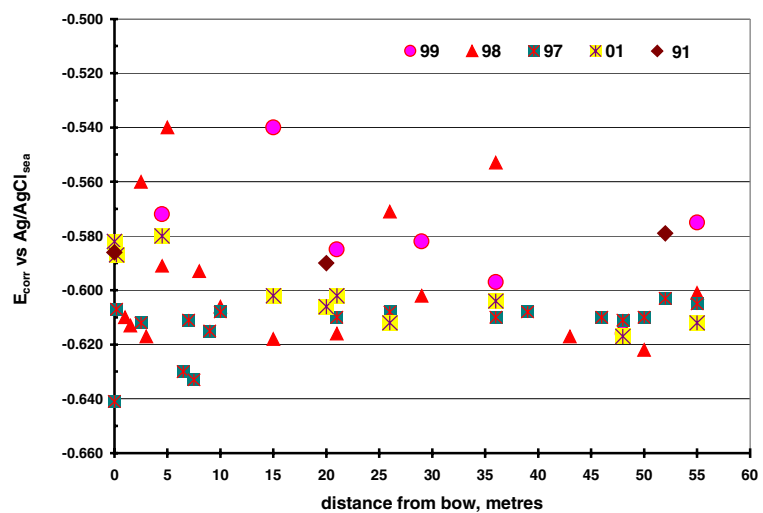
Figure 5. Starboard corrosion potentials for hull plates from 1991–2001

Similar patterns of behaviour were observed for the port side, showing hot spots near the bow, at 5 m, 24 m and 36 m from the bow. Where there is a divergence of the E_{corr} data and the pH values, it is due to the loss of integrity of the hull plates. The site stabilization brought about with cessation of scallop dredging was destroyed by the 'de-weeding' operations. The re-colonization process took more than two years to begin to correct this impact (Figure 5). Without some form of

stabilization, it can be estimated that the wreck will begin to collapse from areas about 4 m to 7 m from the bow and at from 46 m to 51 m from the bow, i.e., about 5 m to 10 m from the stern. This collapse will be dependent on the timing of a major storm and can be expected to occur within the next one to three years.
