# STABILIZATION OF CORRODED ALUMINIUM

Ian D. MacLeod

**Abstract**-A simple washing procedure has been developed for stabilization of corroding aluminium-copper alloys. The use of an ammonia-ammonium sulphate buffer at pH 9.6 in aerated deionized water effectively removes cemented copper metal and copper corrosion products from the surface of the object whilst also removing aggressive chloride ions. This treatment has been used to stabilize a Duralumin sea-plane float which was actively corroding after 46 years' exposure to a marine environment.

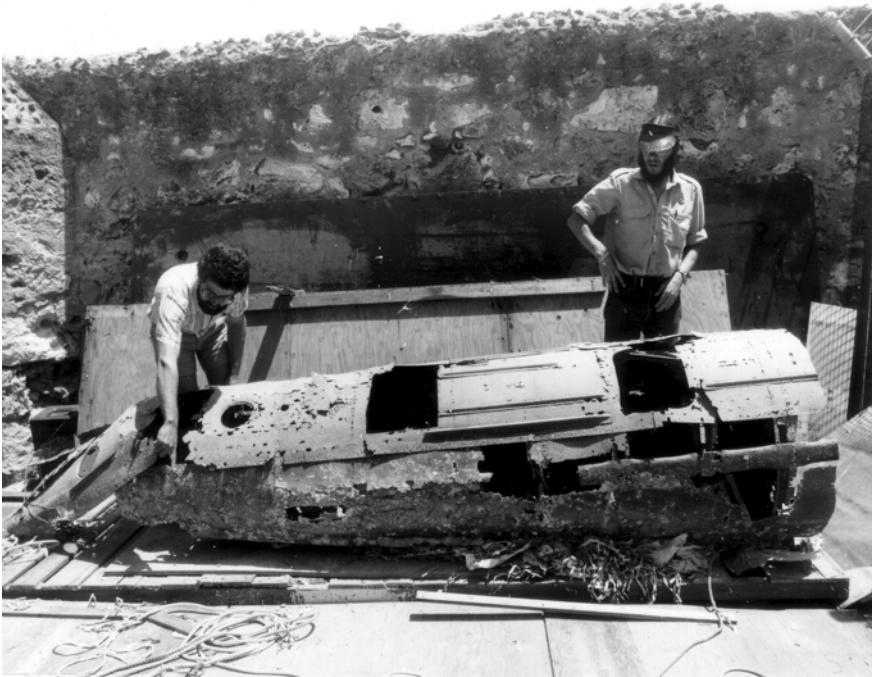
When the float was uncrated at the conservation laboratories after a 3000km journey it was immediately obvious that it had suffered extensive pitting corrosion after being exposed for 46 years in a littoral location. There was evidence of continuing corrosion underneath the red-brown surface coating of pindan, a characteristic mixture of red clay soils of the Kimberley region which have been cemented together with large amounts of sand and some calcium minerals. Large areas were covered with the original tar-like paint and often the concreted sands, tar and metal corrosion products were the only materials that gave form to parts of the float. The major corrosion products detected were aluminium hydroxide (Gibbsite,  $\text{Al}(\text{OH})_3$ ) and an unidentifiable light blue copper-containing material which had a distorted alumina structure. The major calcium mineral was gypsum,  $\text{CaSO}_4 \cdot 2\text{H}_2\text{O}$ , and there were minor amounts of calcite,  $\text{CaCO}_3$ .

Figure 1 The Duralumin seaplane float from the Junkers W33 as received in the conservation laboratories, showing extensive corrosion after 46 years' exposure to salt air.

detailed inspection of the float which showed that up to 60% of the surface skin and structural members had severe pitting and perforation.

The float was cleaned of loose sand by the action of a stiff nylon bristle brush and water before being placed in a tank (3100 litres capacity) filled with deionized water. The chloride and copper concentrations in the wash solutions were measured once a week throughout the treatment period and measurements of pH,  $E_h$  of the solution and  $E_{\text{corr}}$  of the metal were made at the same time. After three weeks' washing in deionized water, 50kg of ammonium sulphate and 50 litres of 0.880 ammonia were added to the solution which gave a pH of  $9.6 \pm 0.1$ . The formal concentrations in the above wash were 0.125M  $(\text{NH}_4)_2\text{SO}_4$  and 0.25M  $\text{NH}_3$ . After 80 days in this solution the float was removed and inspected for signs of corrosion and was scrubbed down once more with a bristle brush before being placed in a fresh ammonia/ammonium sulphate solution. The second wash lasted for 143 days before the scrubbing and solution-changing procedure was repeated. The final wash lasted for a further 178 days after which the float was removed from the tank and dried in air. The final concentrations in the wash were 2ppm copper and 21ppm chloride. Any adventitious iron stains on the aluminium surface were removed by brushing with a solution containing 5wt% oxalic acid and 5wt% EDTA. The float has shown no signs of further deterioration over a period of four months since the treatment was finished. Chloride concentrations were determined using the Buchler-Cotlove chloridometer and copper was determined by atomic absorption spectroscopy.

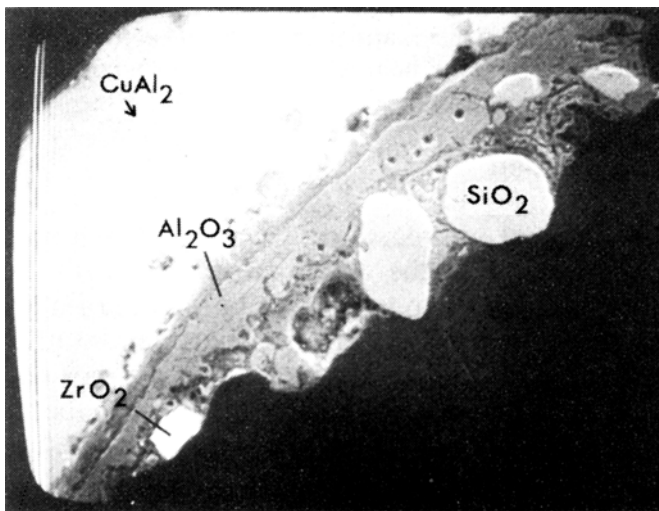
The most severe form of corrosion found on the float was due to pitting. Under mounds of corrosion products consisting of sand grains (silica, zircon), aluminium hydroxide (Gibbsite, Al(OH)<sub>3</sub>) and a blue copper corrosion product were patches of very thin layers of elemental copper (see Figure 2). The copper metal had been redeposited from the surrounding copper corrosion products. The copper corrosion products were formed by the oxidation of the CuAl<sub>2</sub> units in the metal structure. A very common mineral formed during the corrosion of copper in seawater (pH 8.2) is cuprous oxide (Cu<sub>2</sub>O). Under the same conditions an aluminium oxide (Al<sub>2</sub>O<sub>3</sub>) will form as aluminium corrodes. Because of the more reactive nature of aluminium compared with copper, Cu<sub>2</sub>O or any other copper mineral can be converted back to the metal by reaction with aluminium metal,

Figure 2 Scanning electron micrograph of a mounted section of corroded Duralumin from the 'Atlantis' seaplane float. The white spots in the metal are  $\text{CuAl}_2$  units, the dark grey material adjacent to the metal is a mixture of aluminium corrosion products and calcium minerals.

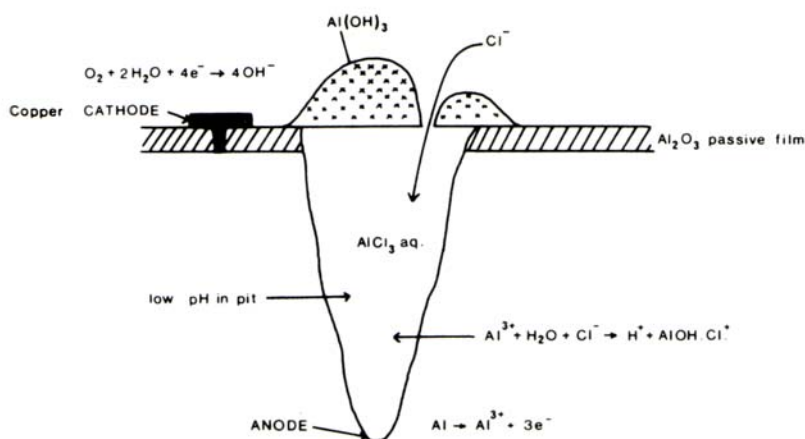
Figure 3 Schematic diagram showing pitting corrosion in aluminium.

In the pitting of aluminium (see Figure 3) the deposited copper acts as a cathodic site for the facile reduction of oxygen [7], viz.
