The
BULLETIN
of the
AUSTRALIAN
INSTITUTE
for
MARITIME
ARCHAEOLOGY

1984
VOLUME 8 NUMBER 2

A GENUINE SIXTEENTH CENTURY FORGED COIN

Dr. Ian D. MacLeod

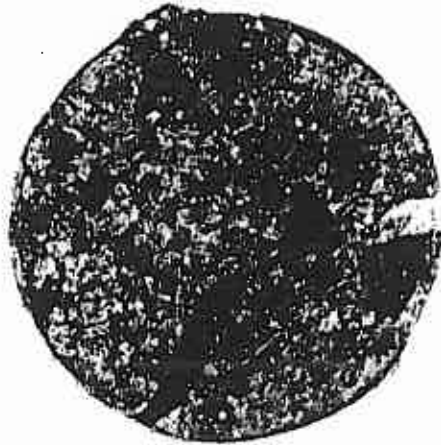
The coin (BAT916) was recovered during the 1974 excavation on the *Batavia* site and was first examined by the author in October 1982. The coin appeared as a fragmented hollow disc about 4 cm diameter and 2 mm thick. It was covered with marine organisms and corrosion products. The seaward surfaces had the same type of concretion and corrosion products that are commonly found on aerobically corroded coins that assay at $93.5 \pm 1.0\%$ silver and $6.5 \pm 1.0\%$ copper. The coin was fragmented (Fig. 1) with about 5% of one surface missing. Lustrous ruby red crystals of cuprite (Cu_2O) lay amongst patches of red brown iron stained concretion and large areas of the blue-green copper (II) hydroxy chloride atacamite, $\text{Cu}_7\text{Cl}_{14}(\text{OH})_{10}\cdot\text{H}_2\text{O}$. The inner surfaces of the coin (Fig. 2) were partly covered with a grey blue corrosion product film which was all that remained of the base metal core.

Fig. 1. Obverse of the forged coin (BAT 916) before any treatment

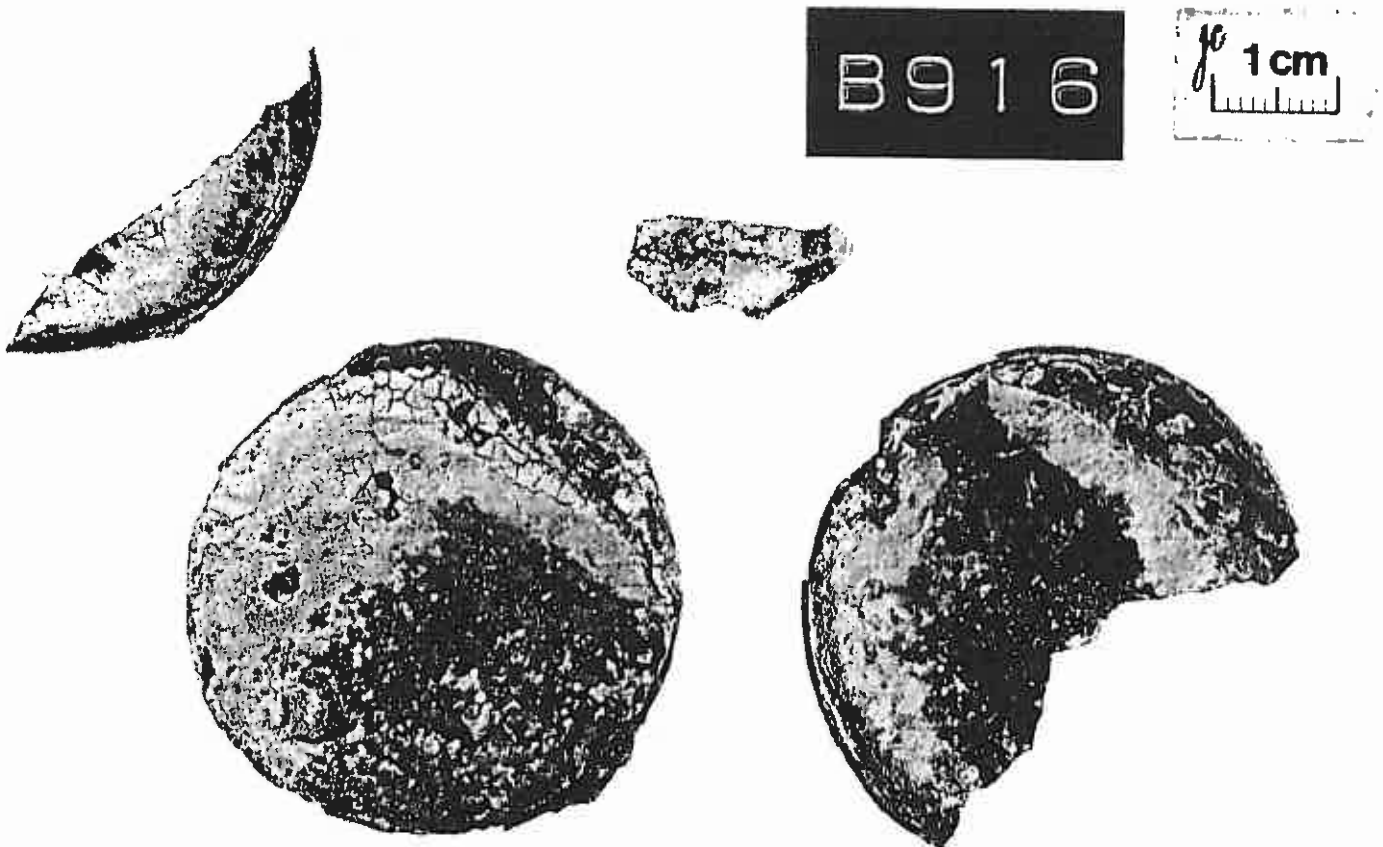
Fig. 2. The inner surfaces of the forged coin showing the corrosion products (light grey) from the core material on a background of silver chloride

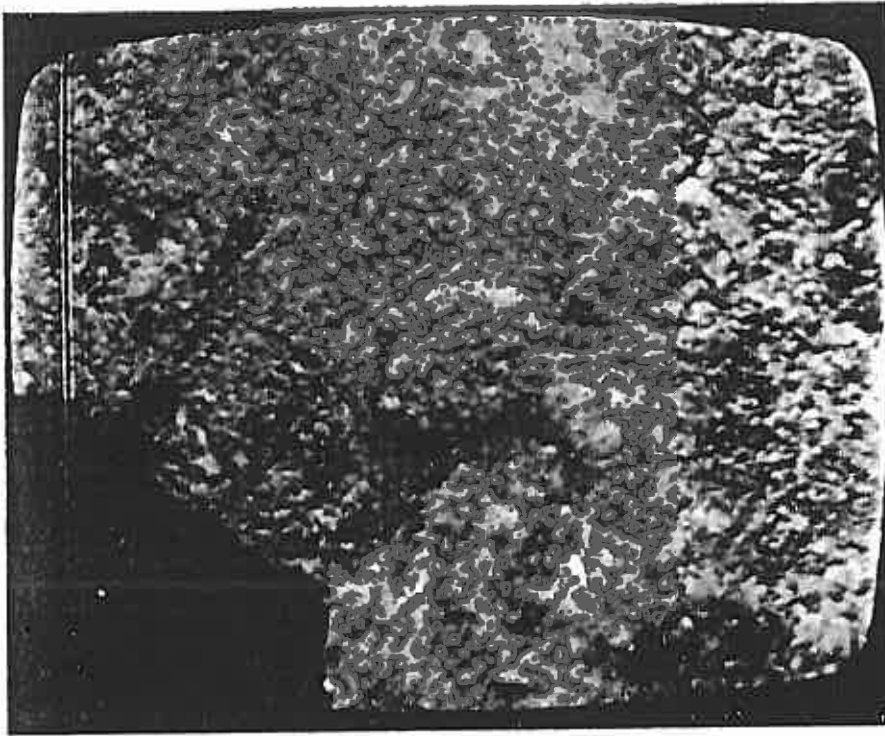
The cleaned inner surfaces of the silver casing were examined under the microscope to see if details of its structure could give any clues regarding the techniques used in its manufacture. Inspection of the SEM micrograph (Fig. 3) showed that the inner surface of the remaining metal appeared to be somewhat porous and that it may have been cast. Since the practical problems of casting a sterling silver skin (m.p. approx. 900 degrees C) around a low melting blank (m.p. approx. 460 degrees C) are great it seemed unreasonable to assume that such techniques had been used. A closer inspection of the seaward surface of the coin showed that it was microporous (see Figs. 3 and 4 for details) - such porosity is not found on corroded genuine sterling silver coins.

Fig. 3. Scanning electron micrograph of the inner surface of the forged coin showing the flow line pattern of the cast silver casing. Full width 2.64 mm

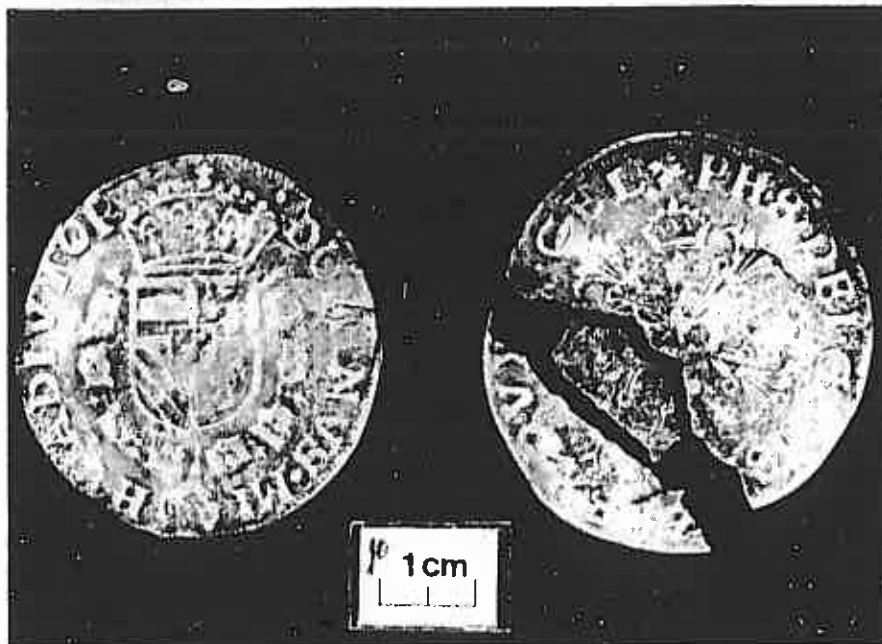
Fig. 4. The forged coin after topical treatment with an alkaline dithionite paste

The dithionite treatment revealed the inscriptions and the lettering PHS.DEI.G.HISP.Z.REX.DUX.GEL, (1)5 68 on the obverse and DOMINUS.MIHI.ADVITOR on the reverse side (see Fig. 4).

Once the corrosion products had been dusted off the inner surfaces of the silver casing the coin was placed in 10 vol% hydrochloric acid for half an hour to remove any copper, calcium and iron minerals from the seaward surface. The upper surfaces were "cleaned" by rolling a cotton bud, covered with a paste of 1M sodium hydroxide and solid sodium dithionite, over the corroded silver. This treatment converted the oxidized silver back to the metal. A few days after the initial dithionite treatment some blue copper sulphide spots had developed on the coin surface. These spots were simply removed by swabbing with 0.1M sodium cyanide in a 0.2M sodium carbonate solution.

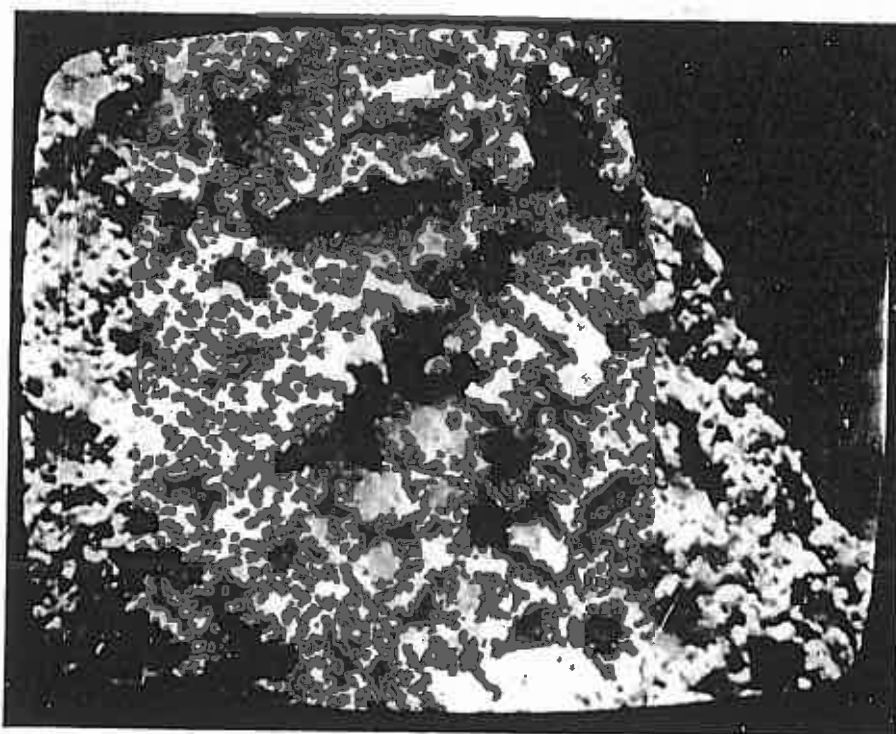
Fig. 5. Scanning electronmicrograph of the outer surface and edge of the forged coin after conservation treatment. The crystalline and porous nature of the surface are readily seen where the metal has been broken. Full width 0.26 mm

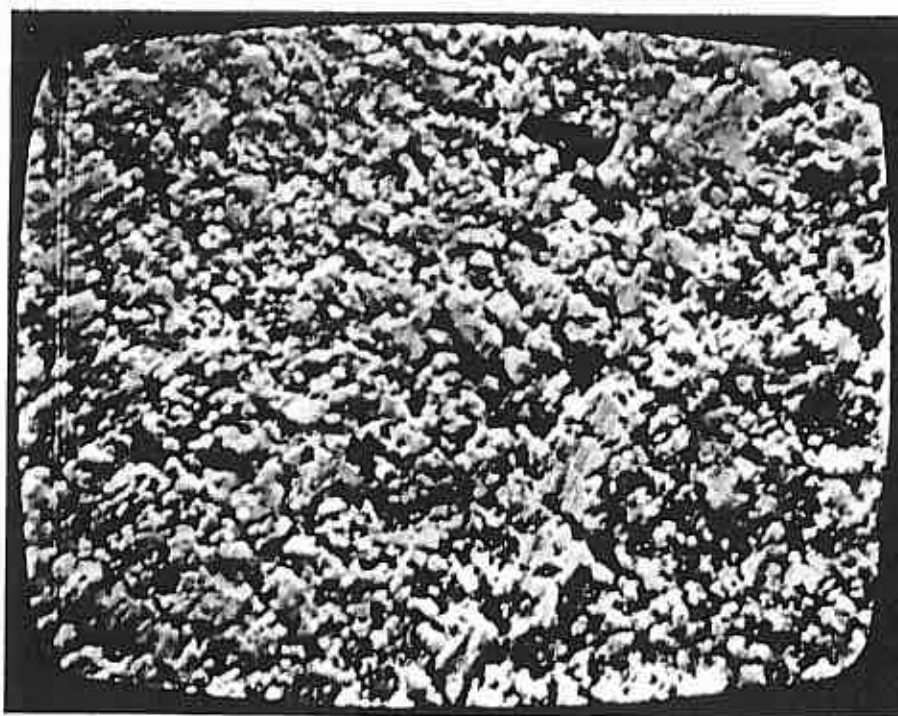
Fig. 6. Scanning electronmicrograph showing the general surface of conserved coin - note the porous nature of the outer layers. Full width 0.26 mm

The etching of the cast blank sealed the ultimate fate of the forgery for once it was immersed in the sea the different composition of the layers meant that the coin functioned as galvanic couple, i.e. a short circuited battery. Porosity from the initial casting would have helped the sea water to penetrate into the tin rich layer. Preferential corrosion of the tin rich inner layer continued until no solid metal remained whereupon the previously protected silver rich layers began to corrode to produce a surface corrosion layer similar to that found on genuine coins. The calculated density of the outer layer of the coin is essentially the same as sterling silver (10.17 cf. 10.35g.cm^{-3}) whilst the inner layer would have had a lower value of 9.4 because of the large amount of tin. Any difference between the weights of the forged and genuine coin could have been easily corrected by a slight increase in the thickness of the forgery. Under the conditions normally encountered in commerce the forged coin would probably have remained undetected.
