## CONSERVATION OF THE STEAM SHIP XANTHO

Ian D. MacLeod

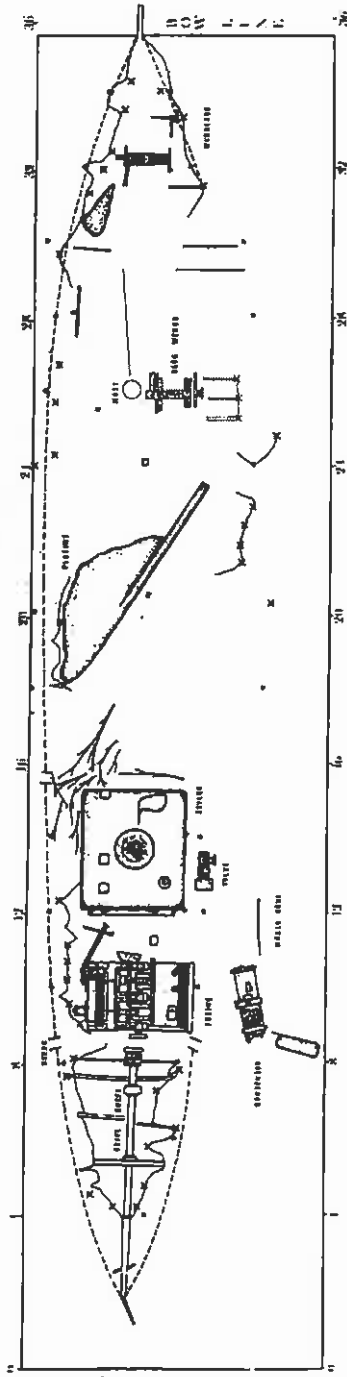
Figure 2  
Plan of the wreck site as examined during the predisturbance survey. The item noted as a condenser was later identified as a steam water heater.

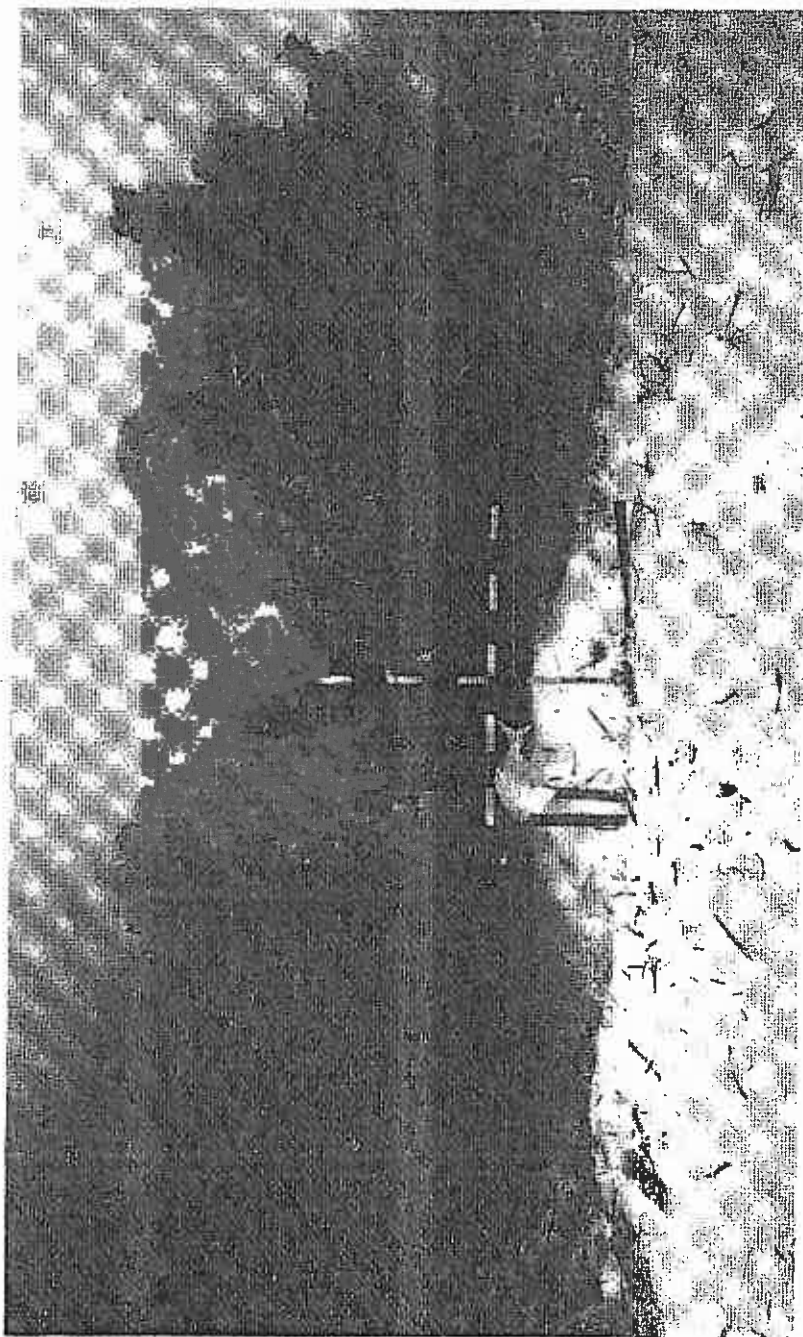
Figure 3  
View of Xantho boiler and engine prior to excavation from the port side. The current flows from left to right. Scale is 1m long.

with upright and encrusting sponges and a few encrusting bryozoa. Small chlorophytans (algae) were found in the light rich areas (water depth 2.9 - 3.3m) while large phacophylans were abundant in water deeper than 3.3 metres. The ship's boiler provided a very good area for studying the effects of the current on the marine growth since its long axis was essentially parallel to the direction of the strong current which ran at between 3 and 5 knots (1.5 - 2.6m/sec). The boiler was approximately 3.2m long, 2.8m wide and 2.6m high. The boiler viewed from the port side is shown in Figure 3.

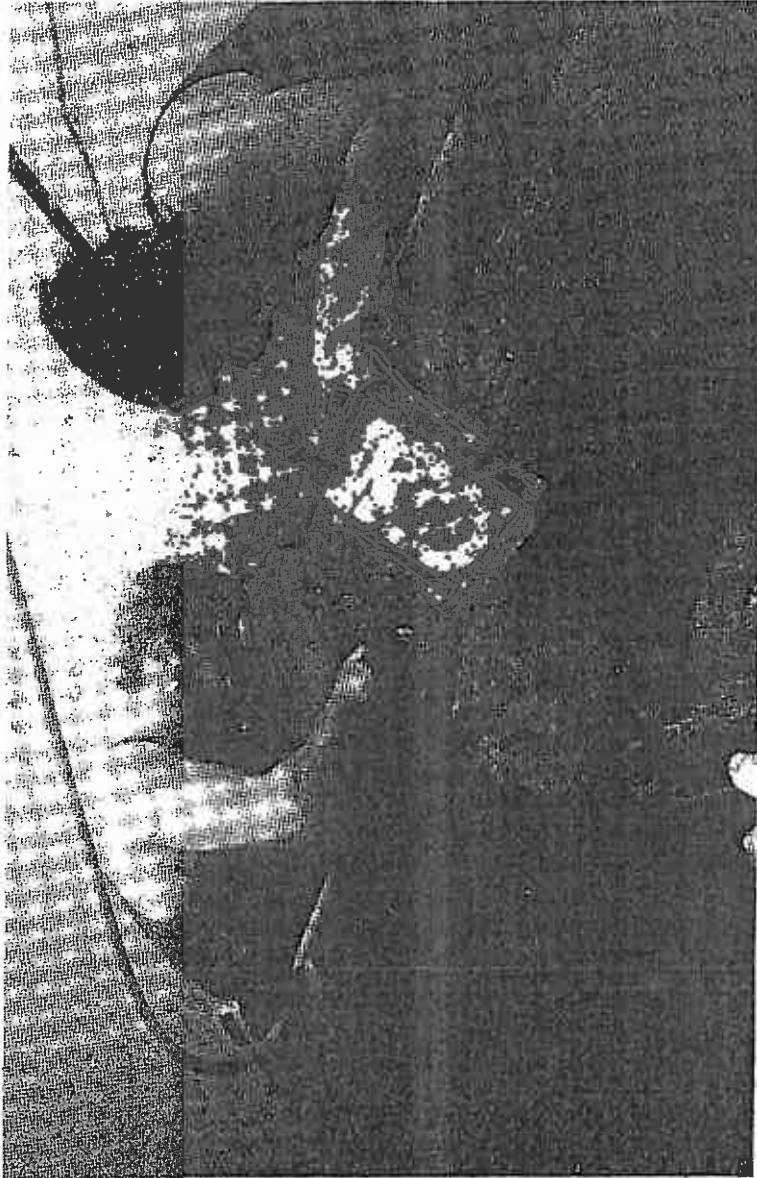
Figure 4  
Drs. MacLeod and North measuring corrosion potentials on the Xantho site during the predisturbance survey. The concretion on a piston is being drilled so that the potential measurement on the underlying material can be made. Photo: Mike McCarthy.

The corrosion potentials were measured in situ using a high impedance digital multimeter (Fluke 8010A), a platinum electrode (0.8mm thick) housed in an epoxy body and a silver/silver chloride reference electrode (Titron model No. 211). Subsequent measurements were performed using a different silver chloride reference electrode (DIMET). Sea water was used as the reference solution. The procedure consisted of drilling into the concretion (using a 1/4" masonry bit and a hand drill) and placing the platinum electrode into the hole while pressing firmly to establish good electrical contact; the reference electrode was placed adjacent to the hole and the voltage measured. For the resistance survey the reference electrode was replaced with a stainless steel probe (Figure 4).

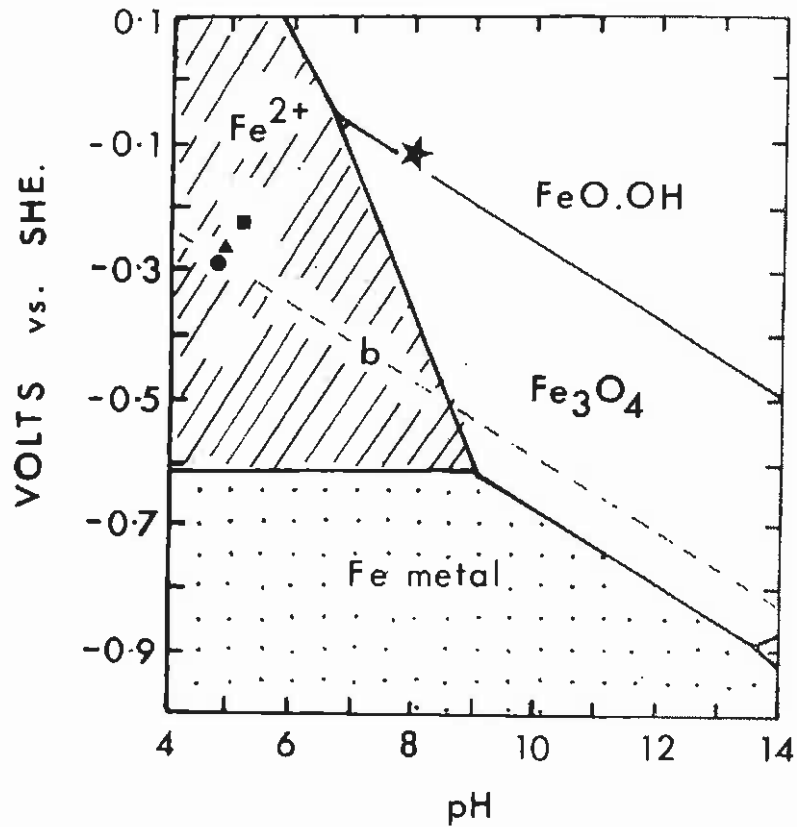
Figure 5  
 Pourbaix diagram for iron in equilibrium with a  $10^{-6}\text{M}$   $\text{Fe}^{2+}$  solution showing on-site corrosion potentials for various parts of the engine. ★ Windlass, ■ deck winch, ▲ mean potential of sixteen objects, ● frame plates, b represents the equilibrium line for water and one atmosphere of hydrogen gas.

A summary of the results of the survey is shown in Table 1 and also in a diagrammatic way in Figures 5 and 6 which show the Pourbaix diagrams for iron and copper in sea water. Although in situ pH measurements were not carried out on the wreck material, the pH of the metal under concretion has been estimated on the basis of previously published data on iron and copper-based concretions.<sup>2,6</sup> When the iron concretion was being drilled, bubbles of escaping gas were occasionally observed. The gas is mainly hydrogen and light weight hydrocarbons which are formed as a result of the corrosion process.<sup>5</sup> Inspection of the Pourbaix diagram shows that the potential of the frame plates lies on the hydrogen discharge line viz. at such potentials and pH water is in equilibrium with one atmosphere of hydrogen gas. Seventeen of the twenty-five sites measured had a corrosion potential of  $-0.268 \pm 0.004$  volts vs NHE (or  $-0.539$  vs AgCl sea water); in effect this shows that they are all in essentially the same corrosion micro-environment. From the observed relationship between corrosion currents and voltage in laboratory experiments the

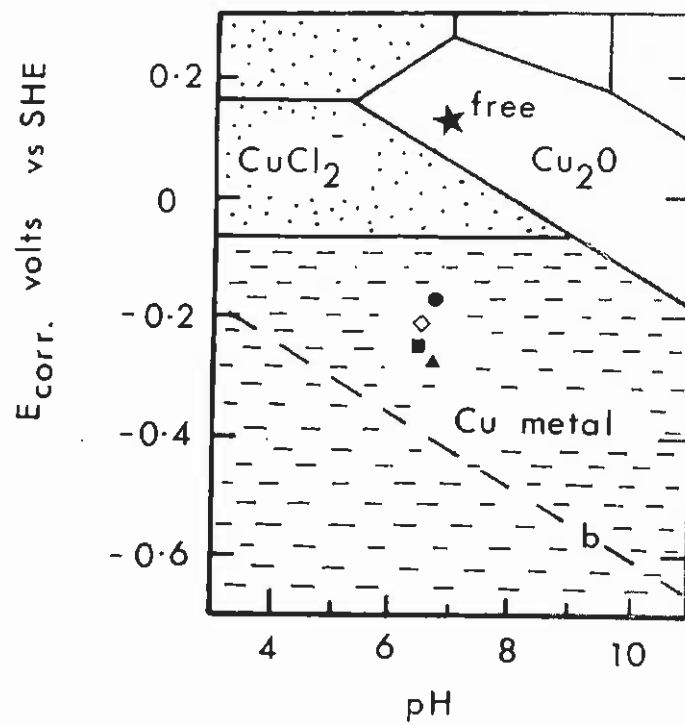
Figure 6  
 Pourbaix diagram for copper in sea water in equilibrium with a  $10^{-6}\text{M}$  copper solution. The on-site corrosion potentials illustrated are for ★ free copper pipe between the boiler and the engine, ● unidentified copper fitting on engine, ◇ steam pipe on water heater, ■ small copper pipe on engine and ▲ for brass steam cocks attached to the engine.

All the potentials observed for the non-ferrous fittings showed that they are all in the immune (for copper and brass) (Figure 6) or passive zones (white metal on crankshaft bearings). The corrosion potentials of the brass steam cocks and valves are largely determined by the iron corrosion potentials since the objects are in electrical contact with the iron metal which has a much larger mass and surface area. Although the copper and iron fittings on the engine have the same potential the results are different; copper and brass will not corrode while iron is actively corroding. The concretion layer observed on the brass and copper fittings was a few mm thick and consisted of a dense white calcareous deposit. Because of the galvanic protection provided by the corroding iron the copper-based alloys act as cathodic sites in the corrosion cell and this causes the surface pH to increase and inorganic calcium carbonate as calcite/aragonite precipitates on the metal. Once this 'protective' layer of  $\text{CaCO}_3$  covers the biologically toxic metal corrosion products, the surface is then subject to normal colonization by marine organisms. The  $\text{CaCO}_3$  layer appeared to act as a barrier to oxygen diffusion since under its protection some of the  $\text{Cu}_2\text{O}$  on the metal surface had been converted to  $\text{Cu}_2\text{S}$  through the action of sulphate reducing bacteria. The less negative potential for the copper tubes and case on the steam water heater is simply due to the relatively small mass of iron attached to the copper tubing, which has a large surface area.

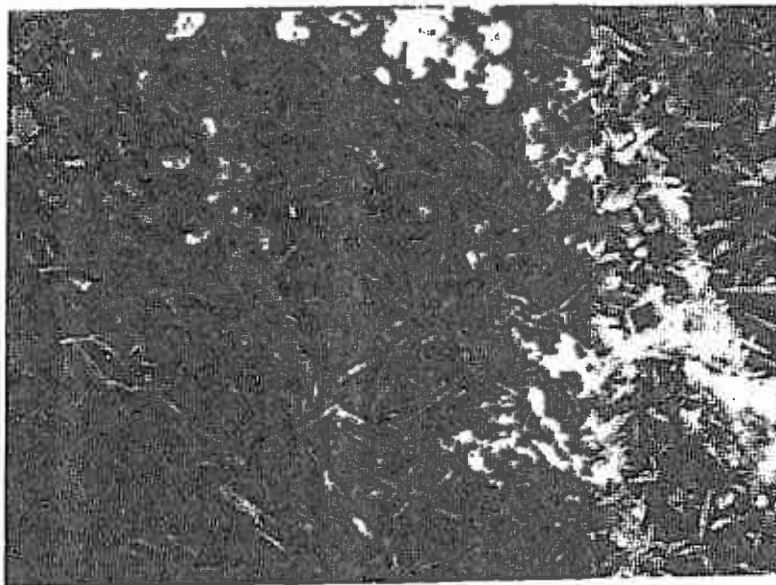
Although the corrosion potential of the white metal bearings on the crankshaft is -0.268 volt vs NHE outside the immunity range for lead it is in a region of stability of passivation through lead sulphate (anglesite) formation. On-site inspection suggested that the 2.5mm film covering the bearings was a mixture of anglesite and calcite ( $\text{PbSO}_4$  and  $\text{CaCO}_3$  respectively).

Figure 7  
 Scanning electron micrograph of the oxidized galena ore. The spikey crystals are phosgenite ( $\text{PbCl}(\text{CO}_3)_0.5$ ) and the plate-like crystals are hydrocerussite,  $\text{Pb}_3(\text{OH})_2(\text{CO}_3)_2$  which overly the present galena crystals. Full width of the photograph is 750  $\mu\text{m}$ .

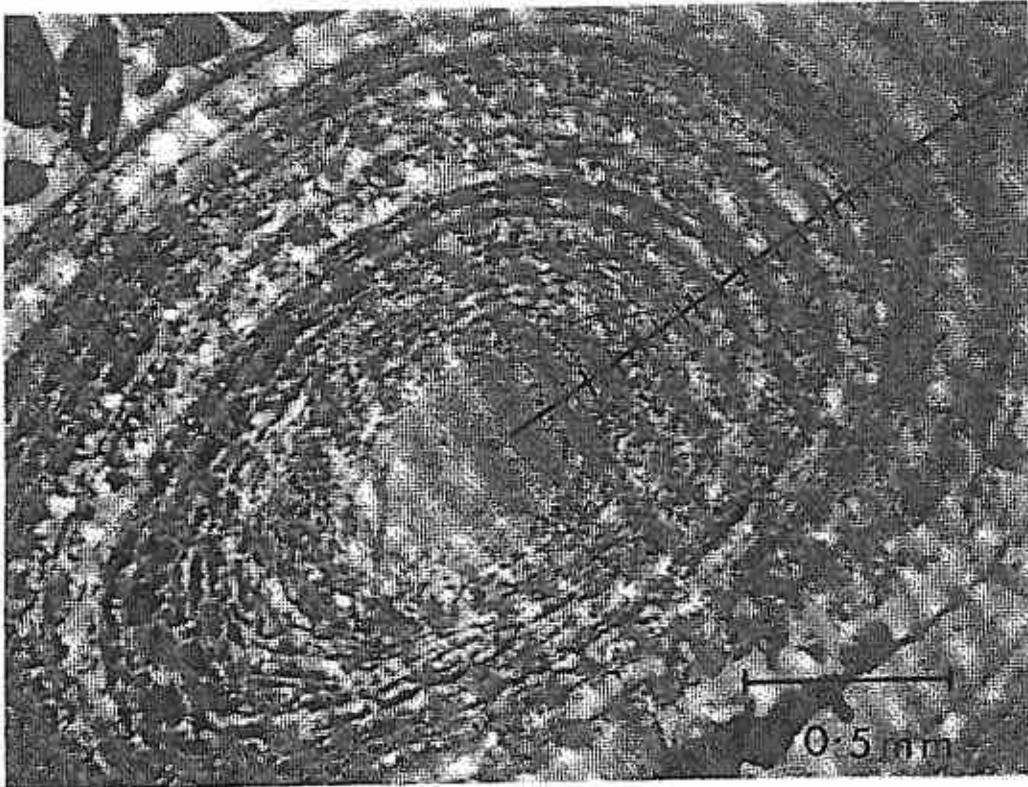
Figure 8

Scanning electron micrograph of a mounted cross-section of mineralized copper wire. The light grey material is the copper mineral chalcocite ( $\text{Cu}_2\text{S}$ ) while the black material is predominantly calcium carbonate. The banded formation is centred around a core of residual copper oxide. The full width of the photograph is 2.6mm.

Examination of a polished specimen of copper wire from inside a water spray device, found lying proud of the seabed in the 1979 wreck inspection tour, showed up a typical banded formation with layers of the copper sulphide chalcocite ( $\text{Cu}_2\text{S}$ ) (Figure 8). Such banding is consistent with the periodic exposure to anaerobic/aerobic conditions over the last 110 years which would occur each time the site was buried/exposed.

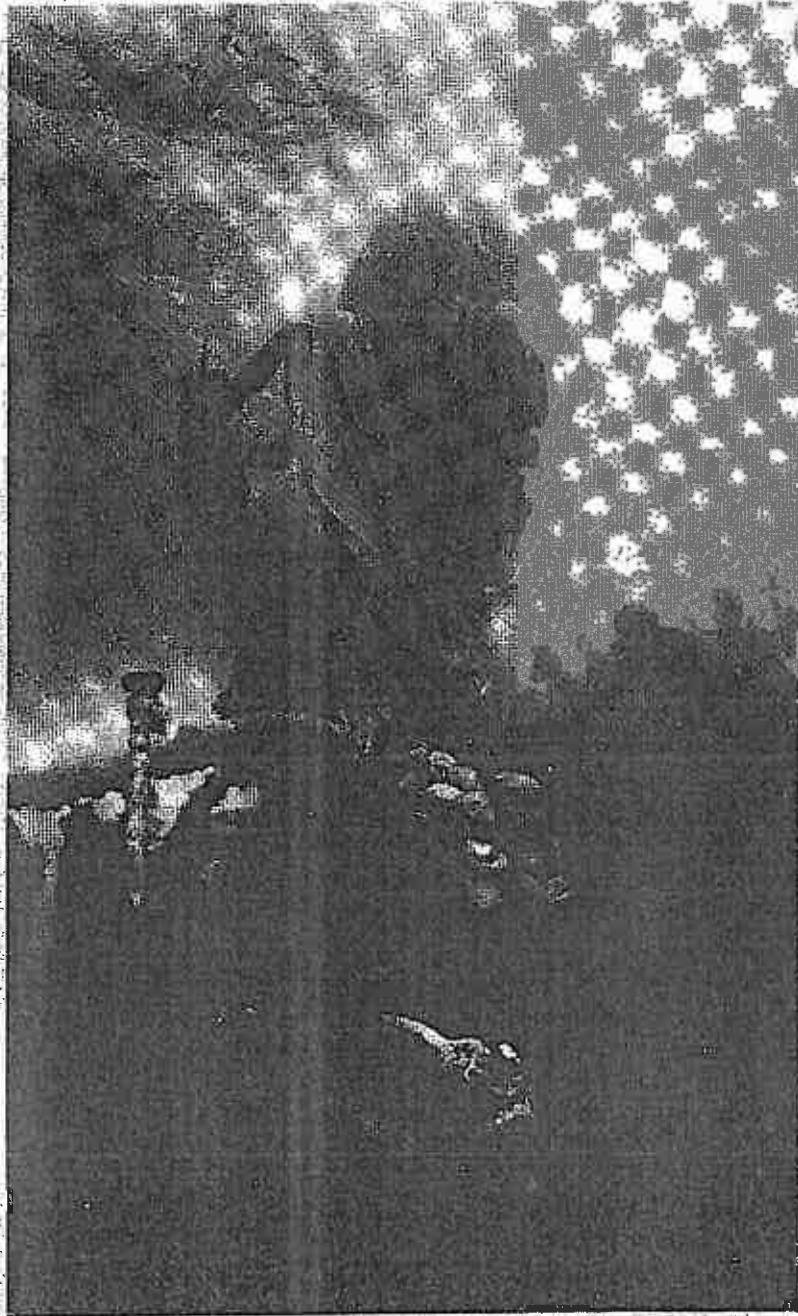
Figure 9  
Raising the Xantho engine. Photo: Pat Baker.
