**THE EXCAVATION, ANALYSIS AND CONSERVATION OF SHIPWRECK SITES**

I.D. MacLeod\*, N.A. North\*\* and C.J. Beegle\*\*\*

**SUMMARY**

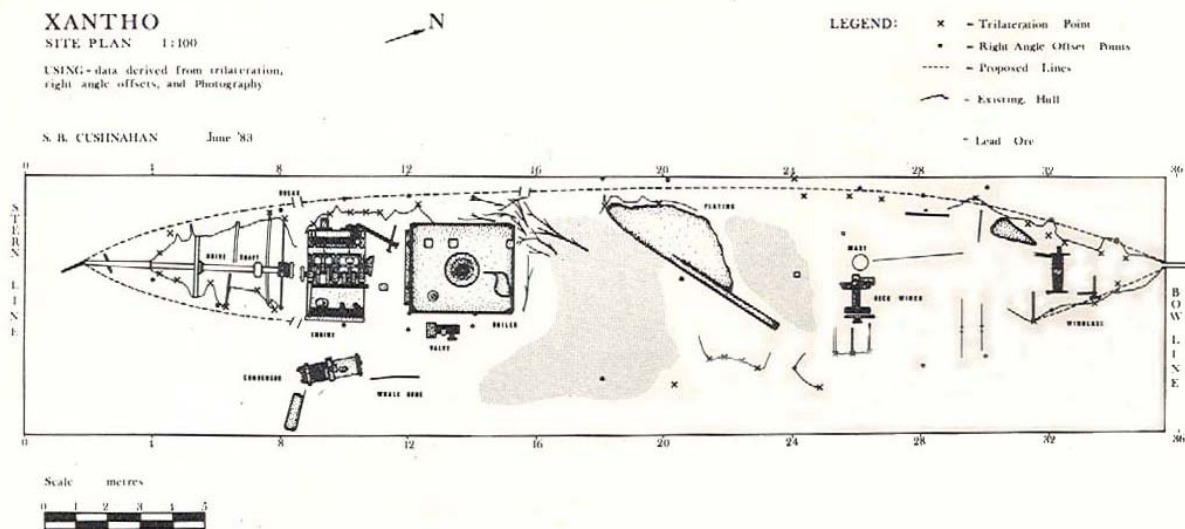
Fig. 2. Plan of the wreck site as examined during the pre-disturbance survey.  
The item noted as a condenser was later identified as a steam water heater.

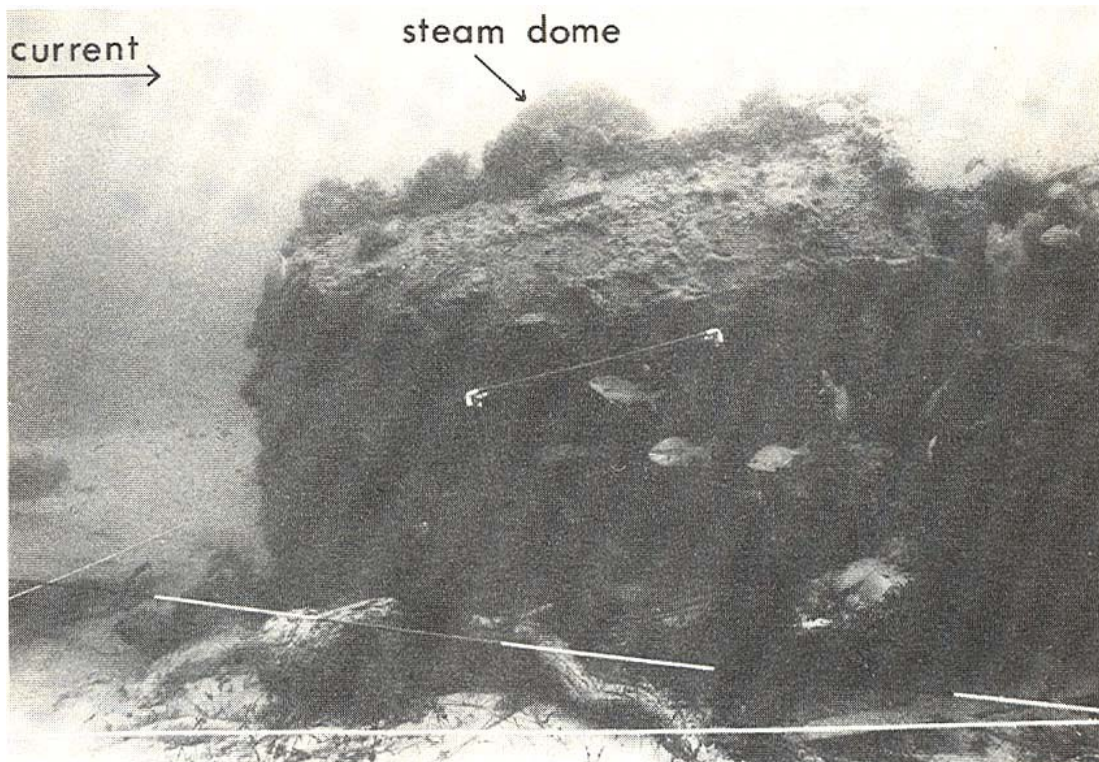
Top of boiler: surge perpendicular to current, approximately 0.5 m in amplitude. Apart from small tunicates living in the shelter of the remains of the steam dome, the top was encrusted with sponges and small green algae. Lower sections of the rounded top were colonized by large brown algae.

Forward side: periodic current fluctuations with a distinct demarcation of growth at 4.1 m depth. Above this line the growth was the same as on the top of the boiler but below, there were large tunicates (100 - 150 mm c.f. 70 - 100 mm in steam dome) and large upright sponges (50 - 100 mm high).

Port side: at depth less than 3.7 m the biological growth was similar to that of the top where the full force of the current is experienced. Between 3.7 m and 4.2 m depth there was a band of large brown algae down to the seabed at depth of 4.9 m.

Starboard side: the current runs along the plane of the face with large tunicates and small sponges covering the area between 3.3 and 4.0 m depth. The same organisms covered the remaining side to the sandy bottom at a depth of 4.7 m but with a much lower density. Above the 3.3 m level the growth was the same as at the top of the boiler.

Aft side: the water flow was irregular and the fauna was more varied than on the other parts of the boiler. The close proximity of the engine caused periodic backflows of water. The surface was covered with large brown algae from the 2.9 m to 3.7 m depth level where the sandy bottom had covered the lower parts of the fire box. Some feather worms and crinolds had colonized the interior of the exposed 70 mm diameter boiler tubes.

Fig. 3. The *Xantho* boiler as viewed from the port side during the pre-disturbance survey. The inside measurement of the square grid scale against the boiler is 1.0 metres. Photo: Pat Baker.

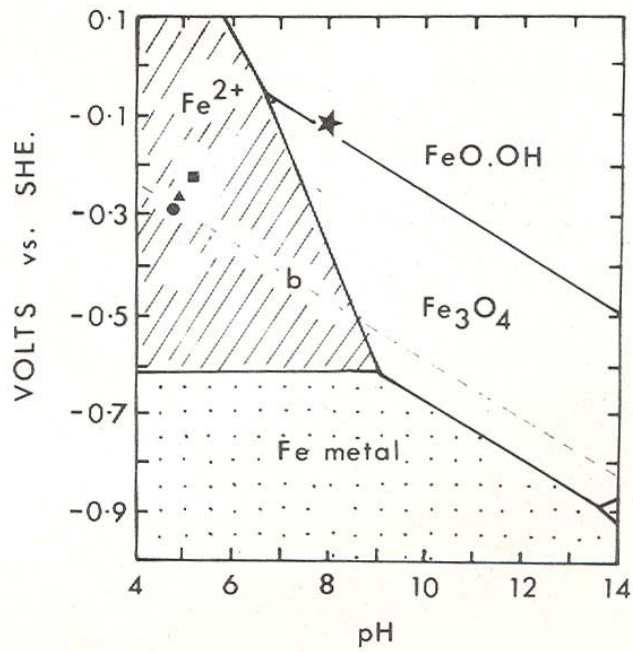
A summary of the results of the survey are shown in Table I and also in a diagrammatic way in Figs. 5 and 6 which show the Pourbaix diagrams for Iron and copper in sea water. Although in situ pH measurements were not done on the wreck material, we have estimated the pH of the metal under concretion on the basis of our previously published data on iron and copper-based concretions (North, 1976, MacLeod, 1982). When the iron concretion was being drilled bubbles of escaping gas were occasionally observed - the gas is mainly hydrogen and light-weight hydrocarbons that are formed as a result of the corrosion process (North, 1982). Inspection of the Pourbaix diagram shows that the potential of the frame plates lies on the hydrogen discharge line, viz. at such potentials and pH, water is in equilibrium with one atmosphere of hydrogen gas. Seventeen of the twenty-five sites measured had a corrosion potential of  $-0.268 \pm 0.004$  volts vs NHE (or  $-.0539$  vs AgCl seawater); in effect this shows that they are all in essentially the same corrosion microenvironment. From the observed relationship between corrosion currents and voltage in laboratory experiments, the standard deviation of 6 mV means that the rates of corrosion are within thirty percent of each other. The difference of 113 mV between the corrosion potentials of the deck winch and the frame plates near the stern reflects a ten-fold difference in their relative corrosion rates. The value of  $-0.103$  volts for the windlass is typical of potentials where no solid metal remains and this was indicated when the drill bit penetrated to a depth greater than 100 mm without striking solid metal.

Fig. 5. Pourbaix diagram for iron in equilibrium with a  $10^{-6}$  M  $\text{Fe}^{2+}$  solution showing on-site corrosion potentials for various parts of the engine. ★ windlass, ■ deck winch, ▲ mean potential of sixteen objects, ● frame plates, b represents the equilibrium line for water and one atmosphere of hydrogen gas.

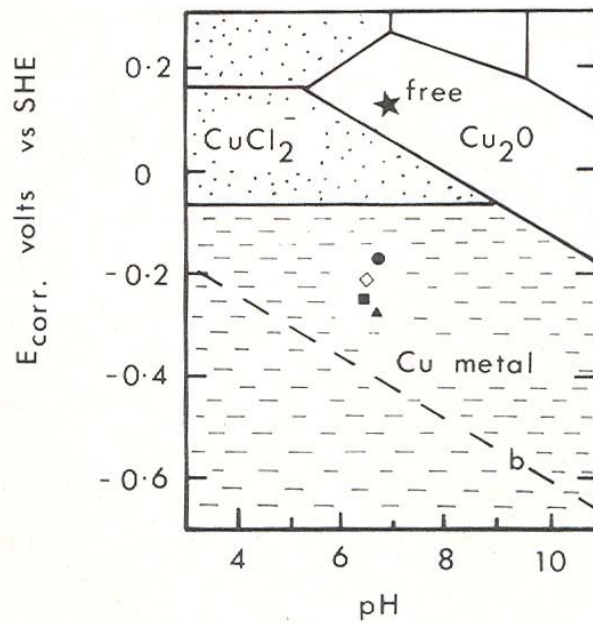
All the potentials observed for the non-ferrous fittings showed that they are all in the immune (for copper and brass) (Fig.6) or passive zones (white metal on crankshaft bearings). The corrosion potentials of the brass steam cocks and valves are largely determined by the iron corrosion potentials since the objects are in electrical contact with the iron metal which has a much larger mass and surface area. Although the copper and iron fittings on the engine have the same potential the results are different; copper and brass will not corrode while iron is actively

corroding. The concretion layer observed on the brass and copper fittings was a few mm thick and consisted of a dense white calcareous deposit. Because of the galvanic protection provided by the corroding iron, the copper based alloys act as cathodic sites in the corrosion cell and this causes the surface pH to increase and inorganic calcium carbonate as calcite/aragonite precipitates on the metal. Once this protective" layer of  $\text{CaCO}_3$  covers the biologically toxic metal corrosion products, the surface is then subject to normal colonization by marine organisms. The  $\text{CaCO}_3$  layer appeared to act as a barrier to oxygen diffusion since under its protection some of the  $\text{Cu}_2\text{O}$  on the metal surface had been converted to  $\text{Cu}_2\text{S}$  through the action of sulphate reducing bacteria. The less negative potential for the copper tubes and case on the steam water heater is simply due to the relatively small mass of iron attached to the copper tubing which has a large surface area.

Fig. 6. Pourbaix diagram for copper in sea water in equilibrium with a  $10^{-6}$  M copper solution. The on-site corrosion potentials illustrated are for ★ free copper pipe between the boiler and the engine, ● unidentified copper fitting on engine, ◇ steam pipe on water heater, ■ small copper pipe on engine and ▲ for brass steam cocks attached to the engine.

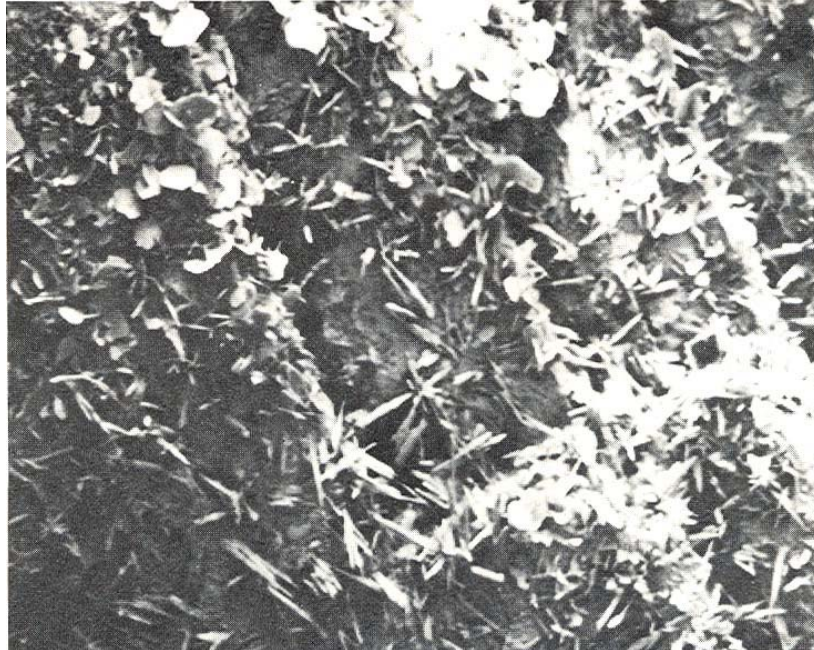
Samples of the galena (lead sulphide) ore were taken for examination under a scanning electron microscope. Mineralogical analysis of the original high purity ore showed that small amounts of minerals other than galena were associated with the deposit, namely lead carbonate, zinc blende, iron pyrites, blue slaty clay and quartz (Wilson, 1926). Since there were no arsenic or mercury compounds in the galena it is unlikely that there was any marked influence on the marine ecology from material leached from the minor compounds of the galena. The SEM micrographs of the galena samples recovered in the pre-disturbance survey (Fig.7) showed that some of the mineral had oxidized. Lead had migrated out of the galena matrix to the surface where it was deposited in two forms. The spiky crystals are phosgenite ( $\text{Pb}_2\text{Cl}_2(\text{CO}_3)$ ) and the plate-like crystals growing into cubes are the hydroxy carbonate hydrocerussite  $\text{Pb}_3(\text{OH})_2(\text{CO}_3)_2$  (Thornber, 1985). A sample of ppm lead while a iron concretion downstream from the mound of galena had 162 sample of concretion from *Vergulde Draeck* (1656) which carried general cargo, was  $61 \pm 6$  ppm. The significance of the solubilization of lead from the cargo (Mann & Deutscher, 1980) on both the corrosion rates and marine biology is yet to be determined. The amount of lead in the concretion from the *Vergulde Draeck* (1656) site probably reflects uptake of lead in seawater by marine organisms such as coralline algae (Sterner and Nickles, 1974).

Fig. 7. Scanning electron micrograph of the oxidized galena ore. The spiky crystals are phosgenite  $Pb_2Cl_2(CO_3)$  and the plate-like crystals are hydrocerussite,  $Pb_3(OH)_2(CO_3)_2$  which overly the present galena crystals. Full width of the photograph is  $750\mu m$ .

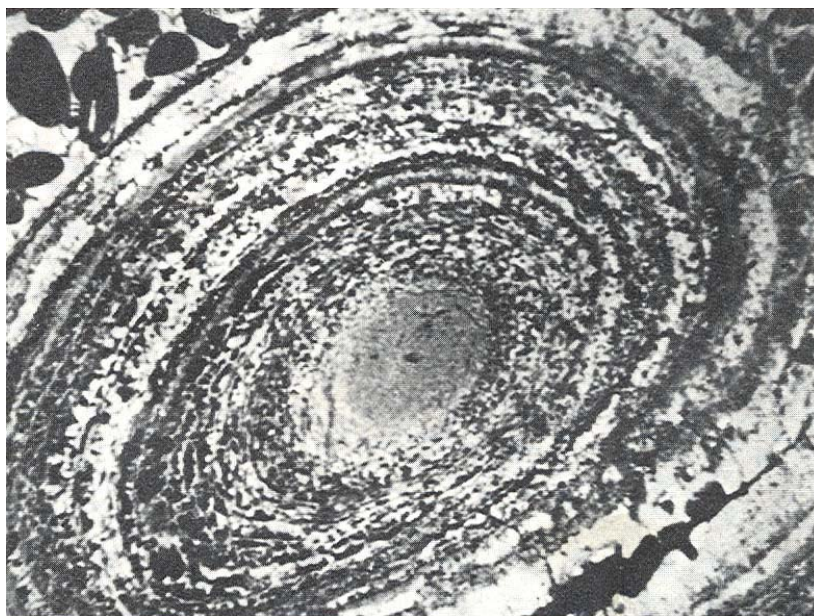
Examination of a polished specimen of copper wire from inside a water spray device, found lying proud of the seabed in the 1979 wreck inspection tour, showed up a typical banded formation with layers of the copper sulphide chalcocite ( $\text{Cu}_2\text{S}$ ) (Fig.8). Such banding is consistent with the periodic exposure to anaerobic/aerobic conditions over the last 110 years that would occur each time the site was buried/exposed.

Fig. 8. Scanning electron micrograph of a mounted cross-section of mineralised copper wire. The light grey material is the copper mineral chalcocite ( $Cu_2S$ ) while the black material is predominantly calcium carbonate. The banded formation is centred round a core of residual copper oxide. The full width of the photograph is  $2.6mm$ .
