## Conservation Management of Iron Steamships - The SS Xantho (1872)

I D MacLeod, BSc (Hons), PhD  
Department of Materials Conservation, Western Australian Maritime Museum

Paper G 91328 originally presented at the Fifth National Conference on Engineering Heritage Perth 3-5 December 1990

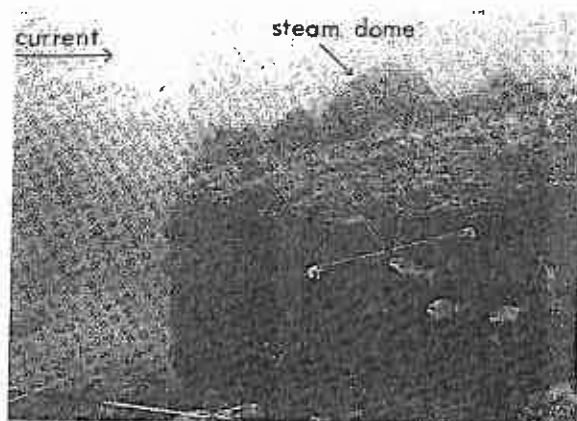
Figure 1 The Xantho boiler viewed from the port side during the predisturbance survey. The grid scale is 1.0 metres. Photo by Pat Baker.

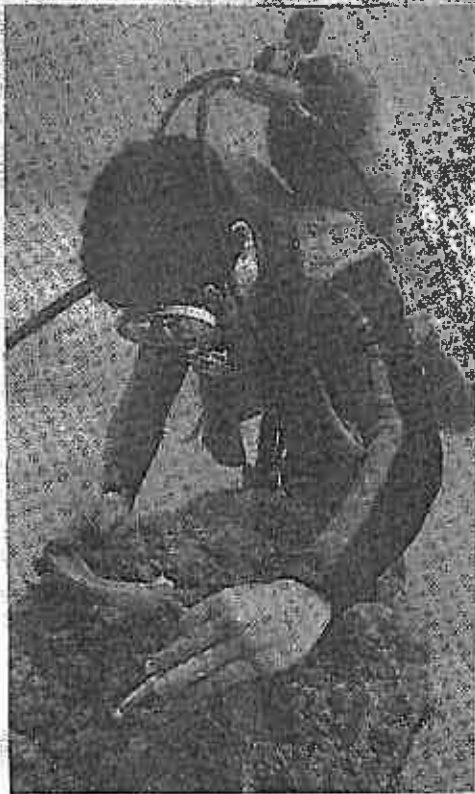
Figure 2 Attachment of sacrificial anodes to the propeller with a G clamp. Photo Jon Carpenter.

Measurements of the surface pH of the stern section after 20 months of treatment showed a fall in acidity, with the pH being 6.6 compared with an original value of 4.8 which represents more than a sixty-fold reduction in acidity. This confirms the predictions made in the laboratory as to the effectiveness of this approach.

Two 28kg zinc anodes were attached through six 'G' clamps to various parts of the stern section. The stern section had previously been separated from the rest of the vessel by

cutting with a thermal lance (Kimpton 1988). By machining the threaded shaft on the clamps to a fine point, it is possible to get good electrical contact with the underlying metal by tightening the thread using the built-in handle. Under such compression the shaft penetrated the 4cm thick concrete to provide a good electrical connection which was confirmed by in-situ resistance measurements. Insulated copper cables were brazed on to the 'G' clamps and the central steel core of the zinc anodes to provide electrical contact. The cost of two 28kg zinc anodes, six 'G' clamps and associated cable and crimps was \$250, which is very small when placed against the value of the wreck material. With the outward diffusion of chloride ions occurring during cathodic protection, it may be possible to perform major parts of a conservation treatment before the object is raised. (Fig.2)

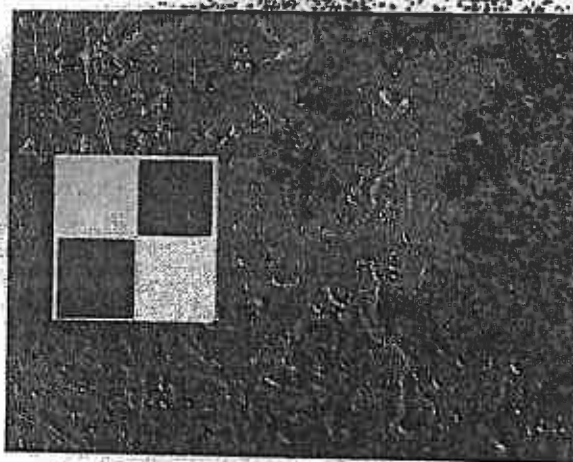
During the corrosion survey on the concreted engine it was noted that the counterbalances on the crankshaft contained lead - the drill bit had cut through the concretion to reveal a soft white metal. After excavation we found that the measurement point was where the lead came to the surface at the filling point of the hollow cast iron sections. Not unexpectedly the non-ferrous fittings on the engine showed little corrosion owing to the fact that they had been cathodically protected by the bulk of the cast and wrought iron of the engine. However, it was noted on the large copper steam exhaust pipe that the surface had been attacked, leaving the distinctive pattern of the serpulid polychaete worm casts etched into the metal. These worms appear to be unaffected by the toxicity of the surface oxides and the secure attachment over sections of the pipe leads to the development of differential aeration cells (see fig.3).

Figure 3. Corrosion of copper steam pipe caused by serpulid polychaete worms. Scale is 2cm. Photo Jon Carpenter.

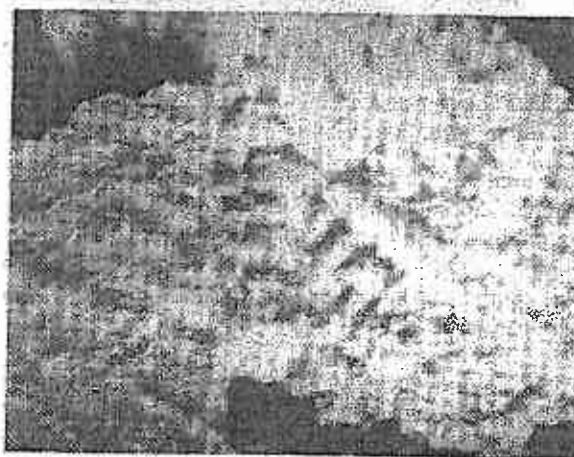
structure consisting of the "Chinese script phase" with average diameter of the characters being approximately 260µm (see Fig 4). The sulphur came from anaerobic bacteria and the zinc levels were typical of a zinc tin bronze.

The material was further examined by X-ray diffraction and the major phase was the tin sulphide  $\text{Sn}_2\text{S}_3$ , and a minor component of the polysulphide,  $\text{Cu}_2\text{S}$ . The formally mixed oxidation state of the tin sulphide, i.e. a mixture of tin (IV) and tin (II) indicates that the site conditions may have been not very strongly oxidising; this supposition is supported by the presence of the non-stoichiometric sulphide  $\text{Cu}_2\text{S}$ .

Figure 4 Scanning electron micrograph of tin and copper corrosion products from a bronze tallow pot. Full width 2500µm.

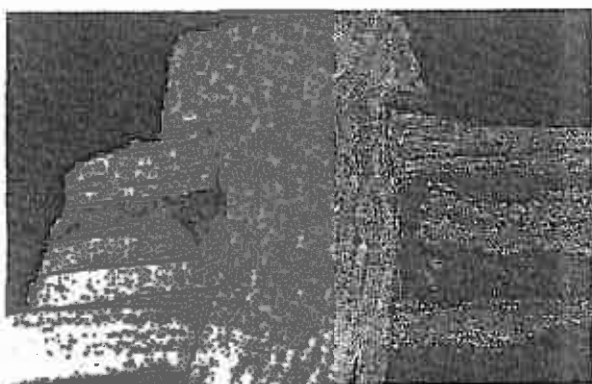
A riveted joint from the 1871 rebuild of the stern of the iron steamship *Xantho* was sectioned and analysed to determine if corrosion problems had been the primary cause of the wreck (see Table 2). It had been reported (McCarthy 1988) that the 'plates had sprung' in a storm immediately prior to the vessel sinking at Port Gregory in 1872. The sectioned piece of metal included a rivet body and head that had bonded three sheets of 6-7mm thickness which had been interleaved with linen prior to joining (see Fig. 5). The chemical analyses of the sheets are reported in Table 2 and are typical of wrought iron of that period. Metallographic examination of the junction shows "flow lines" in the head and body of the rivet which result from segregation of the different metal components; the various inclusions become elongated into long fibres as a result of forging (Johnson 1944). The microstructure consists of ferritic angular grains of different size - where the inclusions are most numerous the grains are smaller because the elongated inclusion phase stopped their growth. Although there are no traces of cold deformation in the grains, the microhardness measurements show major differences in their average values. In a transverse section, the body of the rivet had a mean value of  $277 \pm 26$  HV which is the same as in the head except for areas adjacent to the "flow lines" where values ranged from 323 to 442 HV. The mean microhardness of the plates was the same as in the body of the rivet. At the junction of the rivet and the top sheet the deformed elongated inclusions resulted from the joining process and from the production of the sheet.

Figure 5 Cross section of rivet and metal plates from the stern section; head of rivet 2.35cm.

All of the sheets and rivet are characterised by a massive number of metallic and non-metallic inclusions including two phase slag particles of FeO in a  $2\text{FeO} \cdot \text{SiO}_2$  matrix. Many of the inclusions are fragmented as a result of hammering. A

feature of the microstructure of the sheets is that impurities in the metal have been elongated in two directions - longitudinal and in cross-section. Since the degree of impurity elongation is greater in the longitudinal direction then it can be assumed that it was the main direction of rolling with the first stage of production including rolling in both directions. Examination of the section showed that significant corrosion had occurred in the crevice-like spaces in between the sheets. It is impossible to determine how much of the overall corrosion had taken place prior to the vessel's demise. However, given that preferential corrosion occurred along the lines of extensive working adjacent to areas of greater hardness, it is not inconsistent to blame extensive interseam and stress corrosion for contributing to the demise of the vessel.

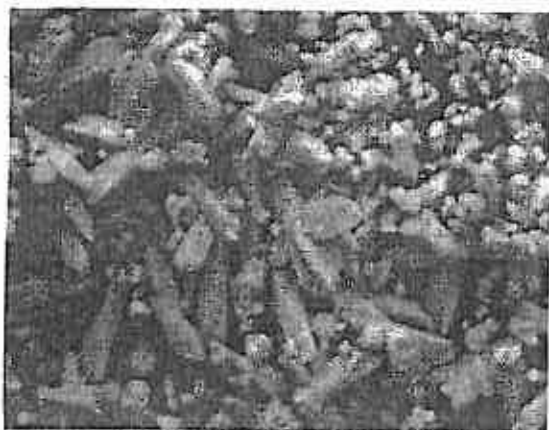
The composition of the forward valve chest is similar to that for a modern heavy-duty Class 50 cast iron (McGuire 1975) except that the manganese and phosphorous levels are very high (see Table 2). The high phosphorus content would make the parts hard wearing, but might make the metal more brittle. Inspection of the deconcreted engine showed a much more pitted and rough surface on the port and starboard pumps. The pumps were directly connected to the crankshaft by a "Scotch Yoke" type arrangement that did not allow them to be disconnected. Samples of the metal were obtained and a metallographic analysis of the inspection plate was undertaken to see what the underlying causes were for the different materials performance of the pumps compared with the rest of the engine. Although the carbon equivalents of the inspection plate and valve chest were similar (see Table II) the higher silicon content and lower manganese levels tend to promote a random distribution of graphite as superimposed and interconnected flakes in the ferritic matrix rather than having more of the carbon combined with iron to form more pearlite. The mode of corrosion is clearly along the grain boundaries around the "inert" graphite flakes. There was also significant porosity associated with the casting. These factors plus the natural orientation of the long axis of grains perpendicular to the surface of the casting mould (Rhead 1945) would have contributed to the ready ingress of the chloride ions and thus the greater extent of corrosion. A fine white deposit on the inside of the inspection plate was examined with an SEM and shown to be crystals of aragonite ( $\text{CaCO}_3$ ) which is consistent with "soft steam" having powered the pumps (see fig. 6).

Figure 6 Scanning electron micrograph of aragonite crystals recovered from inside the starboard pump. Full width 260µm.
