Historic Shipping on the River Murray

CHAPTER 6 Conservation Assessment

Report on the Corrosion of Shipwrecks in the River Murray

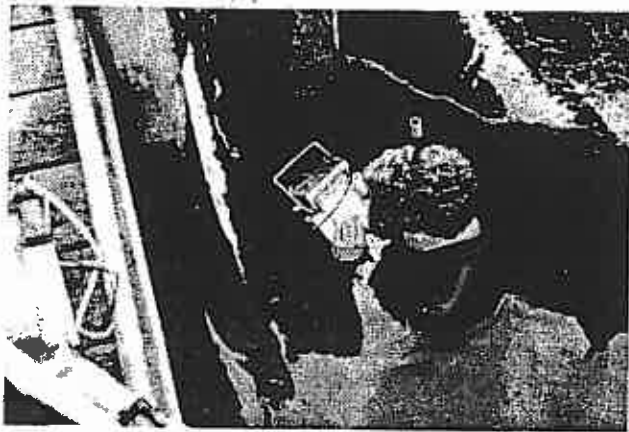
more degraded than on the *Albion* although this is not reflected in different pH values - it should be noted that the original colour of the *Uranus* timber had not yet been exposed at a depth of 3 mm into the surface. The average corrosion potential for the iron plating on the *Uranus* is -0.163 ± 0.008 volts vs. NHE which is 13 mV more positive (less negative) than the average value for the iron plating found on the *Albion*. The small difference in the average voltage of the vessel is probably a reflection of the location of the *Uranus* in the breakwater system which has more water flow around it than the *Albion* has in its location adjacent to the river bank. The recording of the pH profile on the wood from the *Uranus* stern post is seen in Figure 104.

Figure 104 Measurement of surface pH of wooden stem post in the *Uranus* (1992)

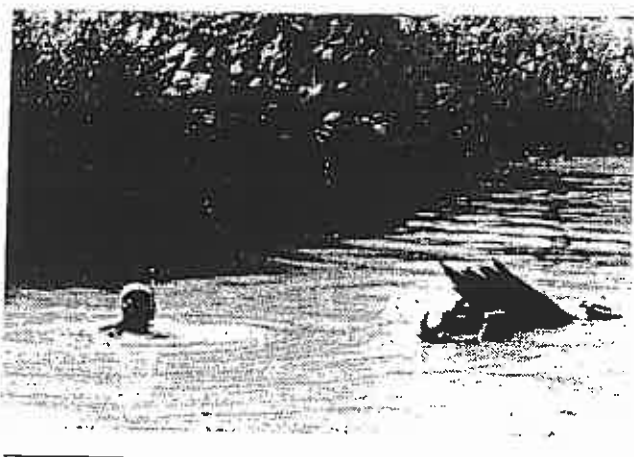
Figure 105 Bill Jeffery inspecting the steam pipe from the *Corowa* engine.

The average of all the iron corrosion potentials measured on this site was -0.156 ± 0.028 volts vs. NHE. Part of the reason for the larger standard deviation of these corrosion potentials compared with the previous sites is that with an increased range of water depth, the *Corowa* site can exhibit a wider range of microenvironments. The other major factor is that we note the more anodic (less

negative) potentials associated with the cast iron fittings associated with the engine. The most negative potential was recorded at the base of the paddle system. Given the juxtaposition of the *Corowa* and the *Crowie* it is not surprising to see that they have essentially the same average corrosion potential and the same inherent rate of corrosion.

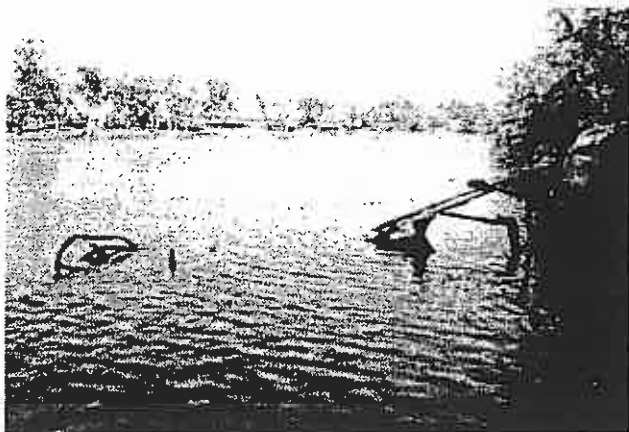
Figure 106 View of the exposed frames of the *Cobar* and the stern wheel of the *William Randell*

The mean corrosion potential of the solid iron fittings, frames and plating on the *Cobar* was -0.111 ± 0.006 volts vs. NHE. This average value is higher (more corrosive) than the *Coroiva* and the *Crowie* and this is due in part to the fact that more of the iron in the vessel is protruding from the surface which gives increased access to oxygen and to the setting up of a series of differential aeration cells.

The higher voltage for the submerged stern deck plating of $+0.081$ volts is indicative of a corroded matrix rather than a true corrosion potential reading which requires some solid metal to be in electrical contact with the point of measurement.

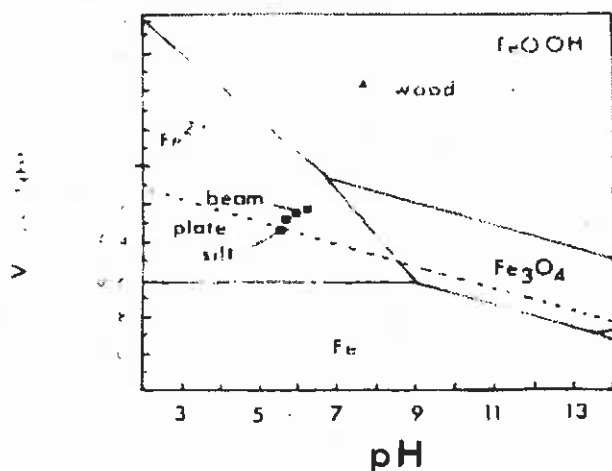
Figure 107 Pourbaix diagram showing corrosion potentials for materials on the *Jolly Miller*

The average corrosion potential for all of the iron fittings on the vessel is -0.282 ± 0.014 volts vs. NHE. or -0.268 volts vs. NHE if the value of the iron bolt out of the silt is not included. The average water depth of the site was between 4 and 8 metres with the remains of the vessel resting on the edge of the river bank which falls away quite

quickly once one moves away from the shore line. The low values of the corrosion potentials is indicative of a good state of preservation of this material.

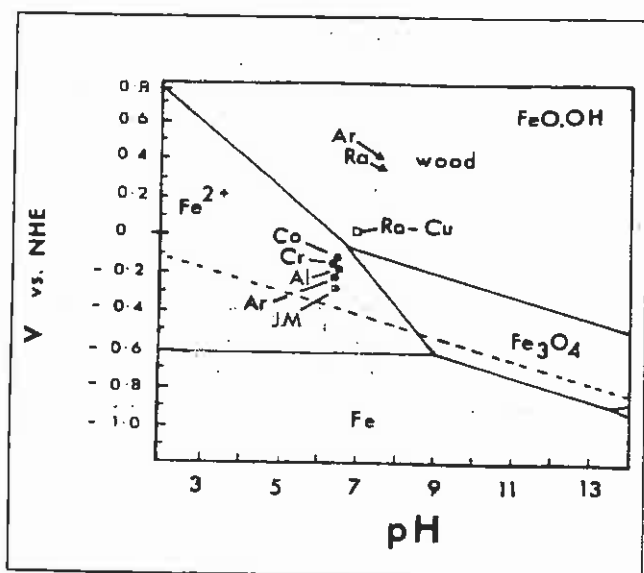
By plotting the average corrosion potentials for the iron fittings and structural materials, from the different sites, on a Pourbaix diagram it is very easy to appreciate the different nature of the sites at a glance. Some of the data is shown in Figure 108 where some sites with essentially the same average E_{corr.} were omitted for the sake of clarity. When the site parameters are summarised in this form we see that all the average E_{corr.} values for sound iron are in the region of active corrosion. The equilibrium reactions appear to be related to the corrosion of iron to produce Fe²⁺ ions which are in equilibrium with magnetite, Fe₃O₄ according to the following reactions,

The more negative values for E_{corr.} found for the vessels upstream of Waikerie and at Loxton and Berri are in part due to the greater depth of water over the sites. It has been observed in the ocean sites that water depth has a major affect on the values of E_{corr.} and, in turn, on the rate of corrosion (MacLeod 1989, p. 2). Although the corrosion mechanism has not yet been validated for river sites, it is most likely that the reduction of dissolved oxygen is involved in the rate determining step in the overall corrosion process. Support for this mechanism is found in the way in which the individual corrosion potentials vary with site conditions. A good example of this is seen on the site of the *Jolly Miller* where the E_{corr.} of the iron in the silt was 82 mV more negative (less corrosive) than values obtained on similar iron sections at a shallower depth which were lying proud of the river bed (see Figure 107).

Figure 108 Pourbaix diagram showing corrosion parameters for wrecked barges and paddle steamers in the River Murray. The symbols used are: Ar(Arnold), Ra(Randell), Ra-Cu(galvanically coupled), Co(Cobar), Cr(Crowie), Al(Albion) and JM(Jolly Miller).

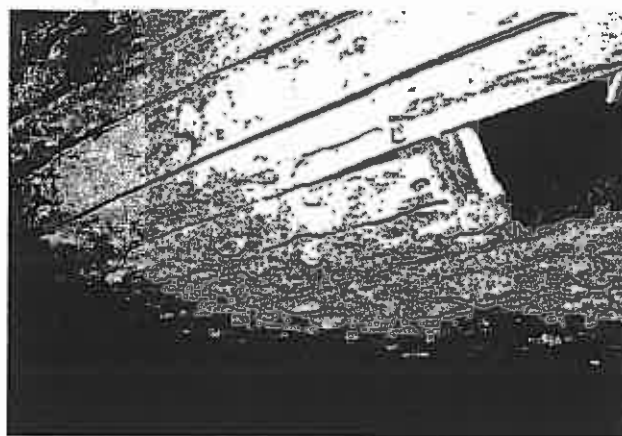
An example of the effects of water movement on the preservation of timber is seen in the degradation patterns on the bottom of the P.S. *Colonel*. The timber has apparently been degraded to a much greater extent in the area adjacent to the wash from the paddles than in the sections where the water flow is less turbulent. The iron corrosion products have apparently preserved the wood in the vicinity of the bolts, see Figure 109, whereas iron is normally associated with the increased rate of chemical and biological deterioration. Further work needs to be done to clarify the mechanism of this apparent reaction - the surface profile may also be due to specific biological degradation mechanisms that pertain to the riverine and riparian environments.

Figure 109 Hull planking on the P.S. *Colonel*

- that ongoing monitoring occurs on all selected sites from which data has already been obtained;
- that sites are monitored for the effects of boat wash and specific deterioration of the fabric;
