AN IN-SITU STUDY OF THE CORRODED HULL OF HMVS *CERBERUS* (1926)

Ian Donald MacLeod, Department of Materials Conservation,
Western Australian Museum

SUMMARY: During massive gales in December 1993 the wreck of HMVS *Cerberus* collapsed two metres into the sea leaving only the superstructure and part of the decks above water. Because of the historic significance of this iron Monitor styled warship a corrosion survey was commissioned to establish the remaining life of the vessel. From a combination of in-situ corrosion potential, pH and metal thickness measurements it has been possible to quantify the present rate of deterioration. The impact of wind, wave action and local water movement within the site have been ascertained. From a combination of long-term corrosion profiles and present residual metal thickness, calculations of original dimensions of plating, ribs and frames have been made. Thus maritime archaeologists and heritage managers now have a new tool with which to investigate the nature of historic iron shipwrecks.

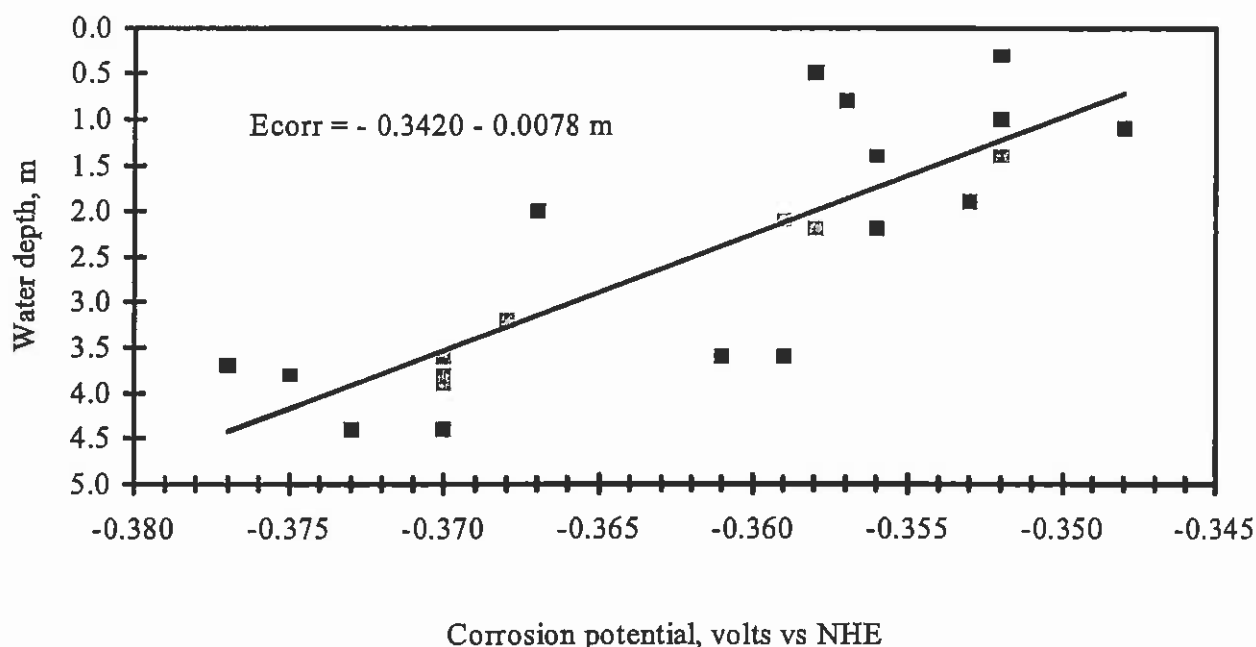
Figure I: Plot of the corrosion potential for the starboard side as a function of the water depth.

The plot of the corrosion potentials, on the starboard side, as a function of water depth, as shown in figure I shows a general trend to less anodic values as the water depth increases. The linear relationship between the mean E_{corr} data at the different water depths had a correlation coefficient of 0.996

Thus the corrosion potential is seen to move to more negative values as the water depth increases at an average rate of 7.8 mV/metre. The fall in E_{corr} with water depth is less than the 18.9 ± 1.5 mV/metre observed on heavily concreted wreck material that was in higher energy zones associated with open ocean and shallow reef strewn waters (3). A similar dependence of E_{corr} with water depth, to that observed on concreted open ocean sites, of 21 ± 3 mV/metre was noted for iron wrecks in the River Murray in South Australia (9). In this case a dense and adherent layer of mud and magnetite prevented direct access of the dissolved oxygen to the corroding metal surface. The physical barrier in the River Murray had a similar effect of separating the anodic and cathodic sites as the concretion has on open warm water marine sites. The general trends in E_{corr} with site location and water depth on the HMVS *Cerberus* site are summarised in table II.

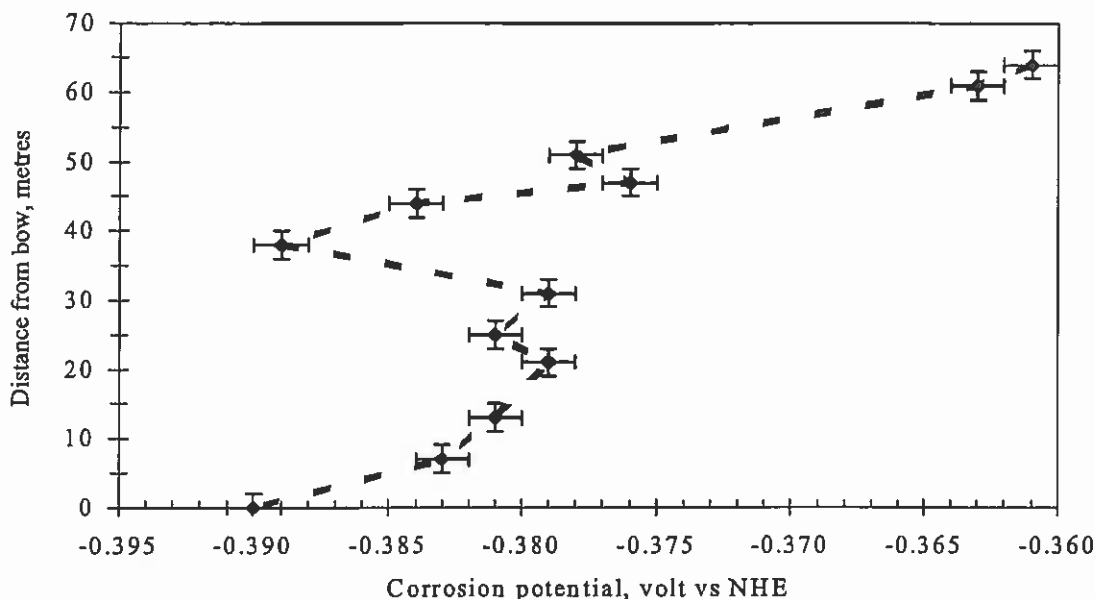
Figure II. Port side corrosion potentials at a depth of 4 metres as a function of distance from the bow.

This equation can then be used to show that the differences in corrosion potential between the bow and the midships of 20 mV equates to a difference of approximately 16% in corrosion rate. Plots of the $E_{corr.}$ and pH data on a Pourbaix or thermodynamic stability diagram (11) show that most of the readings of corrosion potential and pH are in the zone of active corrosion for iron in seawater with a mean $E_{corr.}$ of -0.370 ± 0.011 volts at a mean pH of 7.31. Data sets in this area generally described by equation 5

This equation describes both the observed nature of the corrosion matrix as well as the dependence of $E_{corr.}$ on the pH (14,15). The corrosion potentials at the bow are significantly more negative than the nearby sections and the more cathodic values are probably due to the differences in composition of the stem (bow) compared with the frames and plates as noted in the original specifications (16).

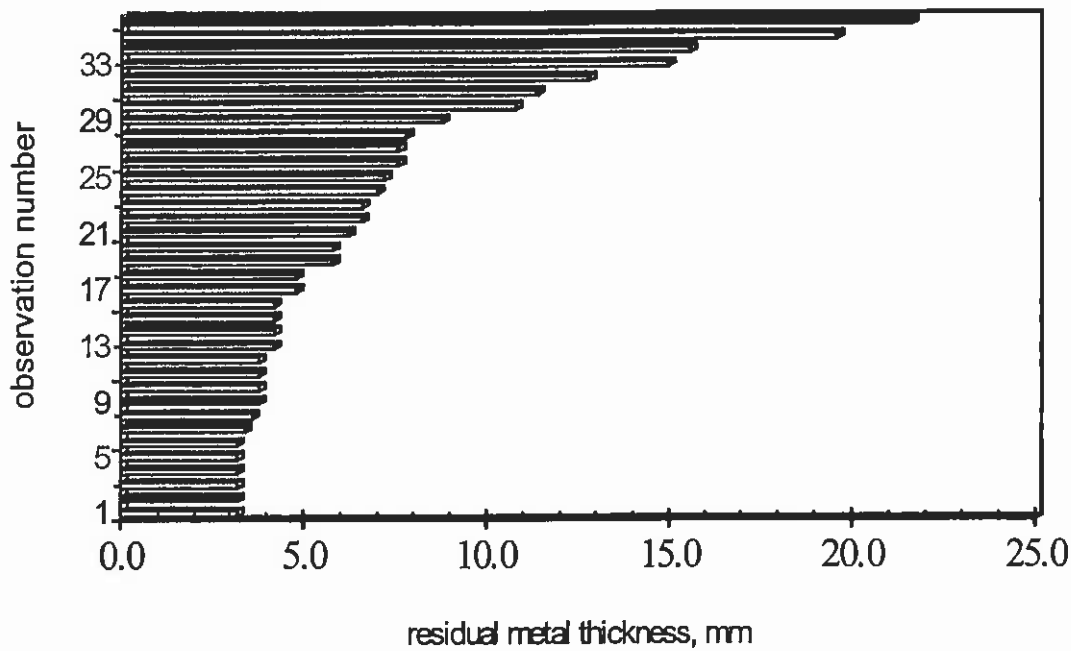
The data on the metal thicknesses observed on the vessel shows that there is a large spread in values from the order of 20-3mm as we move from the bow to the stern. A distribution diagram of the residual metal thickness is shown in figure III. Given that the original armour plating was between 8"-10" (203-254 mm) it is readily apparent that our experimental method has not picked up the massive plating. The absence of the expected metal thickness data is not due to experimental error or to operator ineptitude. Our data relates to a secondary cladding over the armour belt and the degraded values of plating and frames and ribs. Inspection of the starboard side of the wreck shows a clear line of extra plating that ceases about 3 metres below the original deck height. Although this extra layer of plating was not in the original specifications a refit in 1897 saw a strengthening of the armour plating by the addition of an extra "belt" as concerns had been expressed about the ability of the vessel to survive impact from the newer guns. When the data is separated into a number of subsets associated with plating and ribs we see that the mean thickness of materials in the middle of the site is greater than in the areas closer to both the bow and the stern. This trend in residual metal thickness is also consistent with the observed trends in $E_{corr.}$ which are lower in the middle of the site and so reflect a lowered corrosion rate.

Figure III: Plot of residual metal thickness as a function of frequency of observation

This scenario is unreasonable since the data obtained on the depth of corrosion on the shaft housing has been used as a guide and the 42 mV range of E_{cor} values across the site indicates that the overall differences in corrosion rate are small. Given that so much of the original documentation of the specifications for the vessel is extant and that many of the structural members are seen to be in the order of thickness from ½"-19" the estimated original thicknesses are also realistic. The data summarised in table IV indicated that the *Cerberus* used a range of metal thicknesses which generally incremented by 7" and that the upper works have suffered greater corrosion than the middle of the vessel. The amount of corrosion of the upper section is similar to that of the frames and ribs at the interface between the sea bed and the vessel.
