Conservation of the SS Xantho

Ian D. MacLeod

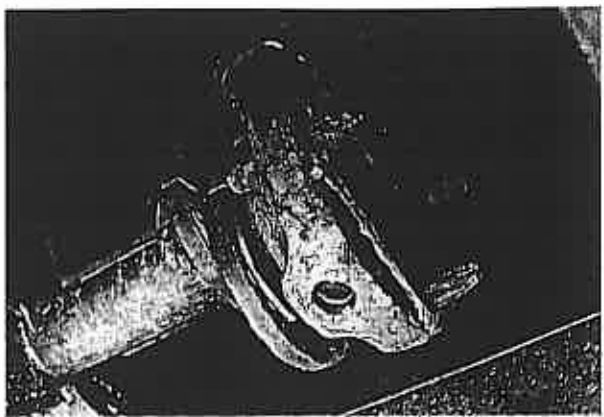
Figure 1. Exfoliation of aft end of crankshaft.

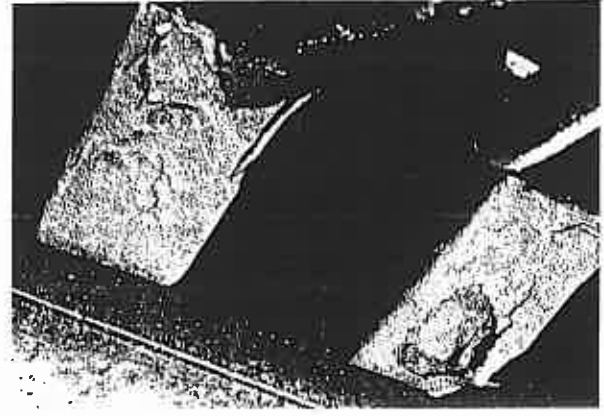
Figure 3. Partly delaminated graphitised zone on a crankshaft counterbalance.
