First Australian Conference on the  
Conservation of Timber Structures

CONSERVATION OF WATERLOGGED TIMBER

The work reported in this paper relates principally to the conservation of ships timbers and other fittings recovered from the wreck of the Dutch East Indiaman, *Batavia* which sank in 1629. The problems of on-site recording and documentation as well as transportation from a remote site to our central laboratories, have been shown to be critical to the ultimate fate of the materials. An outline of the treatment is given and a description of the plant needed to stabilize the conserved material and to maintain a proper display environment is reported. Alternative treatments of controlled dehumidification, without impregnation with aqueous solutions of polyethylene glycol, have been shown to be effective in special cases. Problems associated with oxidation of pyritic minerals in ships fittings are also discussed.

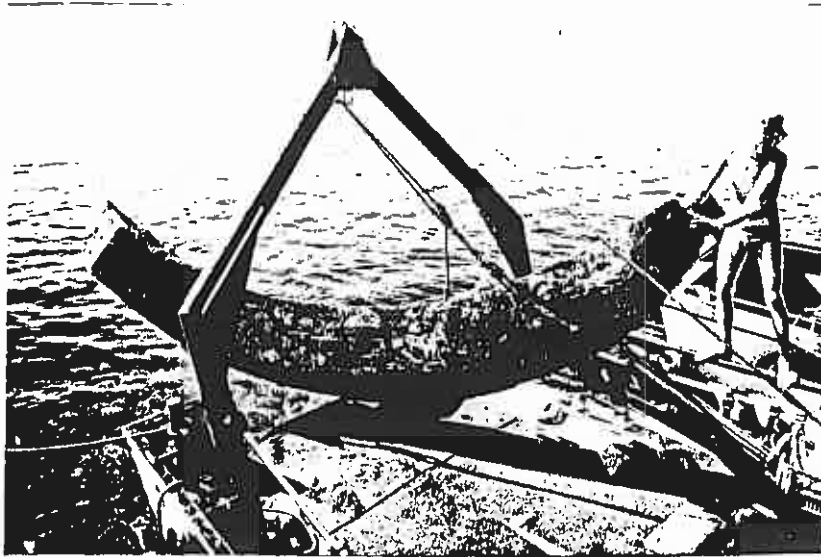
Figure 1: The fashion piece from the port side of the *Batavia* after recovery from the sea bed.  
Photo. P. Baker.

to Indian Ocean swells. With the benefit of hindsight such procedures should be avoided if at all possible since they lead to major cosmetic problems in the reconstruction, viz., all the natural breaks in the planking are scarf joints and so a line of butt joints down the side of the ship spoils the historical perspective. The largest single timber was raised intact and as such the fashion piece weighs over one tonne and was cut from solid oak. It forms the key piece in the reconstruction and details of its conservation have previously been reported.<sup>9</sup> (see figure 1)

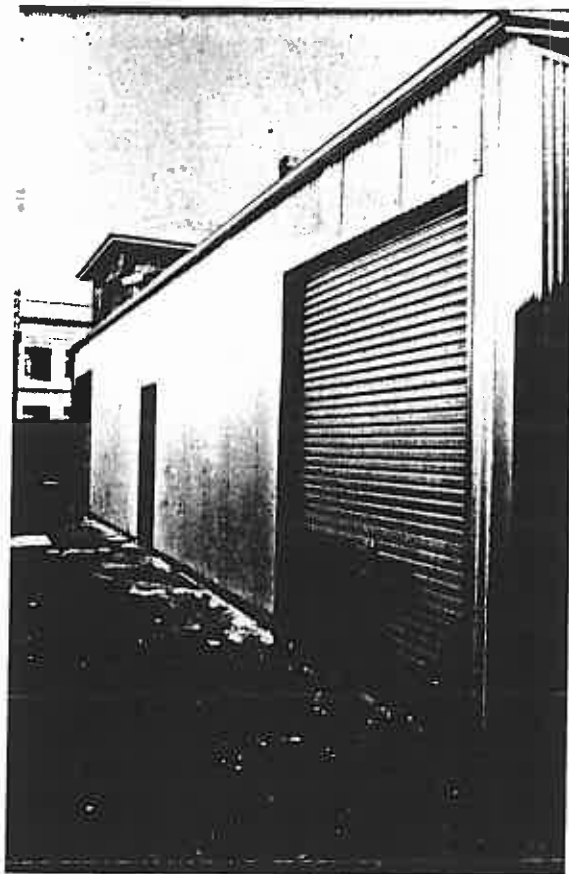
Figure 2a; Dehumidification chambers at W.A. Maritime Museum, showing the external features.  
Photo. J. Carpenter.

Small sections of timber were freeze-dried<sup>4</sup> but all the ships timbers were prepared through controlled dehumidification in a series of three different chambers. The first model was temporarily established in the rear of the old Commissariat building while the front section was being restored as the W.A. Maritime Museum. The aluminium tubing framework was covered with high density clear polyethylene sheeting to form two chambers and the timber was stored on heavy duty steel racks. The two dehumidification units were balanced by two humidifying plants and control of relative humidity and temperature was achieved to within  $\pm 4\%$  and  $\pm 3^\circ\text{C}$  respectively. At relative humidities above 85% the PEG treated timbers tended to sweat but this helped remove excess surface material. The surfaces were brushed with a 70% PEG 6000 solution; since PEG 6000 is less hygroscopic than PEG 1500 and it was thought that such a coating would help to guard the treated timbers from the worst effects of exposure to high humidities. Problems such as earthquakes upsetting the mercury-switching gear on the dehumidifiers lead to temporary rehydration of the timbers and so the process of drying each batch took nine to ten months. The second generation of drying chambers comprised two asbestos cement lined corrugated iron sheds with the same operational plant as before (see figure 2). Whilst this arrangement worked well for humidity control in the 90-70% RH range, it became progressively more difficult to dehumidify as the 60% RH level of the ultimate display condition was approached. Problems of insufficient thermal insulation in the walls, inadequate air flow over the compressor units and corroded heat exchanger vanes within the chambers resulted in many 'restarts' to the drying process.

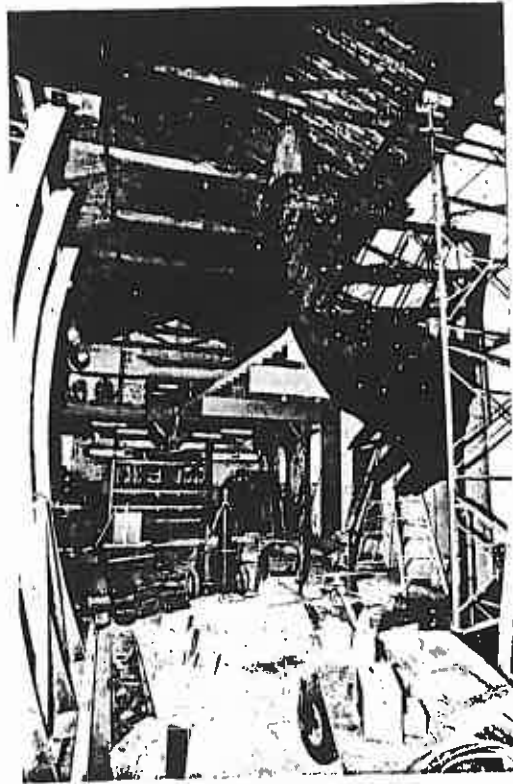
Figure 4: Transom of the *Batavia* after it was raised into final position from being assembled on the floor.  
Photo. J. Carpenter.

All the treated timbers are now stored in the *Batavia* gallery in the W.A. Maritime Museum where conditions of  $22^\circ\text{C}$  and  $55 \pm 5\%$  RH are maintained throughout the year - apart from the normal crises associated with plant breakdown. The design of the air-conditioning plant for a porous salt damaged sandstone structure needs to be addressed elsewhere but it is worth noting that a doubling of the estimated demand on the plant has resulted in the system being able to cope. The reconstruction is progressing at a steady rate and the erection of the steelwork by Geoff Kimpton is a major feat in itself (see figures 4 and 5).

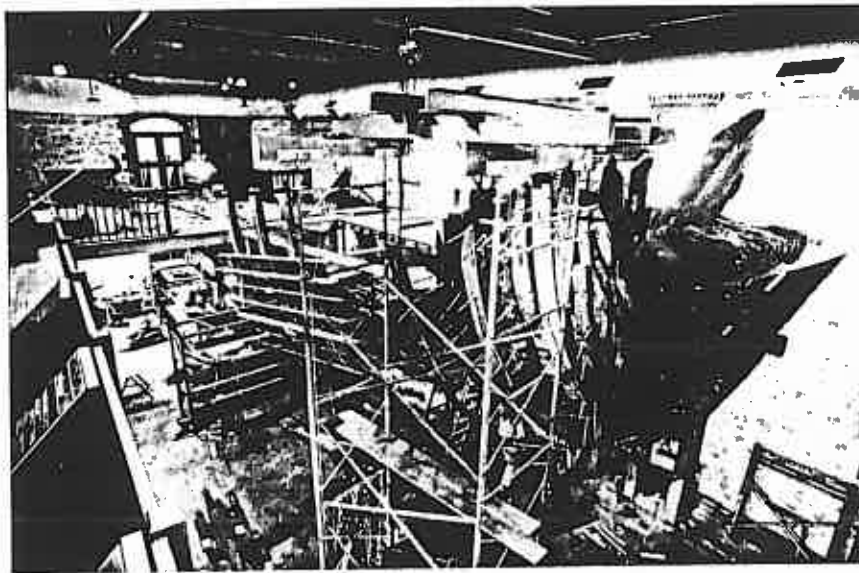
Figure 5: The reconstruction of the *Batavia* November 1986.  
Photo. B. Richards.
