***In-situ* conservation management of historic iron shipwrecks in Port Phillip Bay: a study of *J7* (1924), *HMVS Cerberus* (1926) and the *City of Launceston* (1865)**

Hanna Steyne^{1*}

Ian D. MacLeod²

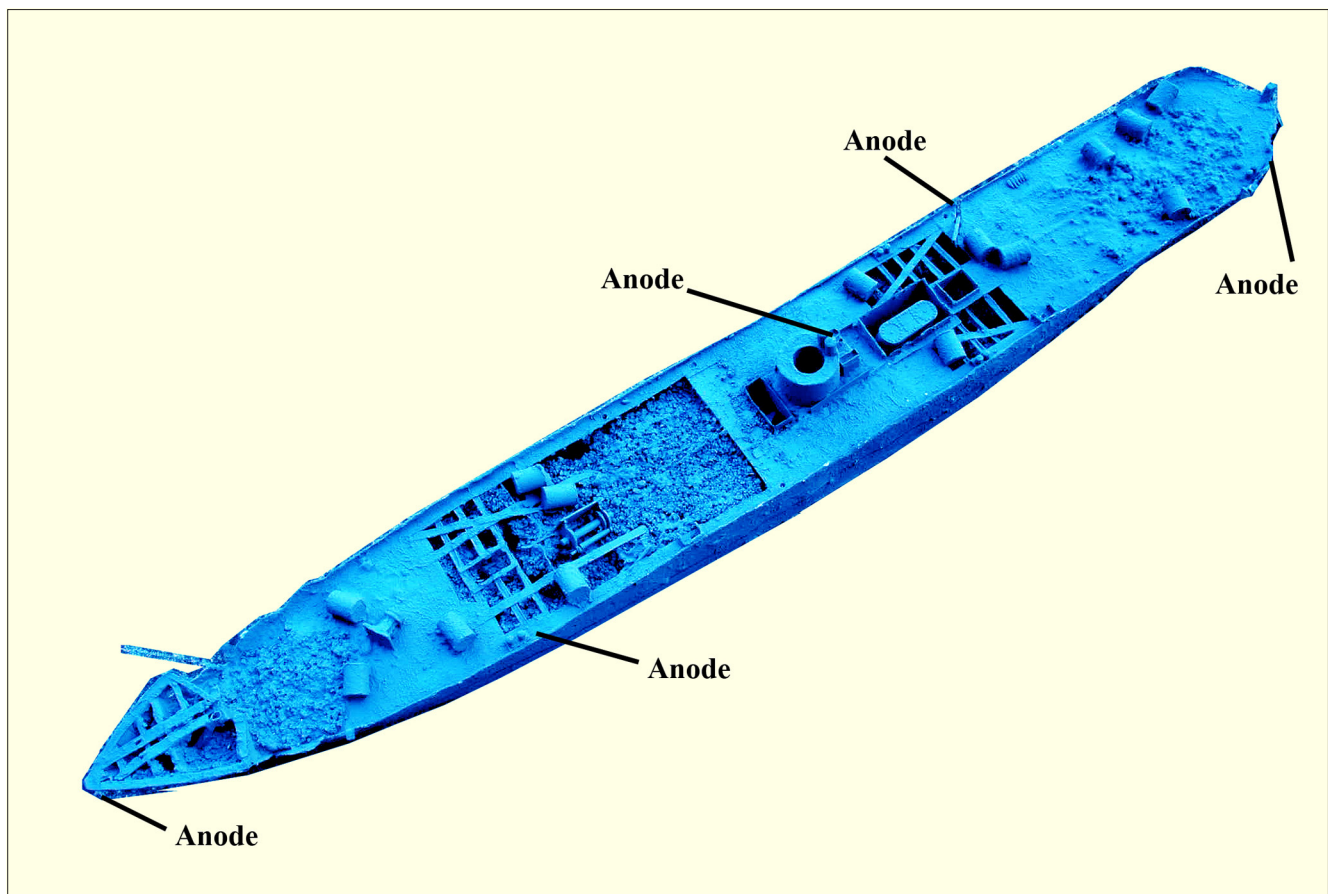
In July 2009 Professional Diving Services were commissioned by HV to place five anodes on the *City of Launceston* hull and engine to slow the corrosion process and delay an expected catastrophic collapse of

Figure 1. Site plan for *City of Launceston* showing location of anodes and the Macquay device.

the midships area. Measurements of E_{corr} during 1997 and 1998 showed an increasing number of hull plates whose voltages indicated that little or no solid metal remained in that section of the vessel. The implication of this observation was that a major storm crossing the site could provide enough energy to cause the collapse of this intact iconic historic iron shipwreck. Due to the fragile nature of the hull plates, 'G' clamps were used to attach the anodes, instead of drilled and tapped connections, at the positions shown in Figure 1. The anodes were placed in positions that would protect the hull, engine and the lower parts of the wreck attached to the engine bed.

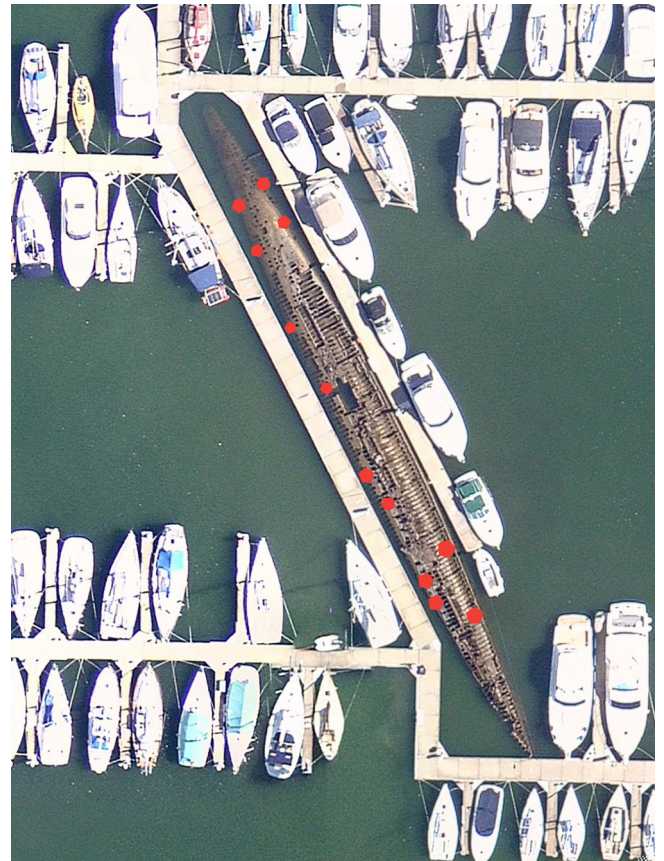
Figure 3. Location of the submarine *J7* in Sandringham Yacht Club showing measurement points.

Two dives were made on the site, with 12 drill holes for pH and E_{corr} measurements taken along both the port and starboard sides, as shown on Figure 3.

The sections of hull that were fully exposed above water had a much harder concretion layer in contrast to the softer and more easily penetrated marine concretions on the submerged sections. The concretion was thin (2–4 mm) in all measured areas. The pH and E_{corr} measurements taken around the hull, shown in Table 1, indicate that the hull is in moderate condition, given that corrosion rates are going to be at a maximum in the splash zone due to wind chop and water movement from passing boats. The data indicates that the corrosion potentials cannot

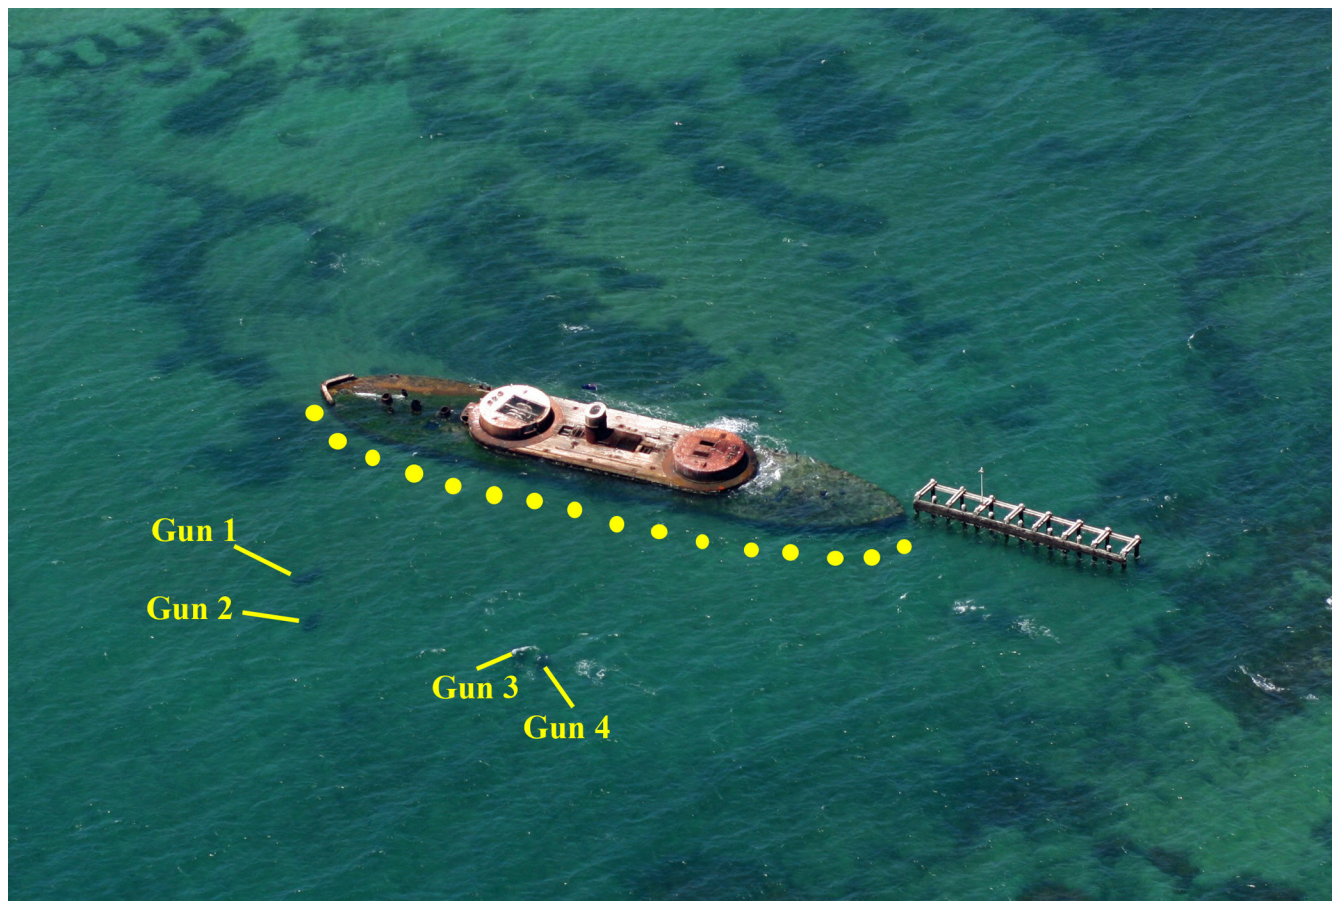
Figure 4. Aerial view of the *Cerberus* site showing location of the gun barrels undergoing *in-situ* treatment and the starboard measurement points.

The four guns on the seabed (named as per Figure 4) had their E_{corr} values recorded and the pH values of guns 3 and 4 assisted the authors to establish the degree of cathodic protection being provided by the anodes. Measurements were also taken on the anodes attached to each gun, and results are presented in Table 4.

The measurements on the four off-site guns indicate that the anodes are working effectively so long as they remain attached. There have been ongoing issues with anodes becoming detached from the guns due to the large swells experienced on the site that causes case-hardening of the heavy gauge multi-strand insulated copper cables. This has been largely addressed by burying the anodes in the sediment and regular inspection by both HV and Professional Diving Services however it seems that occasionally this problem still occurs.

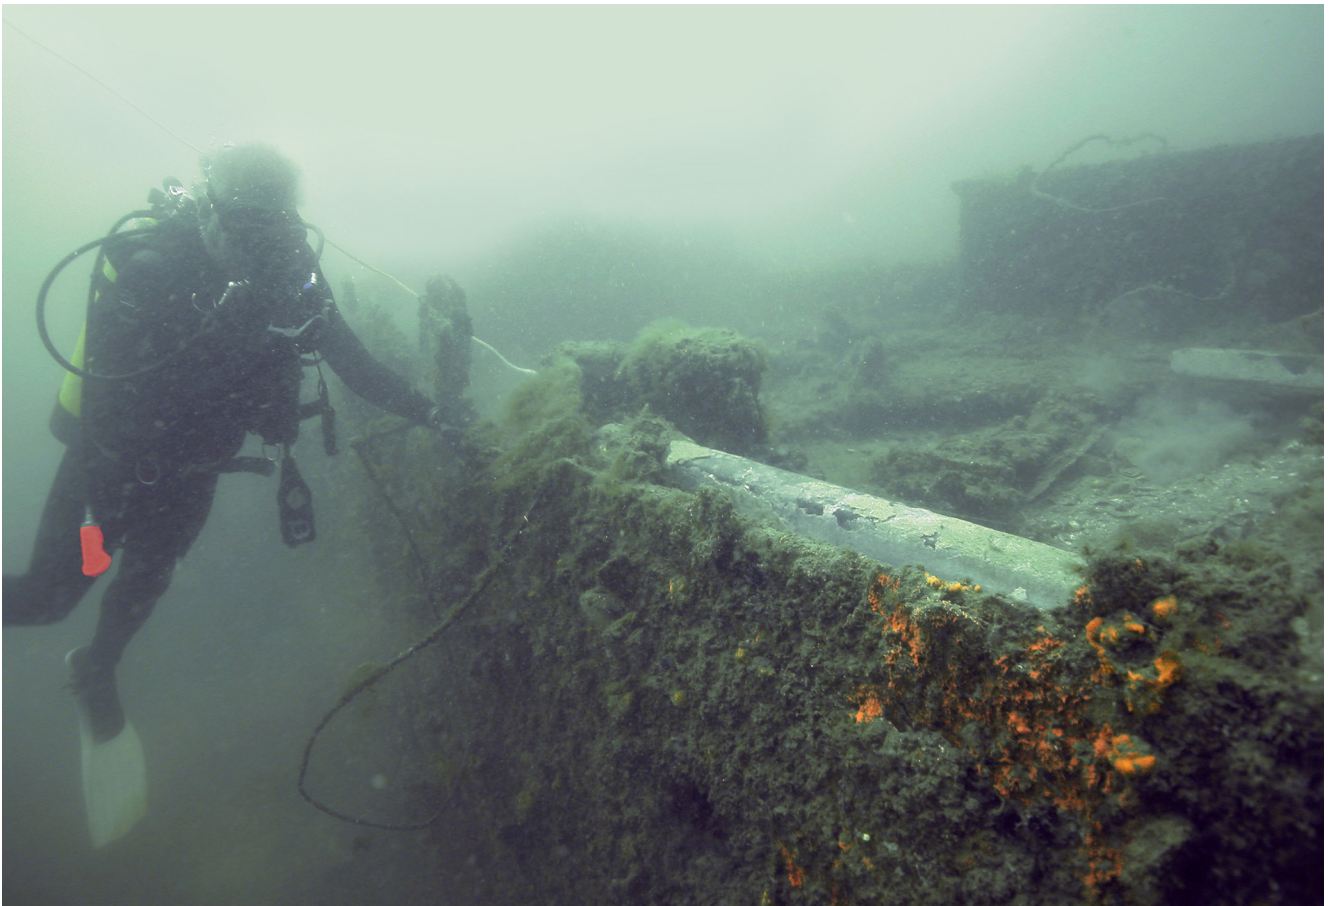
Figure 5. Zinc anode on the *City of Launceston* site showing voluminous corrosion products resulting from protecting the vessel.

The anodes were noted to have a massive covering of zinc corrosion product, as seen in Figure 5, indicating that they were actively corroding.

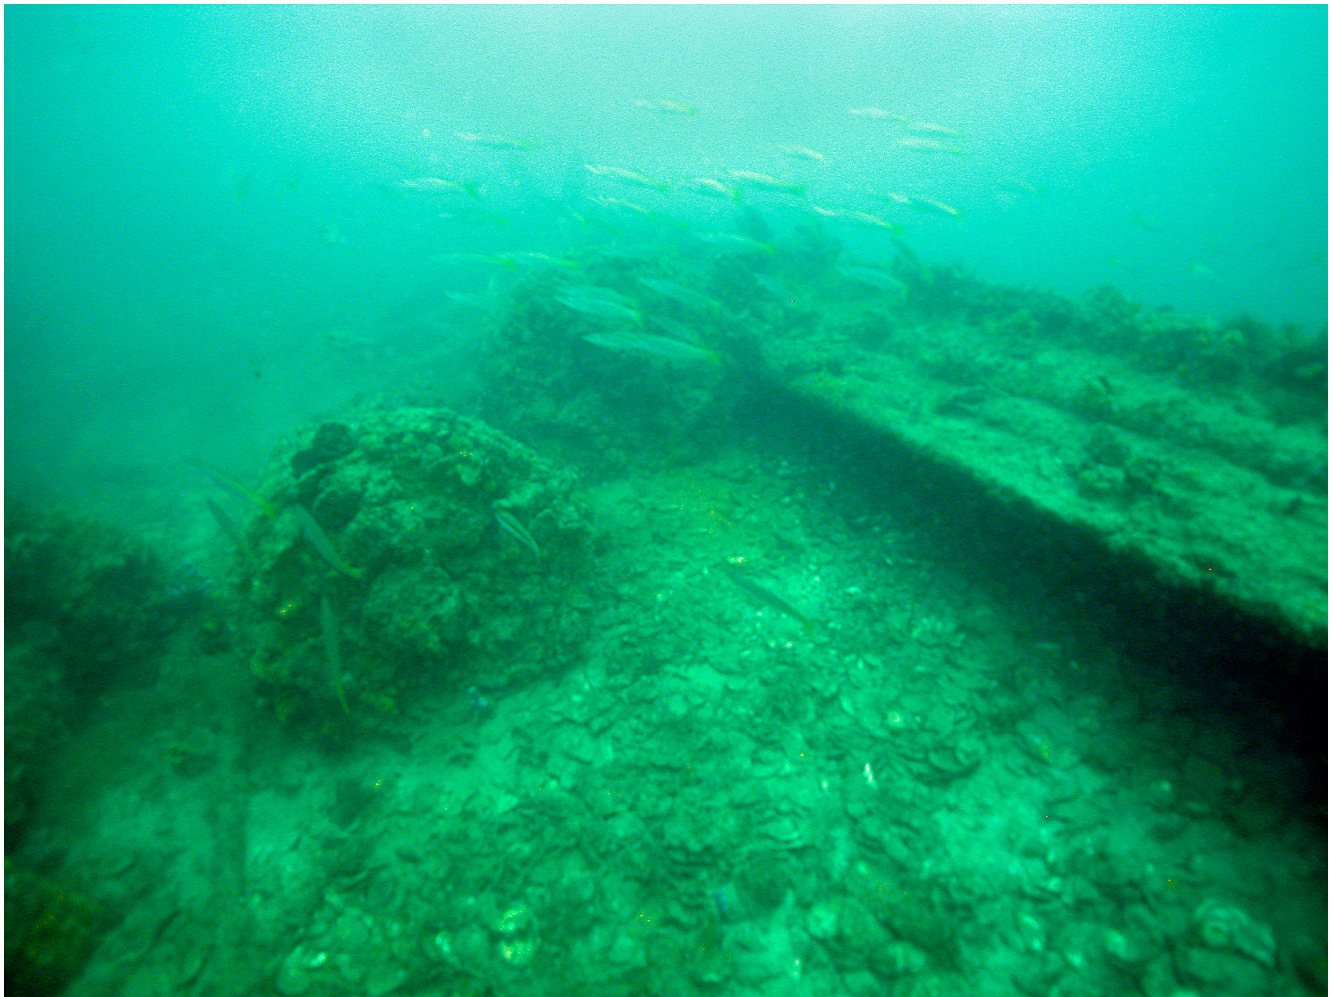
Figure 6. Changes in water flow leading to scouring on the *City of Launceston* site.

A second photographic recording dive on the *City of Launceston* two weeks after the training exercise revealed that the site is continuing to lose sediment, with the spiral staircase now well exposed, and a 'shelf' at the bow now well defined. It seems that either loss of sediment or collapse of some internal, buried feature (possibly a deck) has resulted in a slumping of the visible features (Figure 6). Further evidence of sediment loss comes from exposed features around the stern which have not been observed before.

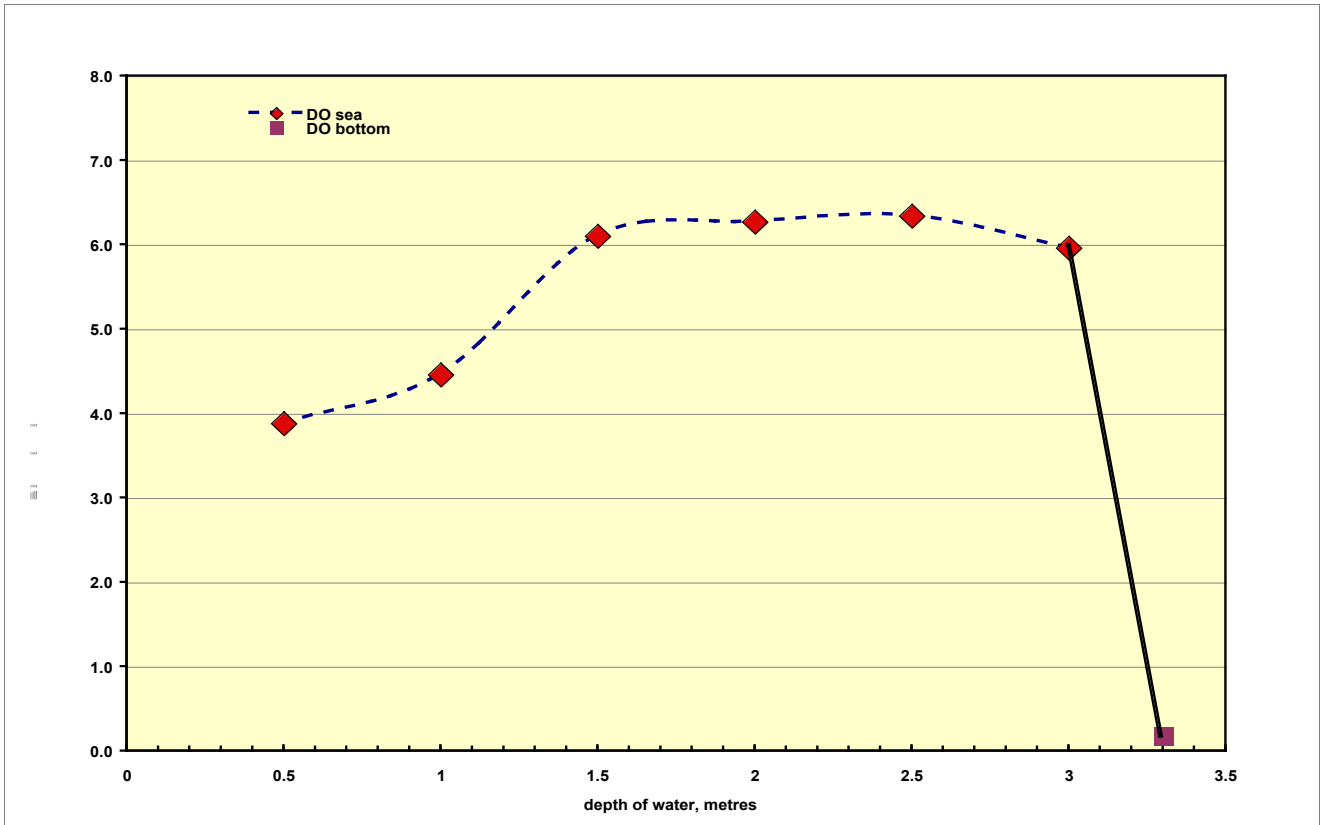
It is noted that at the deepest part of the *J7* site the very low dissolved oxygen level is associated with the weighted probe penetrating the silt mound which is a region characterized by limited exchange with oxygenated sea water.

The work on *J7* revealed the value of collecting the standard parameters of temperature, salinity and dissolved oxygen. Data collected at the *J7* site showed that when the oxygen levels are plotted as a function of water depth they initially increase and then fall to essentially zero at the sediment interface, confirming that the bottom section of the submarine is corroding in an anaerobic microenvironment (Fig. 7).

The dissolved oxygen, salinity and temperature data for the *J7* site are listed in Table 2 where it can be seen that in the first metre of the site the higher temperature of 29°C means that the total amount of dissolved oxygen available to the site is less than in the deeper parts of the site and that the amount of oxygen in the surface waters is significantly depleted, as seen in the plot in Figure 7. The data in this figure shows that the waters surrounding the upper parts of the grounded submarine amounts to 62% of the saturated level and that over the next metre

Figure 7. Plot of dissolved oxygen concentration on the *J7* site in Sandringham Yacht Club marine.

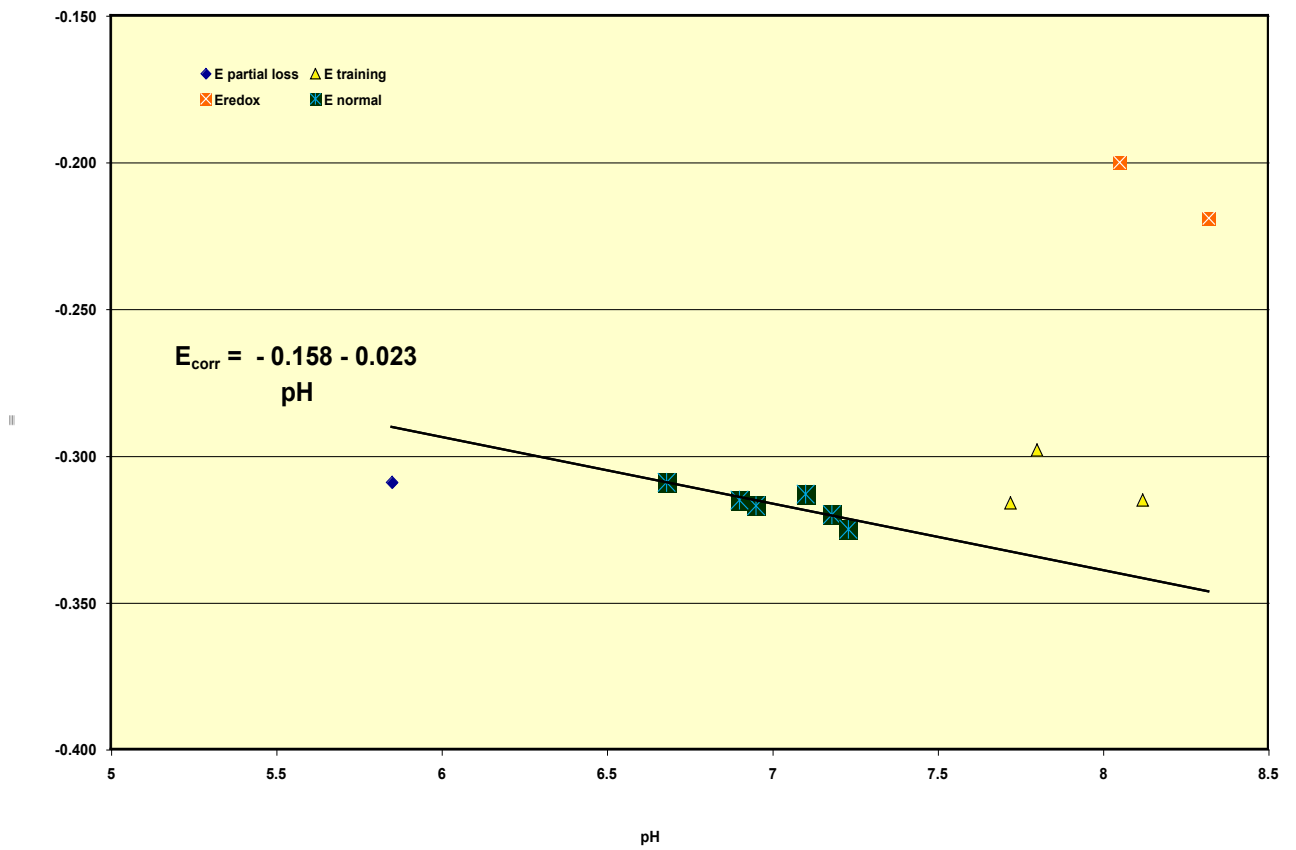
Figure 8. A modified Pourbaix diagram with *in-situ* corrosion data from *J7* illustrating good and bad data points.

The E_{corr} and pH data from Table 1 is plotted in Figure 8 where it is noted that three data points, designated 'training' lie outside the line of best fit and this is due to the trainees taking too long to get the pH electrode inserted

into the drill hole so the pH reading is too alkaline. The increased alkalinity is due to the influx of sea water as the trainees were becoming familiar with how to place the flat surface pH electrode into the custom drilled hole. Once some practical experience had been gained the volunteer divers were able to record meaningful data. The highest corrosion potential readings labelled E_{redox} had voltages more than 100 mV anodic (more positive) of the other values which is a strong indication that the metal is in a highly corroded state. Since there were only two redox data points there is insufficient data to make an informed comment on the apparent sensitivity of these corrosion cells with water depth. It had been previously reported that for highly degraded hull plates on the City of Launceston for the redox voltage fell by 114 mV per metre (MacLeod 2010). Typical sensitivity of the E_{corr} to water depth is of the order the 5-12 mV for most open water wreck sites. The much greater apparent sensitivity to depth is one way of discriminating real corrosion potentials from redox voltages of the corrosion matrix on highly degraded metal fittings. The two redox potentials are also associated with high pH values, greater than the surrounding sea water, and this is likely to be due to these sites being areas of cathodic reduction of oxygen, and reflects processes associated with the complex corrosion microenvironment of *J7* lying in its present location in the Sandringham Yacht Club marina.

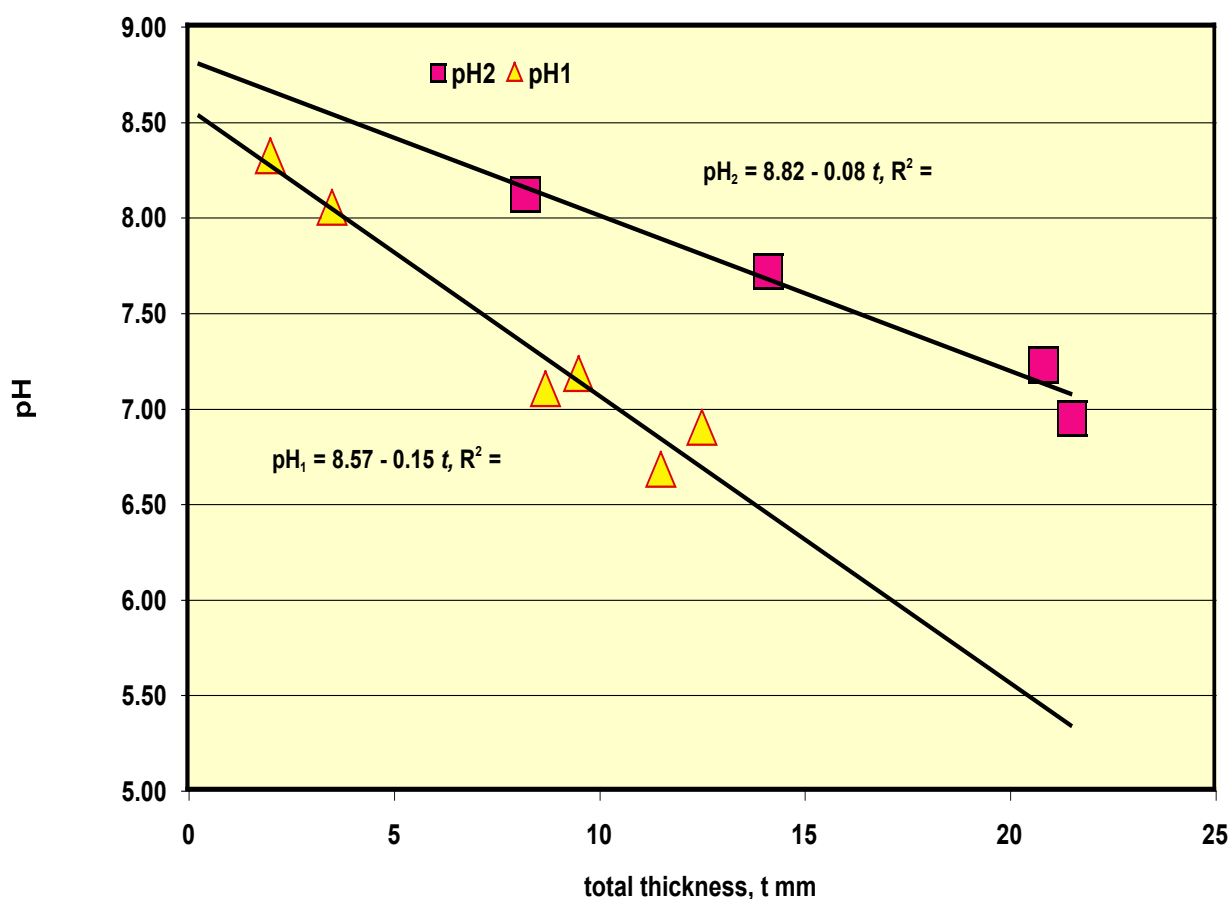
Figure 9. Effect of varying thickness t of corrosion products and concretion on the pH of the matrixes on *J7*.

It was previously noted that the concretion on the submarine was of varying thickness and anecdotal reports indicate that the public periodically remove corrosion products and concretion when visiting the site to satisfy their curiosity to see if there is any solid metal underneath the covering. When the combined thickness, t of concretion and corrosion products is plotted as a function of pH, the data in Figure 9 shows two groupings of data which is not surprising given the complex corrosion microenvironment of the submarine which is buried in silt, exposed to flowing sea water, has wet and dry areas all electrically connected to sections that are permanently out of water but in the zone of being saturated with sea spray. The data groupings reflect the different physical microenvironment of the submarine. The lower line, equation 3, shown in Figure 9 reflects data collected around 1 m below the water line which has thinner concretion,

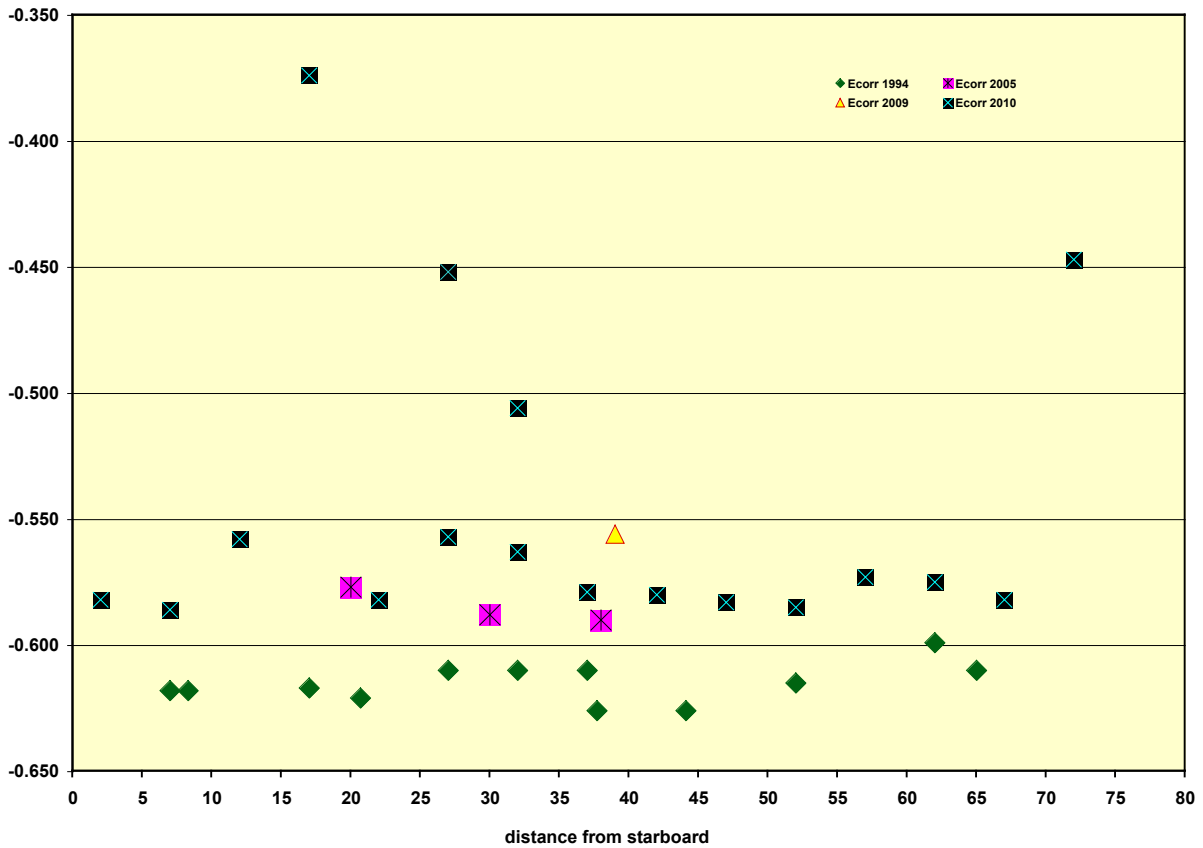
Figure 10. Plot of the corrosion potentials on the *Cerberus* as a function of time of measurement and distance from the bow.

rates of corrosion. This indicates that in addition to continued movement and settling on the seabed, the wreck has yet to achieve an environmental equilibrium since the collapse of the lower hull in 1993. The change in corrosion rate is indicated by the shifting values of the E_{corr} , thus the data in Figure 10 shows an incremental movement of the E_{corr} values towards more anodic (positive) potentials, an indicator of increased corrosion rates.

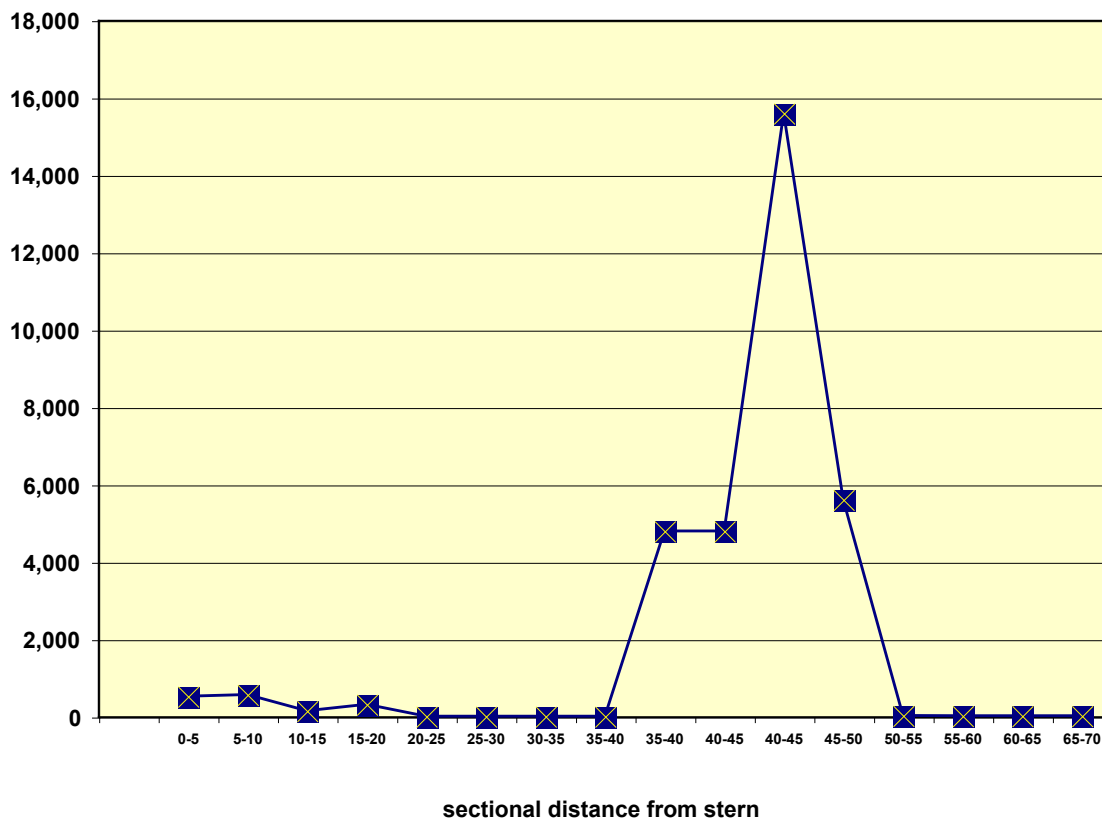
Figure 11. Plot of electrical resistance in kΩ on the *Cerberus* hull along the ship's starboard side.
