# Managing a Monitor — the Case of HMVS *Cerberus* in Port Phillip Bay: Integration of Corrosion Measurements with Site Management Strategies

The hull of the former HMVS *Cerberus* (1926) collapsed two metres during gales in December 1993, leaving the vessel half-submerged. Sunk as a breakwater in 1926, the vessel is one of the few remaining and accessible twin-turret Monitor-style warships from the 1870s. This paper presents the complex history of attempts to stabilize the site and to preserve the wreck. A series of in situ corrosion studies of corrosion potentials, pH, and residual metal thickness have provided a special insight into the processes of decay and have paved the way for future site stabilization. Removal of the four 16-tonne 10 inch Armstrong rifled muzzle loading guns and their in situ treatment alongside the wreck have assisted in relieving some of the stress on the remaining structure. The paper reports on correlations between the corrosion rate and the formation of concretions and how to determine the end point of an in situ treatment for cannon.

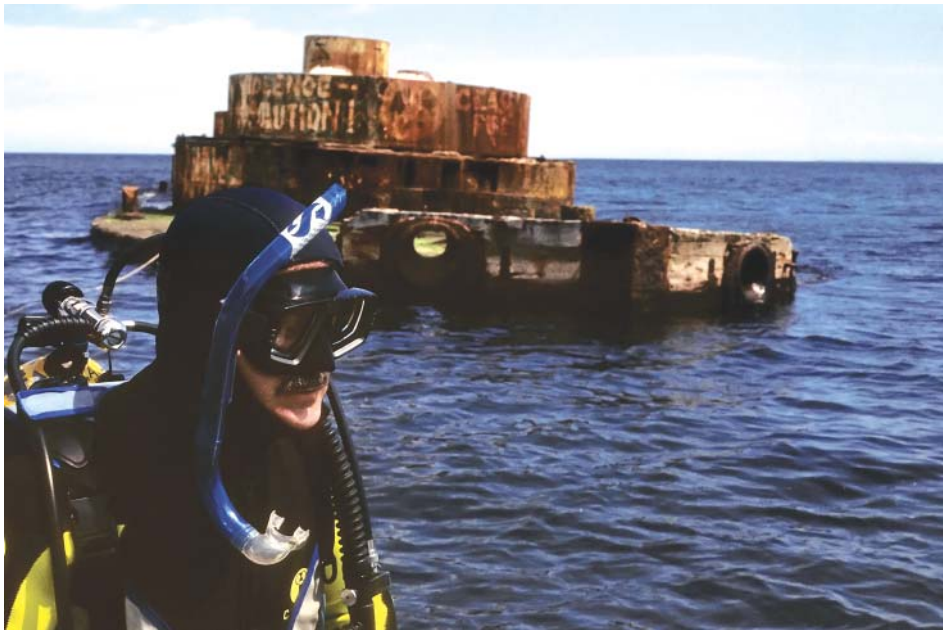
FIGURE 1 MacLeod at the stern of the *Cerberus* at high tide with decks awash, October 1994. Reproduced with permission Heritage Victoria

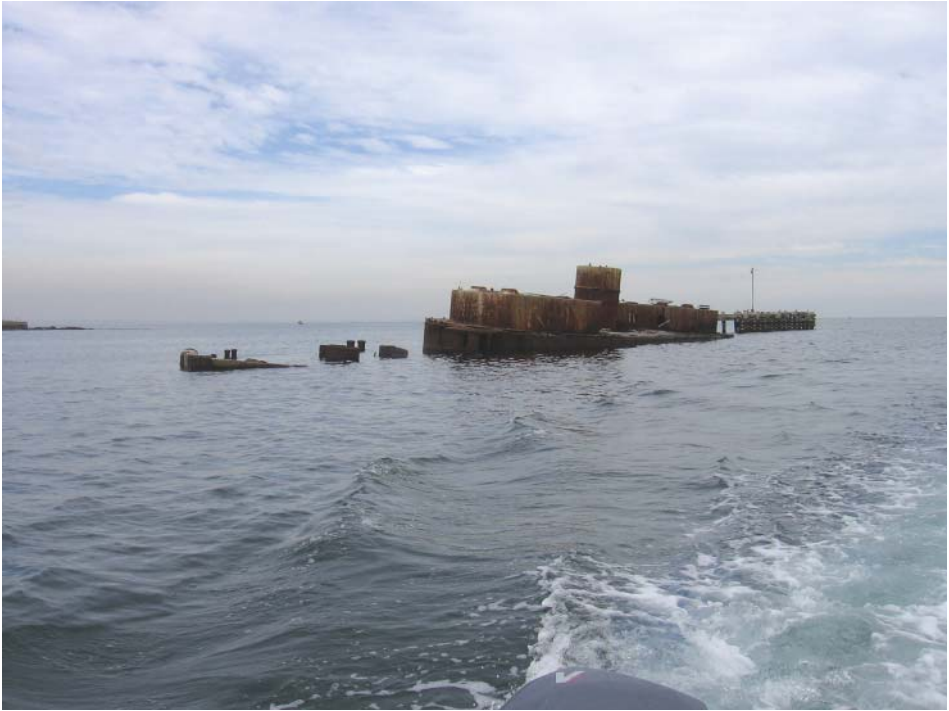
FIGURE 2 Starboard view of the *Cerberus* at high tide in January 2005 with the lower deck awash.

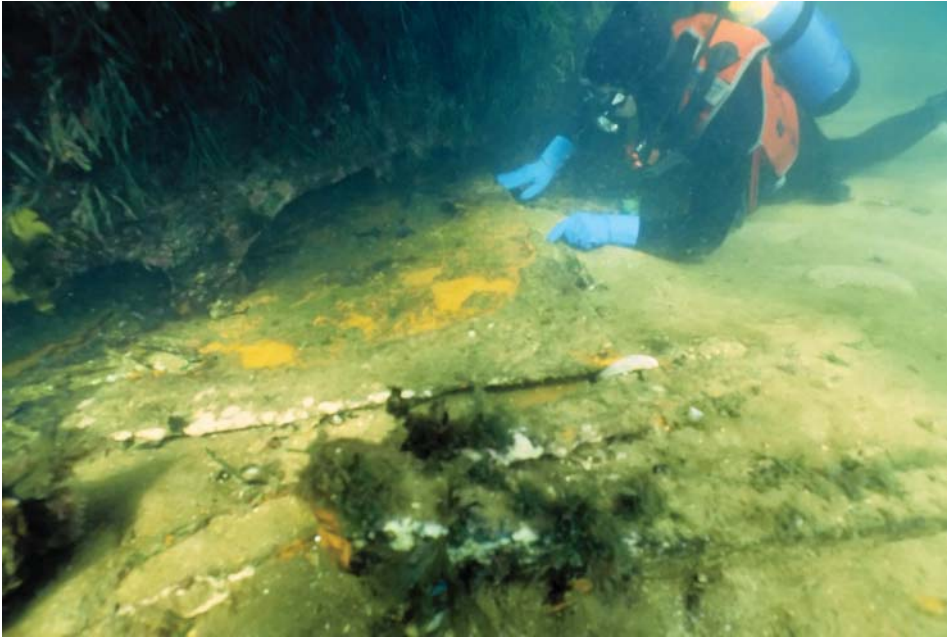
FIGURE 5 Diver inspecting the active corrosion on detached hull plates as shown by the red-brown colouration October 1994.

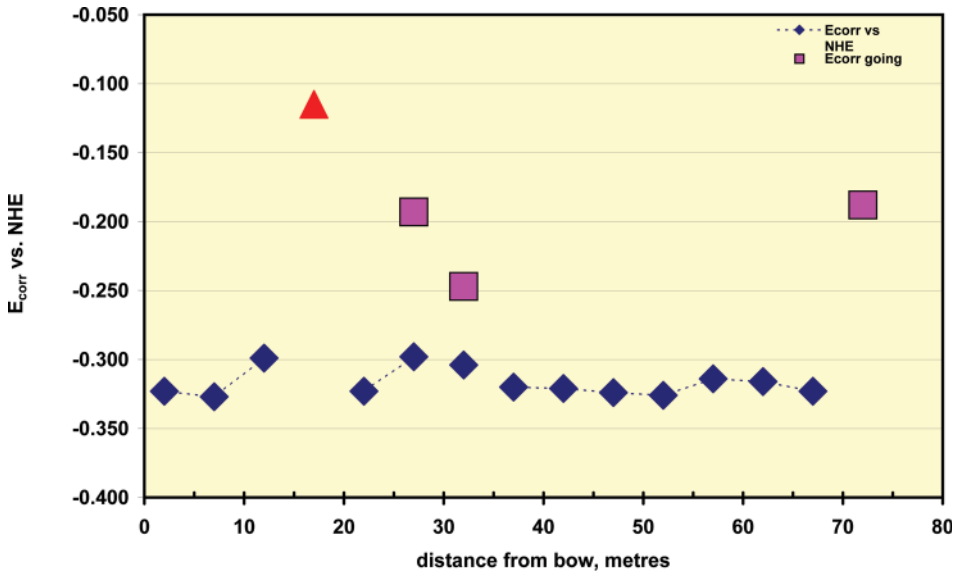
When the 2010 corrosion potential measurements are compared with those of previous years (see Figure 6) it can be seen that only  $\frac{3}{4}$  of the values lie in and around  $-0.325$  volt vs NHE which is the average value for solid metal elements reported for that year. The remaining measurement points are characteristic of redox potentials for disconnected matrices of iron corrosion products (MacLeod, 2010). The other high  $E_{\text{corr}}$  in the region  $-0.200$  to  $-0.250$  volts is characteristic of iron that is largely degraded. Since all measurements in 1999 had all the characteristics of true corrosion potentials, it can be seen that the 2010 data represents a major change in the microenvironment of the wreck. The  $E_{\text{corr}}$  values on the starboard side of the vessel collected in 1994, 2005, 2009, and the present study in January 2010 are shown in Figure 7. There is a progressive shift to more anodic, less negative, values of  $E_{\text{corr}}$  which means that the wreck is corroding at an increasingly faster rate.

FIGURE 6 Plot of  $E_{corr}$  vs NHE of the starboard side of the *Cerberus* in January 2010 showing the loss of metal integrity in nearly a quarter of the tested regions.

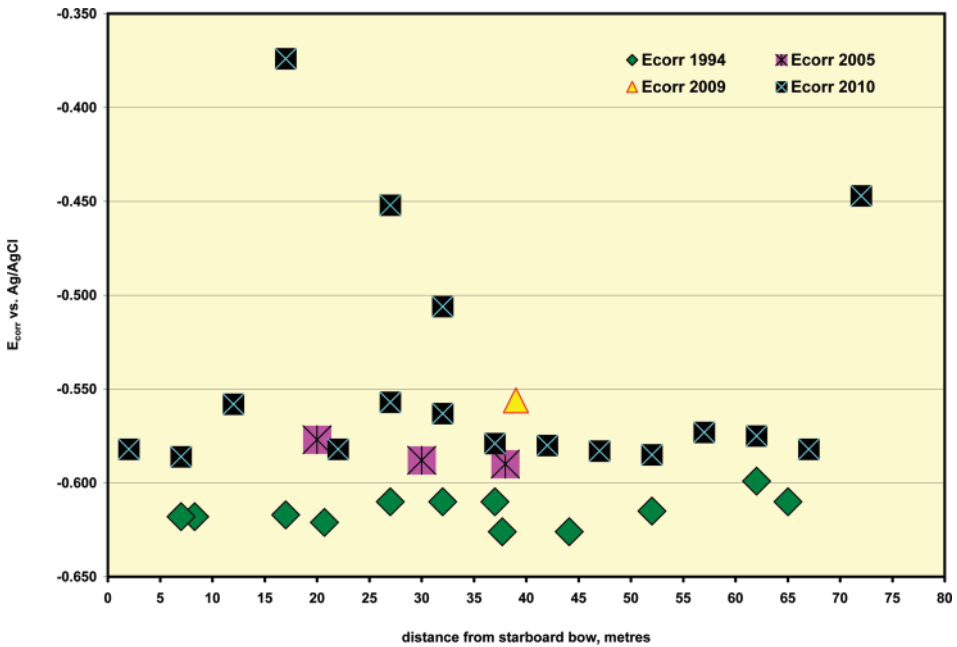
FIGURE 7 Plot of starboard  $E_{corr}$  values in 1994, 2005, 2009, and in January 2010.

In reviewing the continuing degradation of the wreck of the *Cerberus*, it is useful to look at the way in which the  $E_{\text{corr}}$  values changed over time, between 1994 and 2010. The isolated point measurement taken in 2009 was during an assessment of the treatment of the gun barrels, however not much weight can be given to this single measurement as the data in Figure 7 shows a range of  $\pm 11$  mV over a set of measurements. A summary of the increasing rate of deterioration of the vessel is seen in the trends towards more anodic values of the  $E_{\text{corr}}$  as seen in Table 3. These differences in voltage show that the average corrosion rate had increased by 28% between 1994 and 2005 and by an additional 12% between 2005 and 2010.

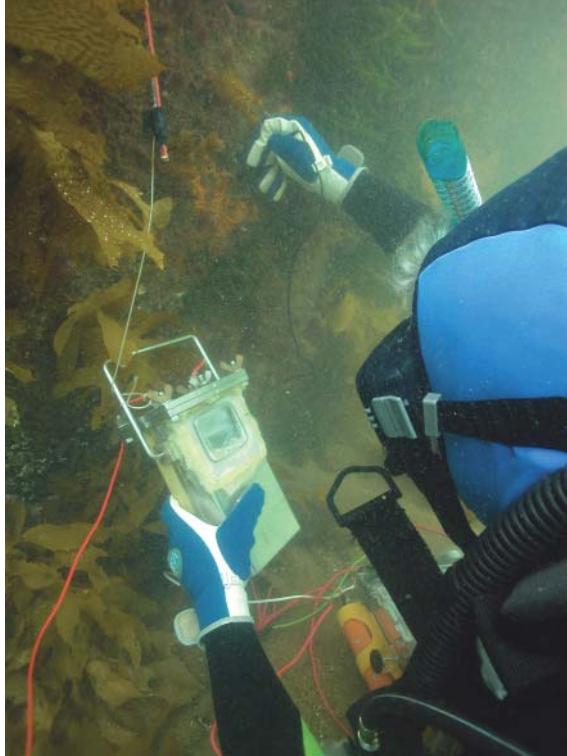
FIGURE 8 Diver measuring resistance between two 5 m separated points on the *Cerberus* hull.

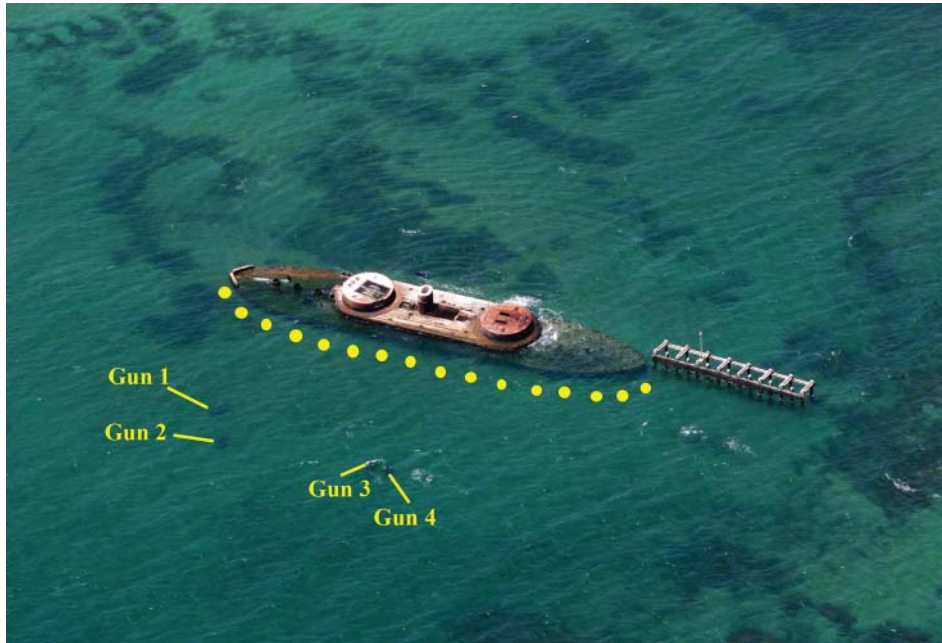
The low resistance along the first eight 5-m sections shows that the first 40 m of outside edge are electrically connected. Sections between 40 and 50 m along the starboard side indicated poor connection, but there appears to be a total break for the interval between 40 and 45 m; that is, there is essentially no connection between the forward and aft parts of the vessel in the area between the turrets. The practical implications of the electrical discontinuity amidships means that any impressed current or sacrificial anode system would need to have separate connections at the bow and stern. More measurements in and around the midships would determine if the break in continuity is due to the disbondment of the additional  $1\frac{1}{16}$  inch layer armour plating or if it is due to a break in the more massive armour belting. Operational safety considerations prevented penetration diving and measurements of the

FIGURE 9 View of *Cerberus* showing approximate resistance measurement sites and gun locations, January 2010.

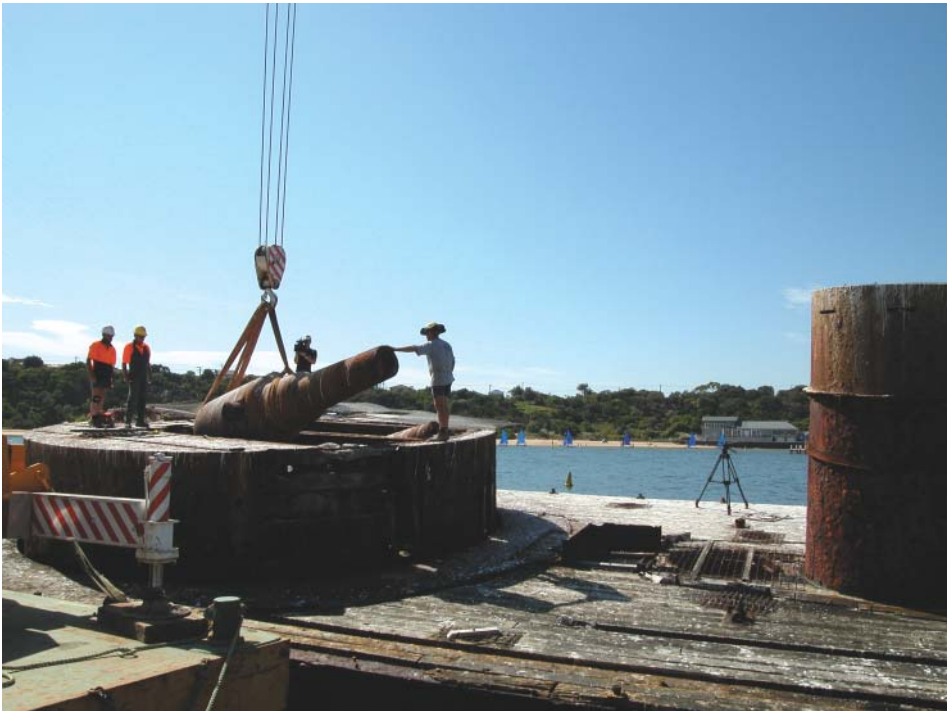
FIGURE 10 Removal of a 16 tonne gun barrel from the aft turret, January 2005, for placement on the seabed.

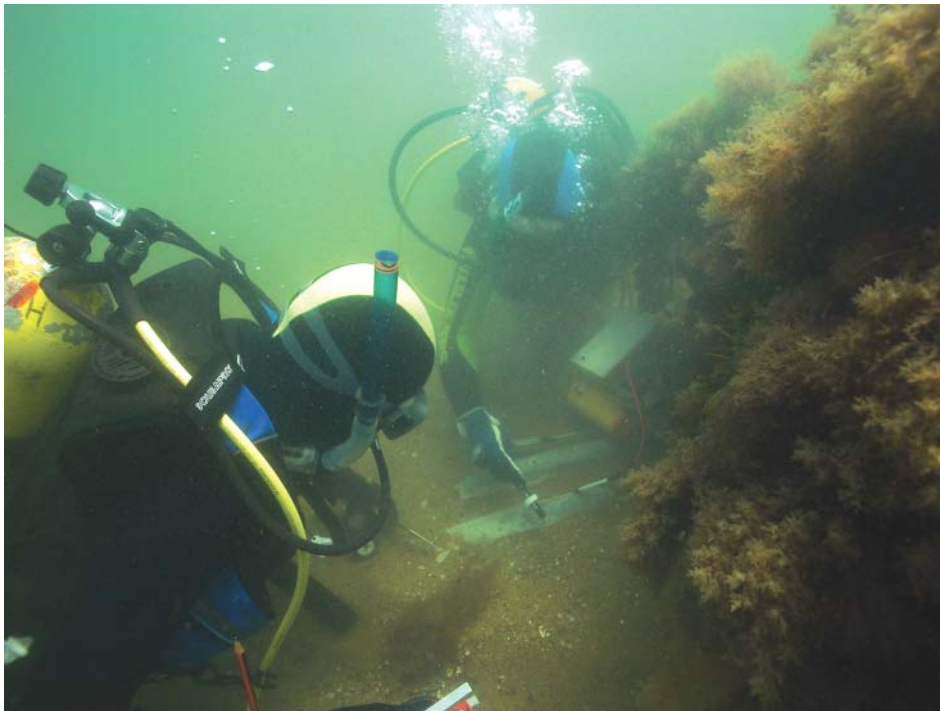
FIGURE 11 Divers taking pH measurements on the anodes attached to one of the *Cerberus* guns.

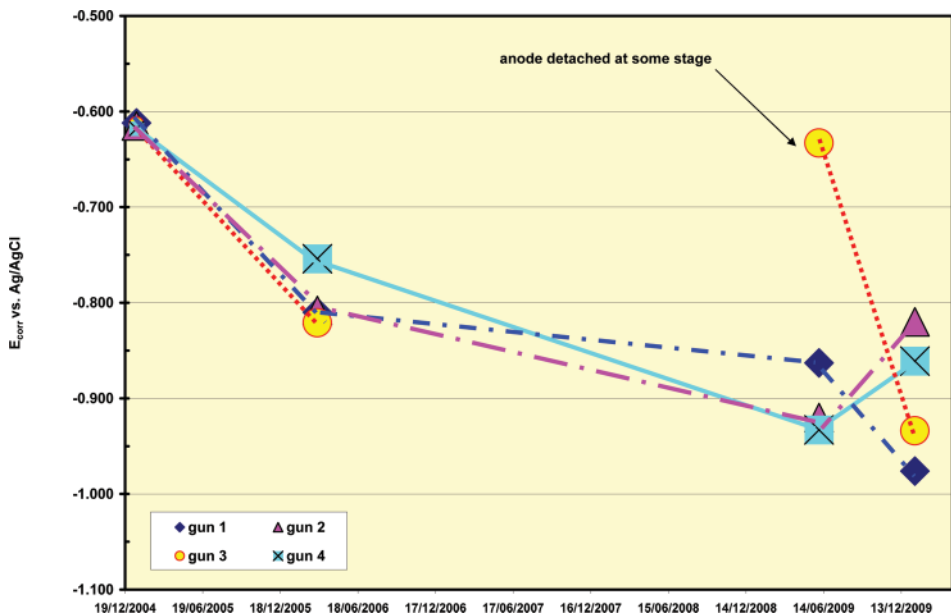
A graphical representation of the  $E_{\text{corr}}$  of the gun barrels is shown in Figure 12 which illustrates the way in which the treatment program has developed over the years. The initial in situ values for the gun barrels were estimated as being the same as the best preserved hull plates at the same depth on the starboard side of the vessel. Chloride ions in the guns undergo active diffusion resulting from the negative polarity of the metal that has been induced by the attachment of the anodes. The median voltage drop of the four guns 14 months after the anodes had been attached was  $201 \pm 30$  mV, and this increased to  $312 \pm 37$  mV after 28 months where it stabilized with the median voltage after 33 months of treatment at a combined drop of  $290 \pm 34$  mV. These voltage drops are indicative of effective cathodic protection (Morgan, 1993) and the attainment of a pH plateau after 28 months of treatment at  $8.14 \pm 0.05$  indicated that the treatment had finished.

FIGURE 12 Plot of  $E_{\text{corr}}$  of the four guns undergoing in-situ treatment on the *Cerberus* wreck site.
