## Conservation of waterlogged timbers from the *Batavia* 1629

Ian D. MacLeod

This paper was originally presented at the ICOMOS 'Built in Wood' Conference, Brisbane, April 1987.

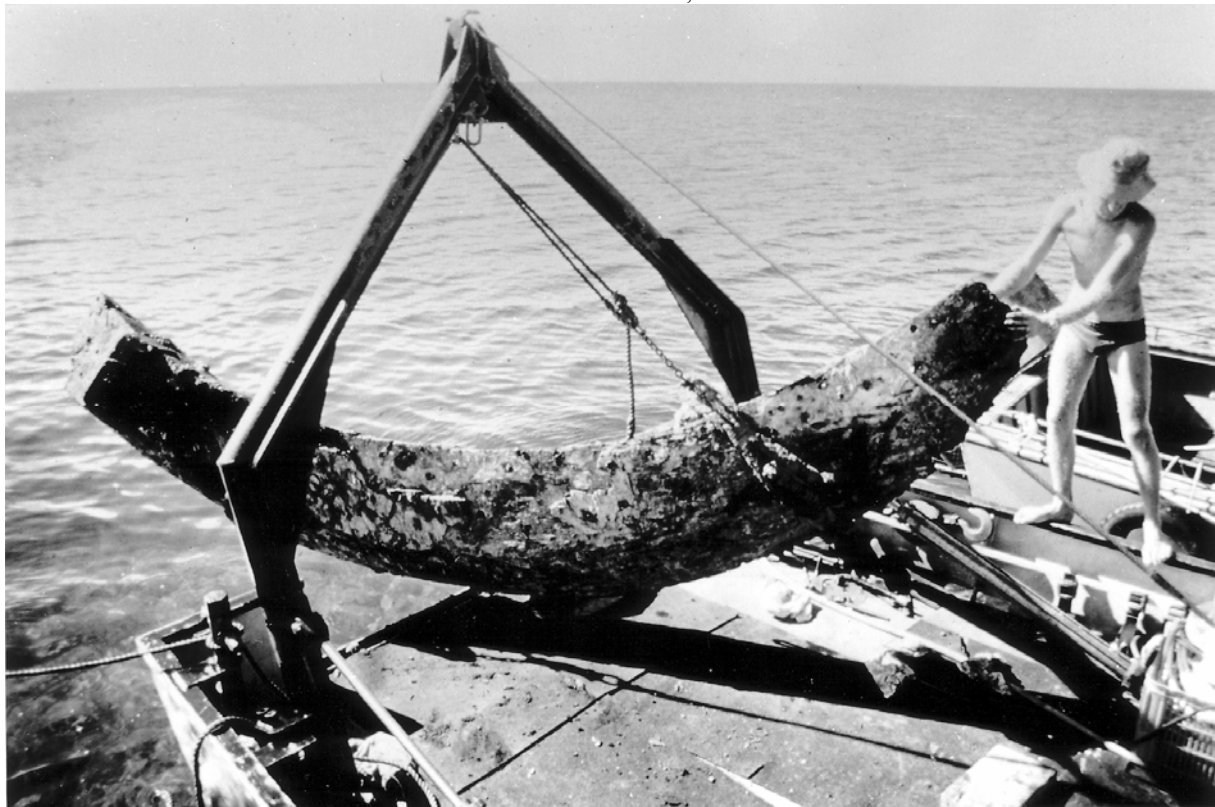
Figure 1. The Batavia fashion piece being recovered from the sea-bed. Photo: Pat Baker.

Owing to limited resources of field equipment and storage on Beacon Island it was necessary to cut through sections of the large timbers so that they could be handled in the often dangerous conditions. Strong surges and heavy surf can easily reduce a four week expedition to only a few days of diving, as Morning Reef in the Wallabi Group of the Houtman Abrolhos is fully exposed to Indian Ocean swells. With the benefit of hindsight such procedures should be avoided if at all possible since they can lead to cosmetic problems in the reconstruction, viz., all the natural breaks in the planking are scarf joints and so a line of butt joints down the side of the ship spoils the historical perspective. The largest single timber was raised intact and as such the fashion piece weighs over one tonne and was cut from solid oak. It forms the key piece in the reconstruction, and details of its conservation have previously been reported (Pang, 1981), see Figure 1. All the transom beams were also raised as single sections of massive proportions.

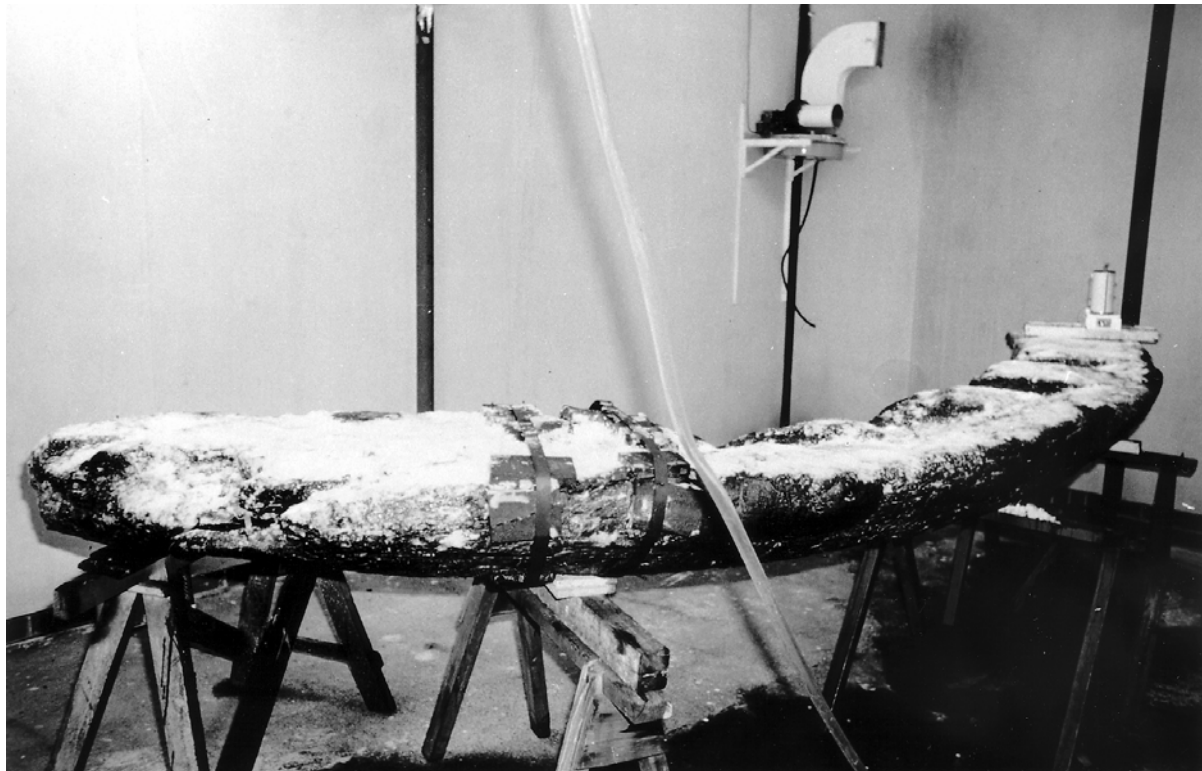
Figure 2. Second generation dehumidification chambers with the fashion piece undergoing drying. Photo: Jon Carpenter.

Small sections of timber were freeze-dried (Pang, 1982), but all the ship's timbers were prepared through controlled dehumidification in a series of three different chambers. The first model was temporarily established in the rear of the old Commissariat building in Fremantle while the front section was being restored at the Western Australian Maritime Museum. The aluminium tubing framework was covered with high density clear polyethylene sheeting to form two chambers and the timber was stored on heavy-duty steel racks. Two dehumidification units were balanced by two humidifying plants and control of relative humidity and temperature was achieved to within  $\pm 4\%$  and  $\pm 3^\circ\text{C}$  respectively. At relative humidities above 85% the PEG treated timbers tended to sweat but this helped
