Corrosion monitoring and the environmental impact of decommissioned naval vessels as artificial reefs

Abstract

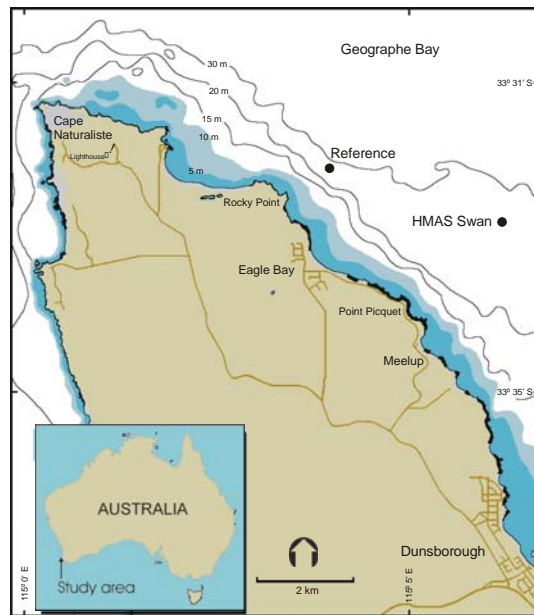
Figure 3. Location of the *Swan* including the sediment sampling positions (Morrison, 1998).

The main objectives of the corrosion monitoring programmes are to measure the corrosion parameters of previously designated sites on each of the vessels at specified time intervals, to ascertain any discernible differences in the corrosion rates between the various locations on the vessels and to ultimately monitor the long-term stability of the vessels. The *Swan* lies 2.4km north-east of Point Piquet, Dunsborough in Geographe Bay,

Western Australia (Figure 3) in 31m of water at high tide whilst the tower reaches to within 8m of the water surface. The vessel rests on the keel, the bow facing north-west with a 10° list to port.

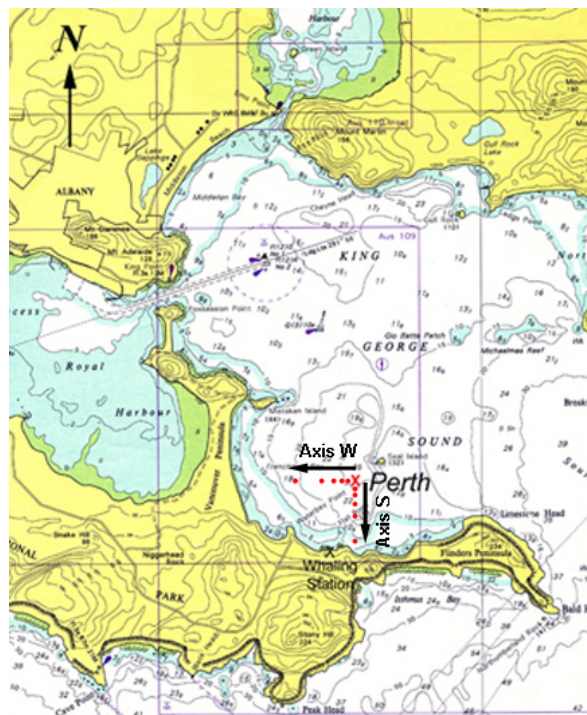
Figure 4. Location of the *Perth* including the sediment sampling positions (Richards & MacLeod, 2004).

The *Perth* lies in King George Sound, Frenchman Bay, Albany, Western Australia about 9.5km south-east of Albany (Figure 4). The vessel rests on the keel with the bow facing approximately east with no noticeable list to either side. The total depth to the keel at the sediment line is about 34m. The remains of the radar tower rises 4m out of the water surface to act as a navigation marker.

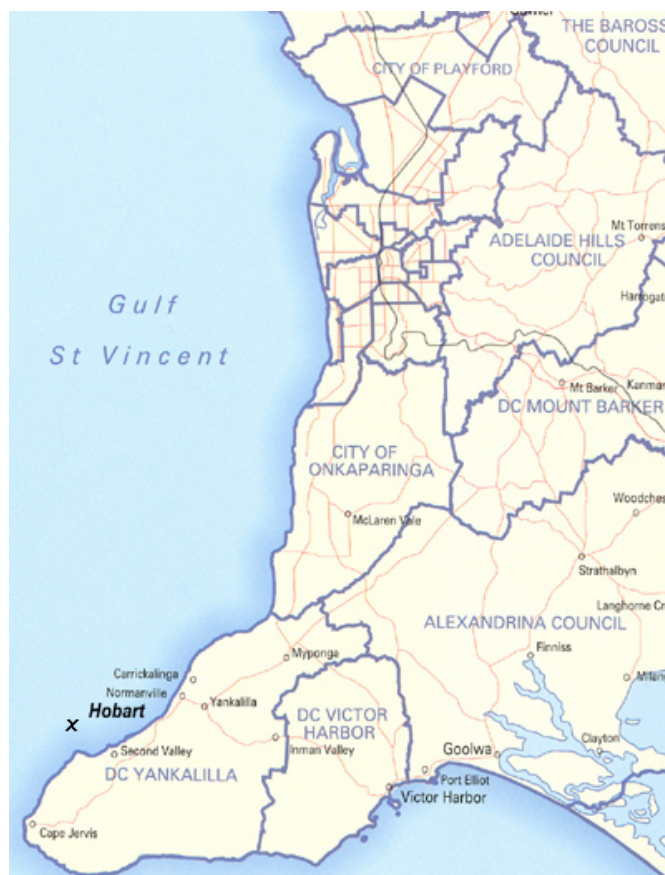
Figure 5. Location of the *Hobart* (Richards 2003a).

The *Hobart* lies offshore, about 7.5km west of Marina St Vincent, Wirrina Cove in Yankalilla Bay, Gulf St Vincent, South Australia (Figure 5). It lies in a roughly east-west orientation with no noticeable list to either side, with the bow facing approximately east. The total depth to the keel at the sediment line is about 28m, the depth to the main deck is 23m, while the remains of the radar tower rises to within 5-6m of the water surface dependent on the tidal range.

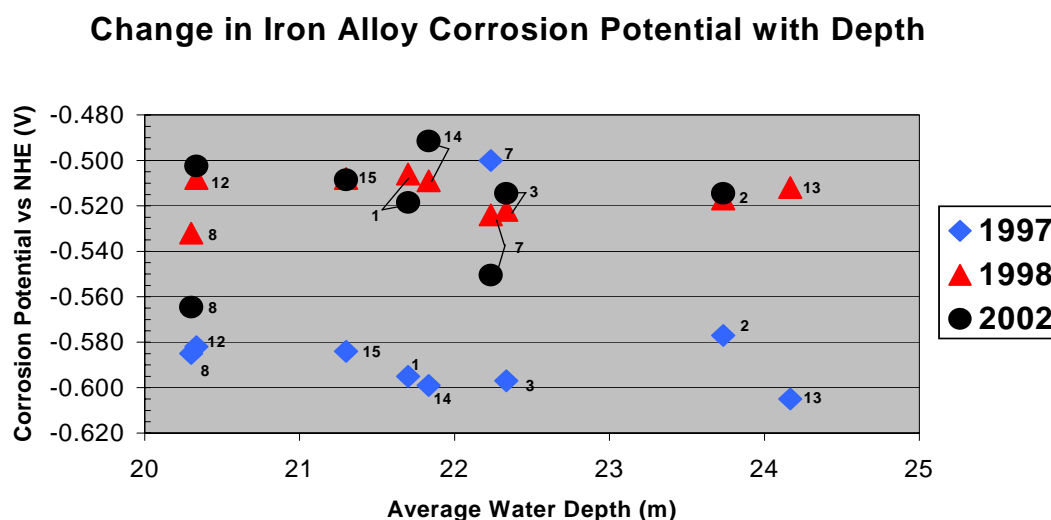
Figure 6. The relationship between the iron alloy corrosion potentials and depth for the *Swan*.

As is evident from Figure 6, there appears to be no correlation between changes in corrosion potential with average water depth on the *Swan* even after four years of submersion. There was also no emergent trend between the aluminium alloy voltages measured on the *Swan* and the average water depths. Similarly, the corrosion potentials for the iron and aluminium alloys on the *Perth* and the *Hobart* showed no correlation with increasing water depth. The lack of any apparent dependence of E_{corr} on depth is simply a reflection of the inter-connected nature of the structural elements of the vessel and that large sections of the ships are still electrically connected with each other and therefore the voltages expressed do not relate directly to the measurement point. The ships are very much still in the initial stages of deterioration and although there has been some colonisation of the vessel's surfaces, due to the anti-foul present below the waterline of the vessel and the protective paint systems, no significant concretion formation has occurred on the steel hulls during their period of immersion. Therefore, the usual film free iron corrosion mechanism applicable to concreted iron objects where the anodic and cathodic sites are separated by a semi-permeable concretion membrane does not apply to these vessels at this point in time. Experience with the wreck of the *Fujikawa Maru* (1944) in Chuuk Lagoon has shown that this wreck is only now just beginning to have E_{corr} values that are sensitive to water depth (MacLeod, 2003). The *Fujikawa Maru* has a very similar site orientation to the *Perth* in that it is lying upright on its keel on a flat seabed so it is expected that a decade or two will be needed before any E_{corr} values on the naval vessels show any systematic behaviour with regard to water depth.

The total amount of water movement generally decreases with increasing depth thereby reducing the total amount of oxygen flux to a metal surface. The general rate of deterioration of concreted metals on shipwreck sites is very dependent on the water depth and the flux of oxygenated seawater over the objects lying proud of the seabed. Therefore it is expected for concreted iron alloy artefacts that the corrosion potentials will decrease with increasing depth. The corrosion potentials and the average depths of the points measured at the specified time intervals for each vessel were graphed to ascertain if there was any emergent relationship between the two variables since the time of scuttling (Figure 6).

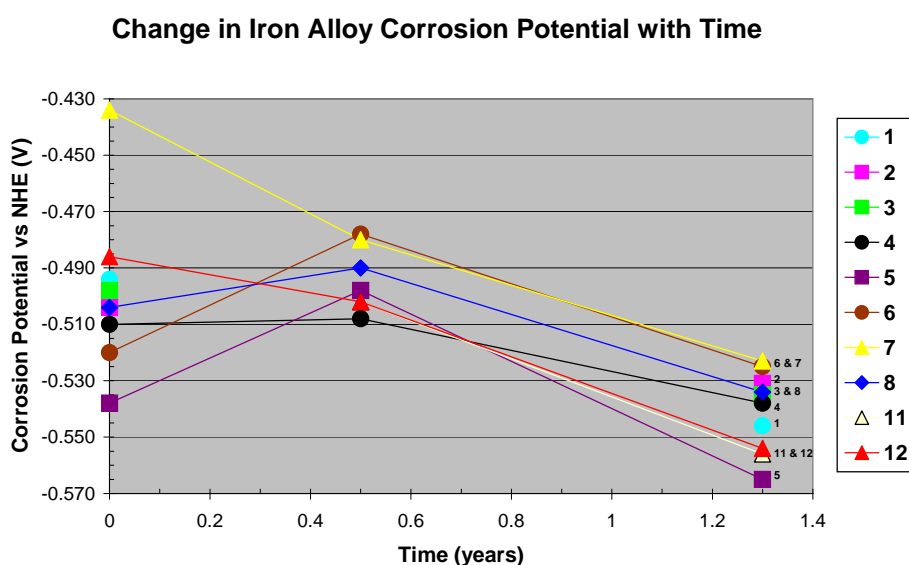
The corrosion behaviour of the *Perth* and the *Hobart* for the first six months is very similar, therefore only the *Perth* results will be presented. The aluminium alloy points on the *Perth* are reacting similarly to the iron alloy points (Figure 7) and there appears to be a relatively random scatter of points during the first six months of immersion. The baseline corrosion potential of point 7 on the *Perth* appears to be anomalous and may have been caused by partial electrical connection between the platinum electrode and the bolt during measurement. This random scatter for the *Perth* and the *Hobart* may reflect differences in the amount of sea water penetration through and under the paint film in the vicinity of the measuring points and this, in turn, would lead to a range of dry to wet corrosion cell mechanisms occurring under the paint layers. Therefore, interpretation of any differences between individual data points or sets of the same is not possible for the first six months of immersion. However, after sixteen months there was a small, relatively consistent decrease in the average corrosion potentials of both the aluminium (0.055V) and iron (0.045V) alloy measuring points on the *Perth*, reflecting more effective and uniform penetration of the seawater under the protective paint film and the establishment of a series of localised corrosion cells after a further ten months of submersion.

Figure 7. The change in iron alloy corrosion potentials on the *Perth* with time.

This decrease in the average voltages after sixteen months could also indicate a relatively small decrease in the corrosion rate of the vessel. This may be caused by the increase in secondary colonisation of the hull and superstructure after this time but there is no significant uniform formation of concretion, which would cause some partial separation of the anodic and cathodic sites effectively slowing the corrosion rate. Therefore, it may be that this decrease in the average corrosion potentials coupled with slightly more acidic pHs at the metal surfaces after sixteen months is more consistent with a slight increase in the corrosion rate due to the development of localised corrosion cells on the vessel as the seawater penetrates the paint layers, causing pitting corrosion of the iron and aluminium under this passive paint film. Unlike film free corrosion mechanisms, with pitting corrosion a decrease in corrosion potential indicates an increase in the corrosion rate.

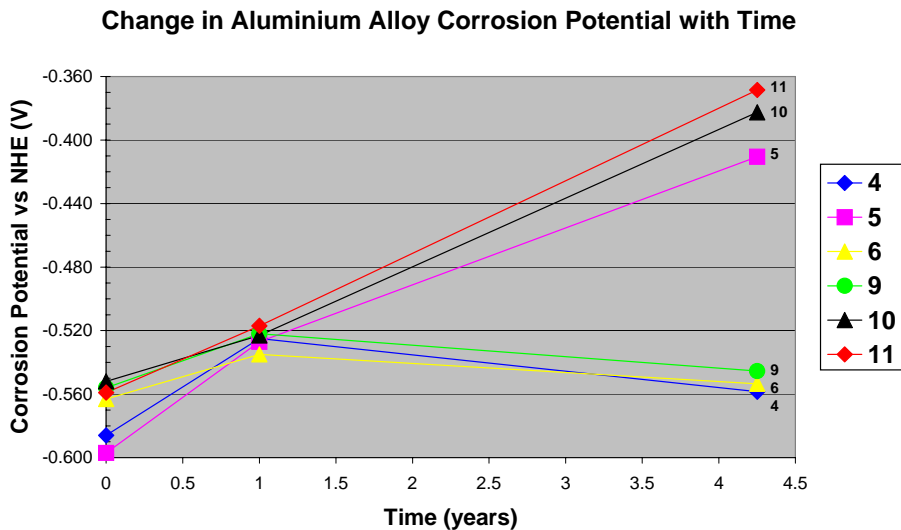
Figure 9. The change in aluminium corrosion potentials on the *Swan* with time.

The aluminium alloy points are reacting similarly to the iron alloys with respect to total water movement and localised turbulence factors. The less negative corrosion potentials of aluminium points **5**, **10** and **11** indicate they are subject to a more corrosive environment than positions **4**, **6** and **9**. Point **4** is positioned on the port side corner of the bridge behind a large splash guard, point **6** is mounted on the wall on the rear of the radar tower and point **9** is mounted on the wall, behind a ladder on the starboard side of the superstructure. All three points are considerably more protected from excessive water movement than the other more exposed positions.
