**THE EXCAVATION, ANALYSIS AND CONSERVATION OF SHIPWRECK SITES**

I.D. MacLeod\*, N.A. North\*\* and C.J. Beegle\*\*\*

**SUMMARY**

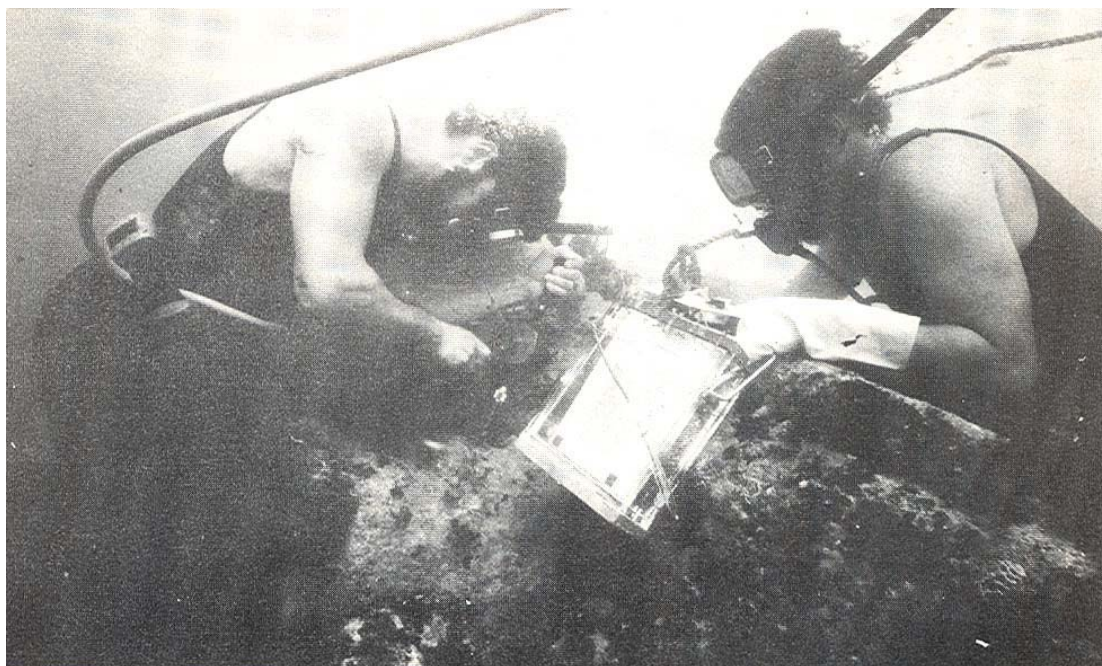
The corrosion potentials were measured In situ using a high impedance digital multimeter (Fluke 8010A), a platinum electrode (0.8 mm thick) housed in an epoxy body and a silver/silver chloride reference electrode (Titron model No. 211). Subsequent measurements were performed using a different silver chloride reference electrode (DIMET). Sea water was used as the reference solution. The procedure consisted of drilling into the concretion (using a ¼" masonry bit and a hand drill) and placing the platinum electrode into the hole while pressing firmly to establish good electrical contact; the reference electrode was placed adjacent to the concreted metal surface and the voltage measured. For the resistance survey the reference electrode was replaced with a stainless steel probe (see Fig.4) and both were brought into contact with the holes drilled in the metal concretion.

Fig. 4. Drs. MacLeod and North measuring corrosion potentials on the *Xantho* site during the pre-disturbance survey. The concretion on a piston is being drilled so that the potential measurement on the underlying material can be made.

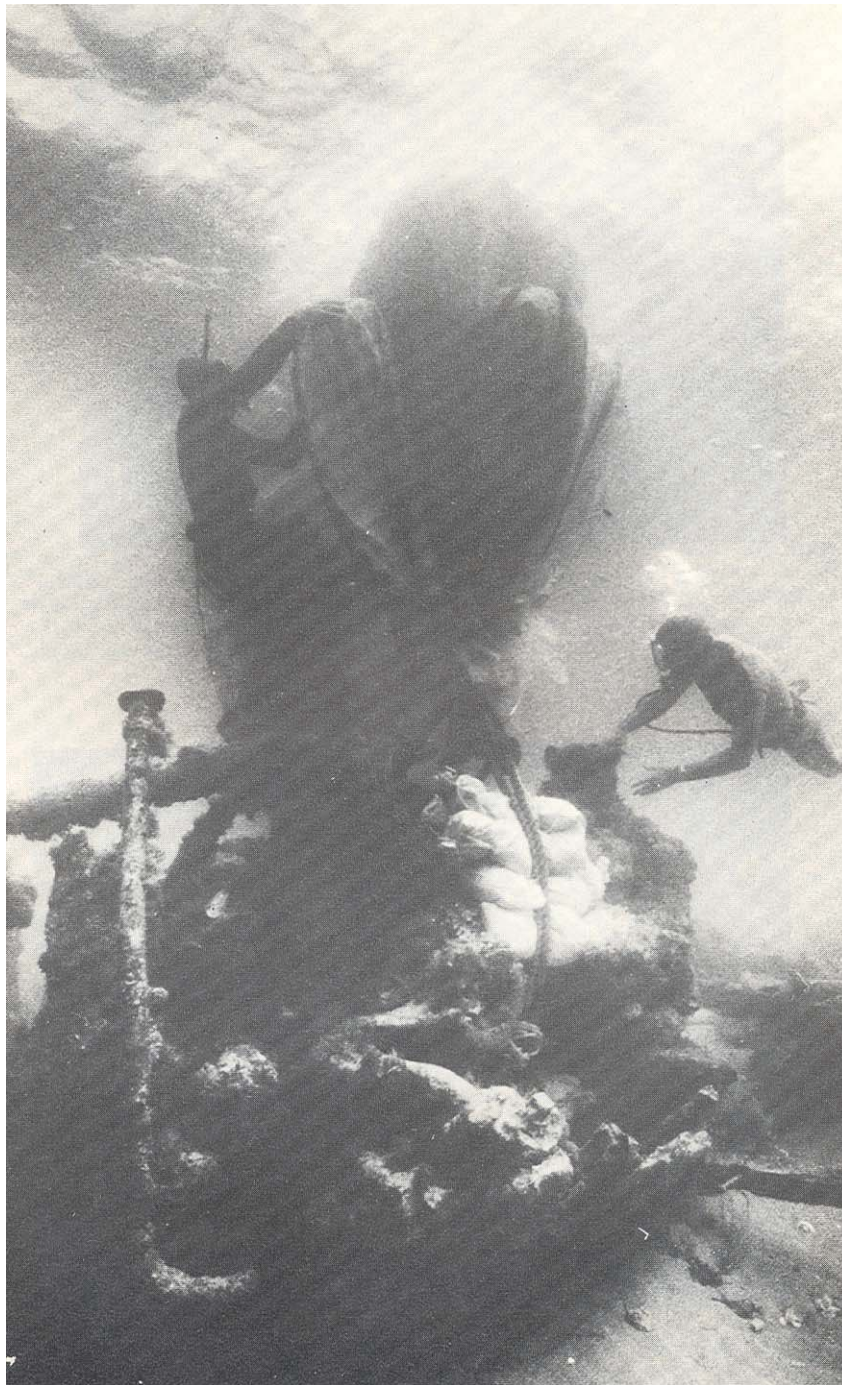
of attaching several air bags to the engine using heavy-duty, 5 cm thick, synthetic rope and broad-woven lifting strops with lifting capacities of 1 tonne per thickness. The engine was cushioned from localized lifting pressure by distributing the load with sandbags (Fig.9). After clearing the site, the engine was towed to a steel sled in shallow water. The sled was then raised and attached to the engine before both were gently lowered to the seabed by deflating the lifting bags. One day after removing the engine, and immediately prior to its being brought onto dry land, the corrosion potential was remeasured at the same reference point. The voltage was the same as found on the initial survey (within experimental error) and 121 mV more positive than before the cable from the anode was cut (see Table II). Although the anodes were not operating at full efficiency, the observed swing of 121 mV in the steel potential would have caused a reduction of approximately 90% in the iron corrosion rate, i.e. the anodes gave effective protection to the engine. The potential of the boiler and the copper steam water heater were remeasured on the main site and found to be unchanged by the removal of the engine, i.e. we were able to demonstrate that extraction of the engine caused no immediate changes in the microenvironment of the remaining artefacts.

Fig. 9. Raising the *Xantho* engine. Photo: Pat Baker.
