***In-situ* conservation management of historic iron shipwrecks in Port Phillip Bay: a study of *J7* (1924), *HMVS Cerberus* (1926) and the *City of Launceston* (1865)**

Hanna Steyne^{1*}

Ian D. MacLeod²

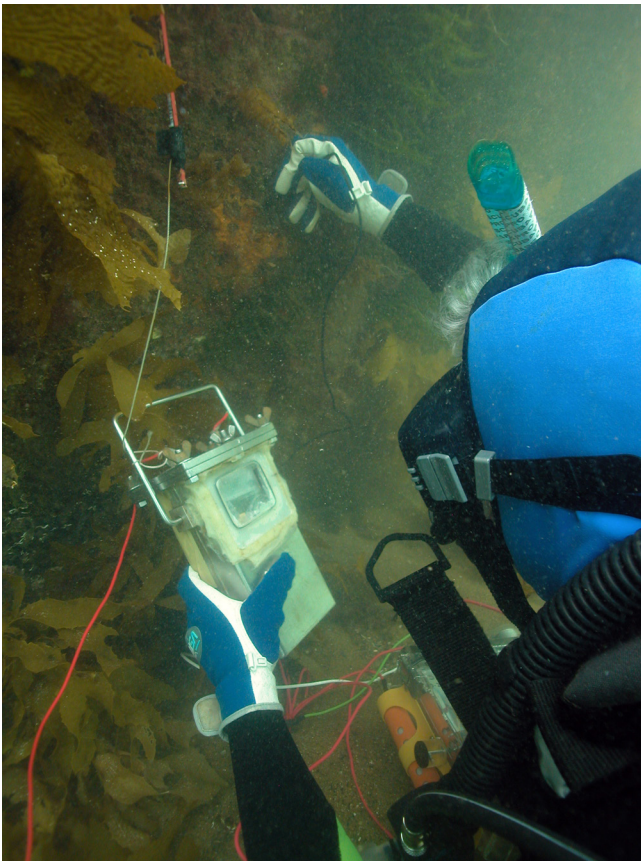
Three dives were undertaken on the *Cerberus* hull and the guns over two days. Measurements on the hull were taken by teams of four, with one diver operating the drill, one holding the far end of the resistivity meter, MacLeod taking pH, E_{corr} and resistivity measurements (Fig. 2) and

Figure 2. Divers undertaking resistance measurements on the hull of HMVS *Cerberus*.

Measurements were taken on the hull at 5 m intervals, along the starboard side measured from the stern with a tape measure, as shown in Figure 2. All drill holes were made approximately 1 m from the seabed, into the armour plating.
