# Managing a Monitor — the Case of HMVS *Cerberus* in Port Phillip Bay: Integration of Corrosion Measurements with Site Management Strategies

The hull of the former HMVS *Cerberus* (1926) collapsed two metres during gales in December 1993, leaving the vessel half-submerged. Sunk as a breakwater in 1926, the vessel is one of the few remaining and accessible twin-turret Monitor-style warships from the 1870s. This paper presents the complex history of attempts to stabilize the site and to preserve the wreck. A series of in situ corrosion studies of corrosion potentials, pH, and residual metal thickness have provided a special insight into the processes of decay and have paved the way for future site stabilization. Removal of the four 16-tonne 10 inch Armstrong rifled muzzle loading guns and their in situ treatment alongside the wreck have assisted in relieving some of the stress on the remaining structure. The paper reports on correlations between the corrosion rate and the formation of concretions and how to determine the end point of an in situ treatment for cannon.

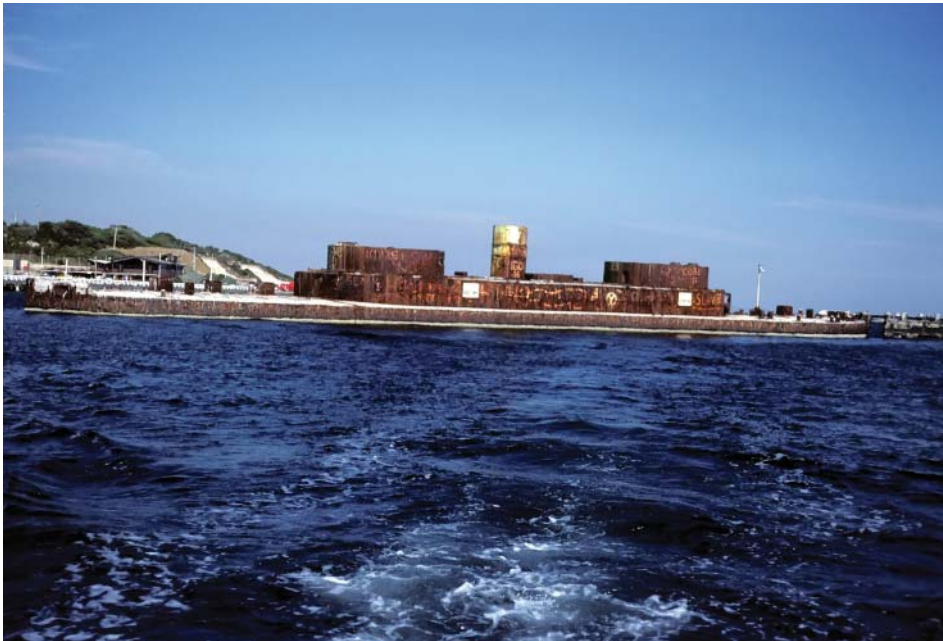
FIGURE 3 View of HMVS *Cerberus* in 1977 showing original profile and the relatively low free board.

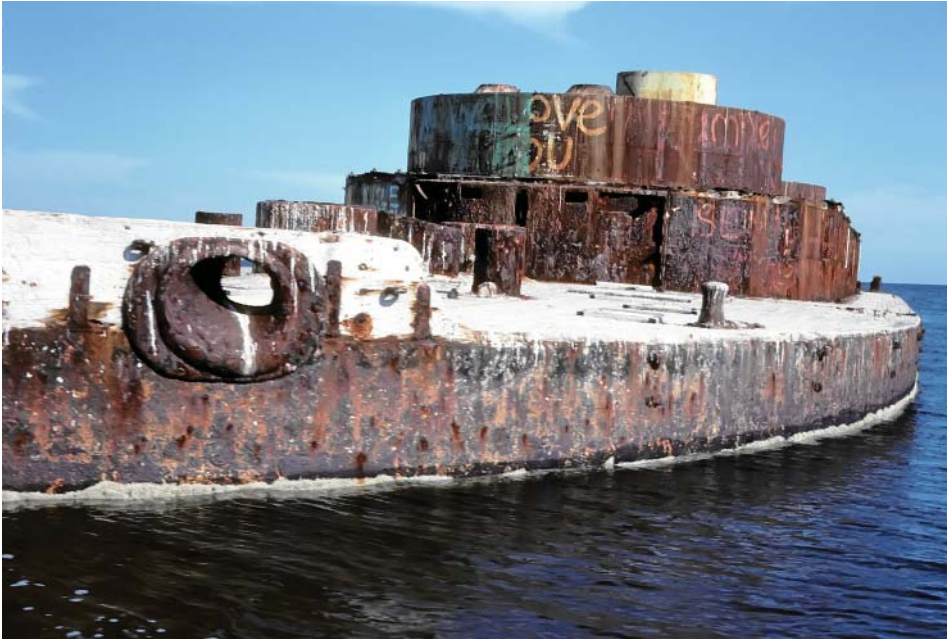
FIGURE 4 Detailed view of the stern of the *Cerberus* in 1977 before the collapse showing the rear turret and part of the conning tower.
