# 350 years of marine corrosion in Western Australia

I.D. MacLeod and N.A. North

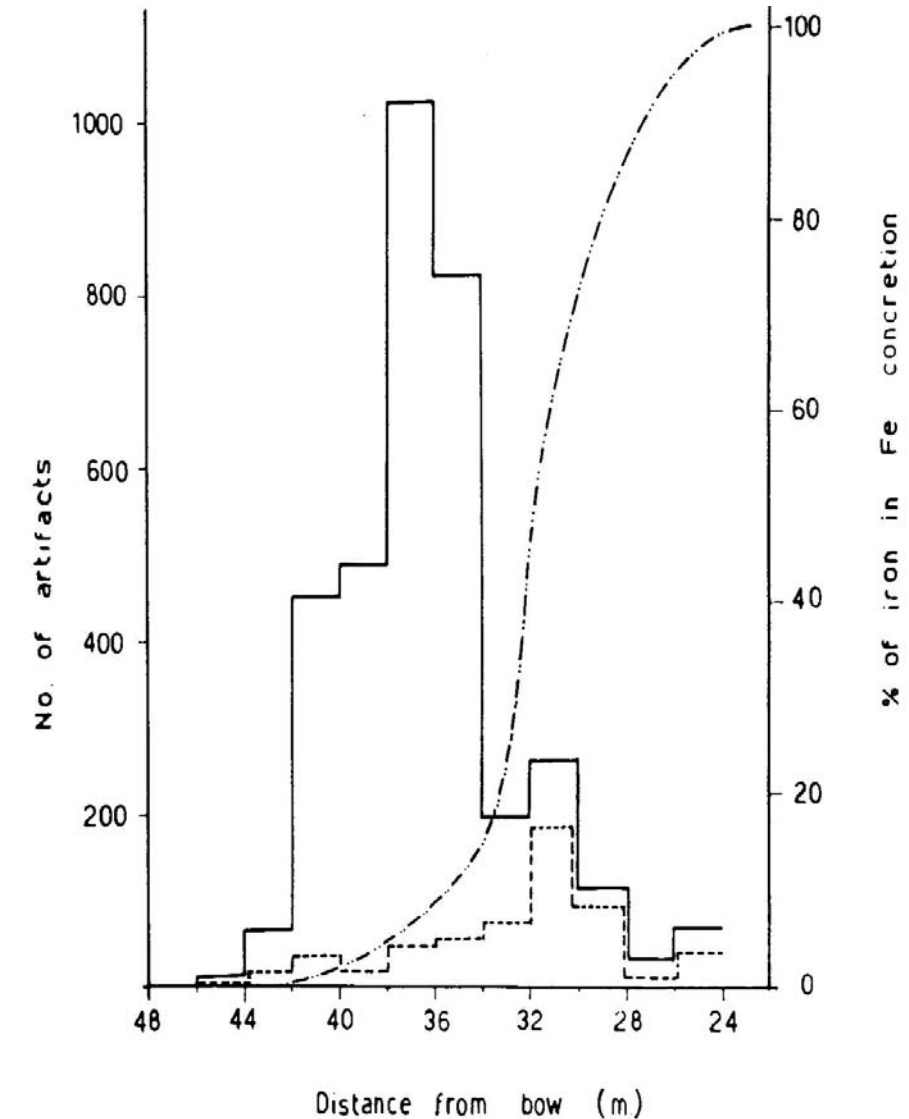
Fig 1 The distribution of artifact finds at the Point Cloates wrecksite----- copper and copper alloys---- iron concretions..... percentage of iron concretions which retained some solid iron.

$(\text{OH})_2 \text{CuCl}_2$ ), which is the major marine copper corrosion product (See Fig 1). This does not retard corrosion of the underlying metal. Because of the high chloride content and relatively high pH of seawater the formation of basic copper carbonates so typical of land based sites, such as azurite ( $2\text{CuCO}_3 \cdot \text{Cu}(\text{OH})_2$ ) and malachite ( $\text{CuCO}_3 \cdot \text{Cu}(\text{OH})_2$ ), does not occur to any significant extent. Similarly no examples of the basic copper sulphates, antlerite and brochantite, have been found in the thirty odd samples examined to date by x-ray techniques.

An examination of the material recovered from the first season of excavation (1978/79) at the "Point Cloates" wreck site shows that a remarkable number of copper/copper alloy objects were found, some 4700 copper nails, 500 copper tacks, 200 spikes plus 300 bolts, bars and miscellaneous fittings. The distribution of these finds is shown in fig 2 as are the number of iron artifacts. Of the 450 iron objects registered only 135 of them, mainly canister shot, had any solid metal within

the concretion. The increase in the targe of iron artifacts containing residual metal is seen to rise as the number of copper items falls which may be due to sacrificial protection of the "copper" materials by the iron - see Table 1 for the relevant corrosion potentials in seawater.

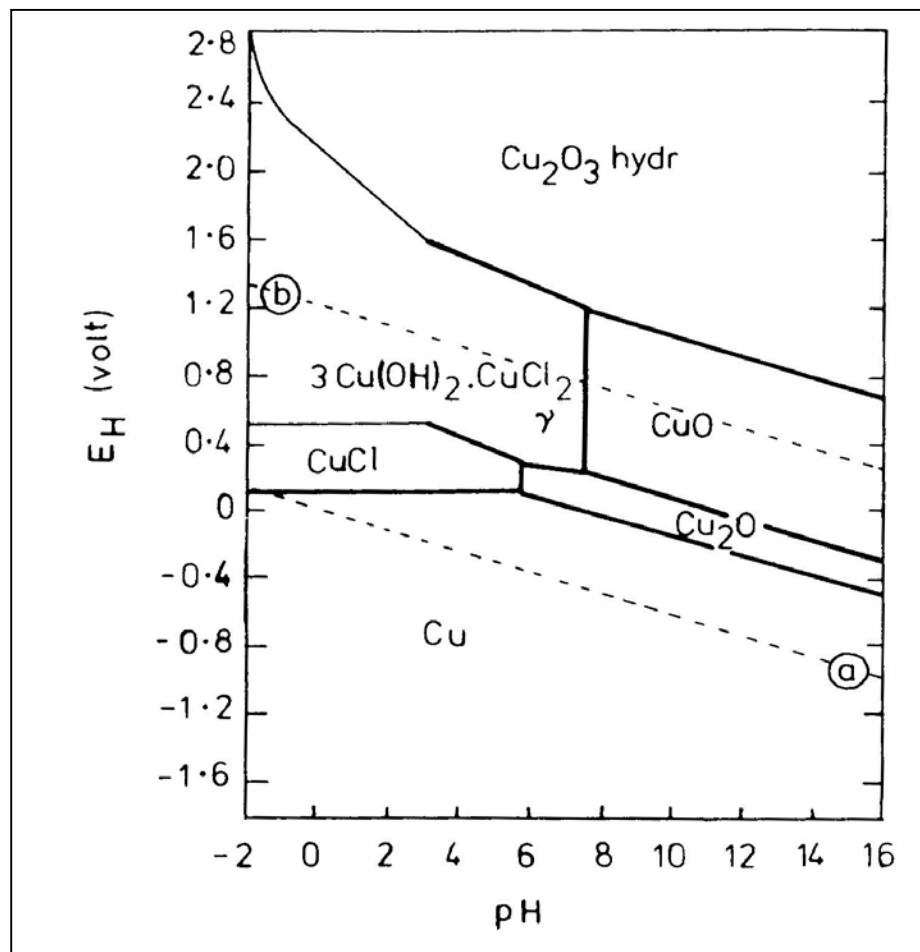
Fig 2. Pourbaix diagram for the following equilibrium conditions for Cu-Cl-H<sub>2</sub>O at 25°C at 1 molar chloride.
